Failure analysis of pulverizer pipe elbow in PLTU boiler

Hendri Chandra¹, Rizki Zulkarnain^{2,*} and Muhammad Rafli Fazal³

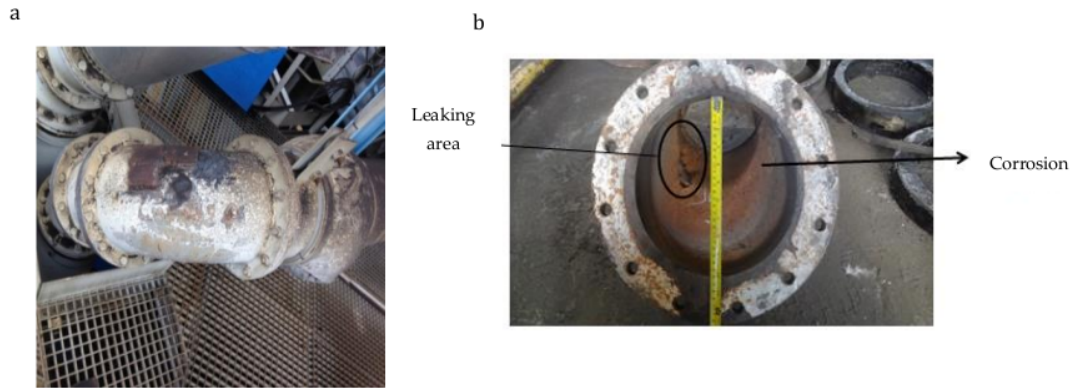
pipe there has been loss of metal which is indicated by a leak on the surface of the pipe so that a patch is made on the pipe as shown in the Figure 3 below.

Figure. 3. (a) The condition of the pulverized pipe in operation; (b) Observation of the pulverizer pipe elbow on the inside

From the results of observations focused on pulverized pipes in the field that are no longer used, it shows that in general these pipes have suffered wear damage due to abrasive powdered coal fluid flowing in the pipe due to the abrasive flow of powdered coal fluid flowing in the pipes and based on the chronology of the pulverized pipes, they have undergone pipe replacement (re-piping), and repairs by patching using silicon so that the pipe can still operate.

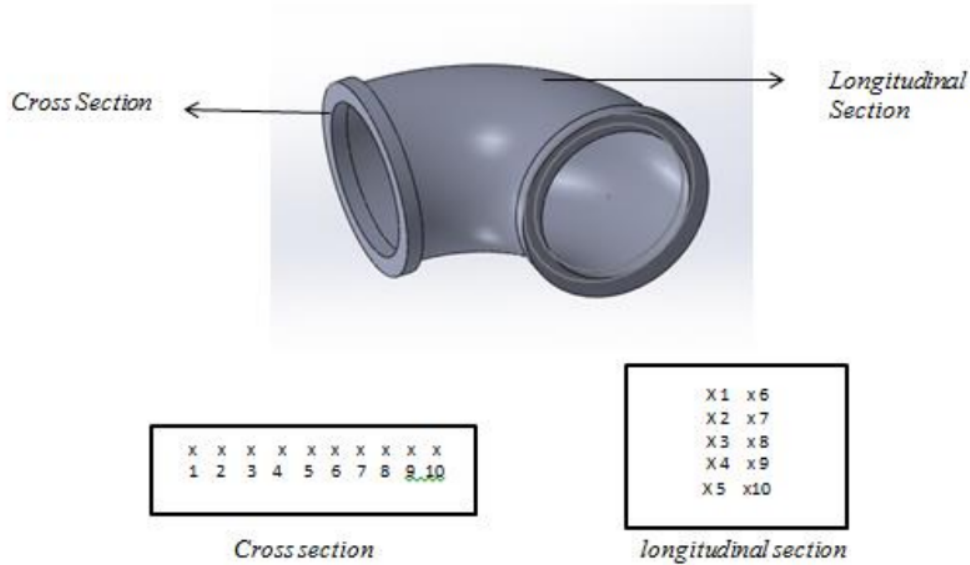
Figure. 4. Hardness testing sketch

It can be seen from the table above that the hardness value in the sample has a nominal minimum hardness value of 155.01 HV in the cross section and 170.59 HV in the longitudinal section. If the hardness value of the elbow material is harder than the hardness value of the coal particles, then the elbow material will be more resistant to abrasiveness. While the hardness value of coal is 59 HGI, this shows that the elbow surface material is harder than the coal particles flowing in the pulverizer pipe.

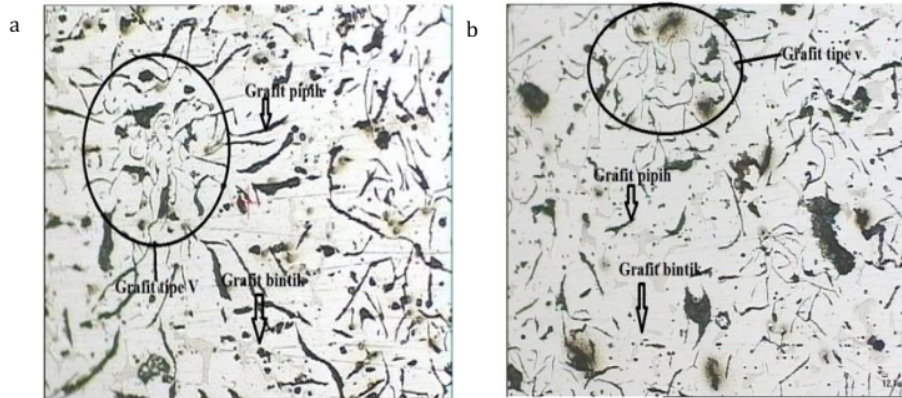
Figure 5. (a) Cross section before etching 100x magnification; (b) Longitudinal section before etching 100x magnification

The results of microstructural observations on elbow samples in the cross section and longitudinal section before etching showed that the gray cast iron was flake graphite type V (with star-like graphite). From the picture above it can be seen that the condition of the sample is not good, there are lots of nodules and corrosion which indicates that the elbow has many indications of defects caused by abrasives caused by coal particles flowing in the pipe, especially in the longitudinal section there is a lot of corrosion and nodules. so that the microstructural image of the sample is somewhat different from the microstructural image of gray cast iron in general. The microstructure was carried out at three points in each cross section and longitudinal section, from the figure above it shows that from microstructural observations before etching on the elbow samples which were directly affected by the abrasive the results showed that there were many defects in the samples.

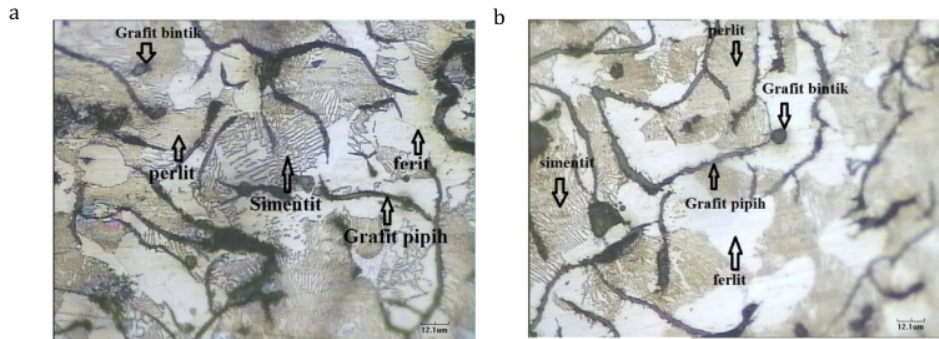
The results of observing the microstructure after etching show that the microstructure of the elbow material is ferrite (white), pearlite (black), cementite and graphite. Ferrite has clay properties, pearlite is ductile and has excellent wear resistance, so cast iron is a very suitable material for pipes. Cementite is very hard so that cementite deposition causes wear resistance. Graphite is a soft and brittle crystalline form of carbon. The state of the pieces of this graphite has a great influence on the mechanical properties of the casting, with graphite in the form of flakes causing stress concentrations at the edges (Figure 6).

Figure. 6. (a) Cross section after etching magnification 500x; (b) Longitudinal section after etching magnification 500x

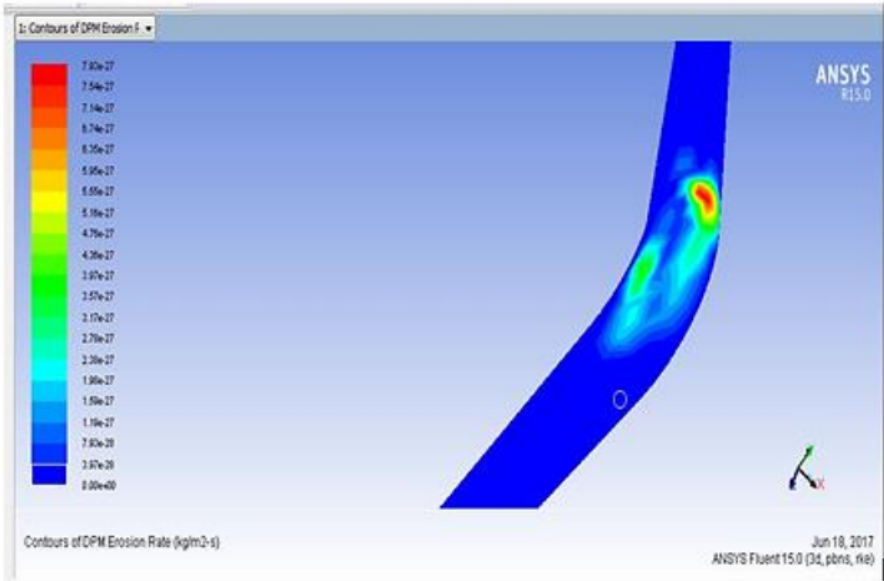
Figure 7. ANSYS erosion corrosion modeling

The results of the ANSYS simulation in the figure above show that the main factor causing the leaking of the pulverizer pipe elbow is erosion corrosion as shown in the figure, in the leaking area the concentration of corrosion is higher than in other areas, which is indicated by the presence of a red color in the area. Areas affected by erosion corrosion are marked in light blue, green, yellow and red, the magnitude of the maximum erosion corrosion value that occurs in the pulverizer pipe elbow with an erosion rate of $7,93 \times 10^{-27}$ kg/m²s.

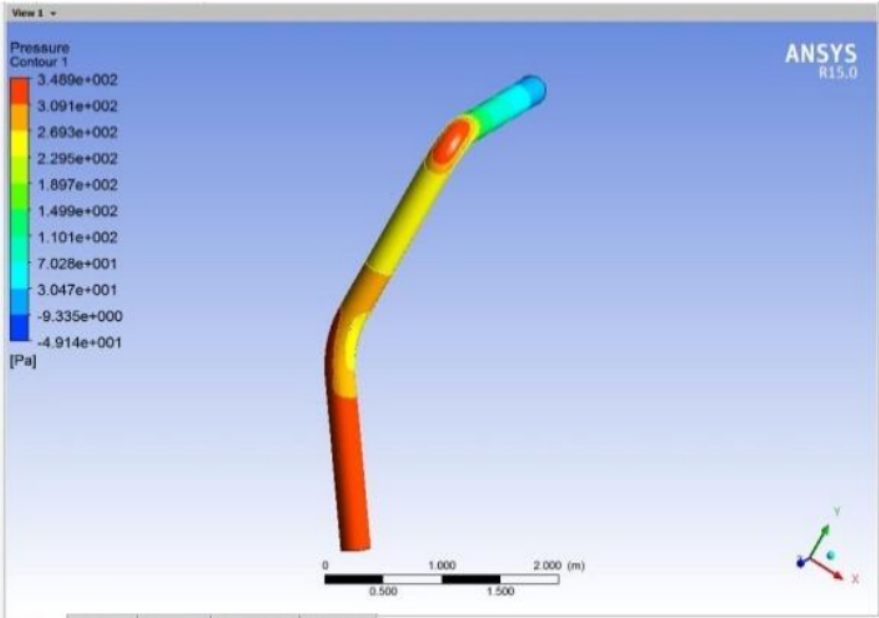
Figure 8. ANSYS pressure contour modeling results

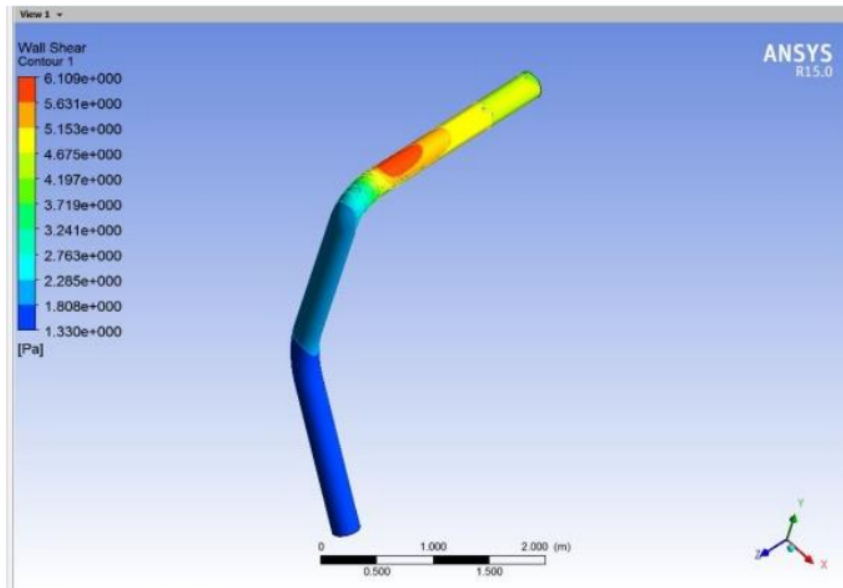
Figure. 9. Results of ANSYS shear stress contour modeling

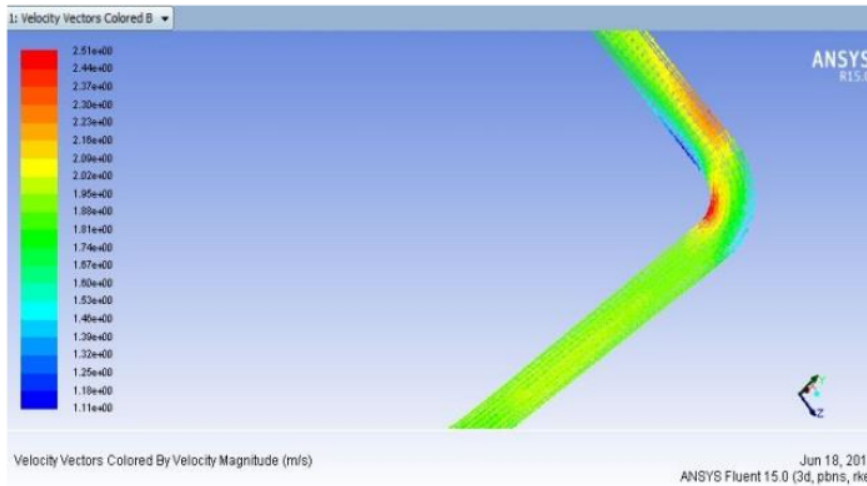
Figure. 10. ANSYS speed vector modeling results

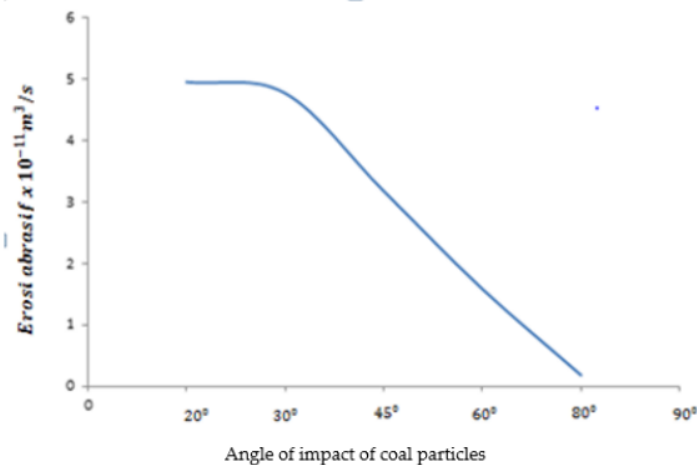
Figure. 10. Graph of erosion rate relationship with impact angle

From the calculation above it can be concluded that the greatest erosion rate occurs at an angle of 20° with a value of $4,9548 \times 10^{-11} \text{ m}^3/\text{s}$, the smaller the angle of impact of coal particles hitting the pulverizer pipe elbow material, the greater the erosion rate that occurs in the pulverizer pipe elbow material. The angle of impact of coal particles on the pulverizer pipe elbow affects the rate of erosion which causes damage to the material.
