The Soft Story Challenge to Architectural Design in Earthquake-Prone Areas

Livian Teddy* & Gagook Hardiman

ABSTRACT

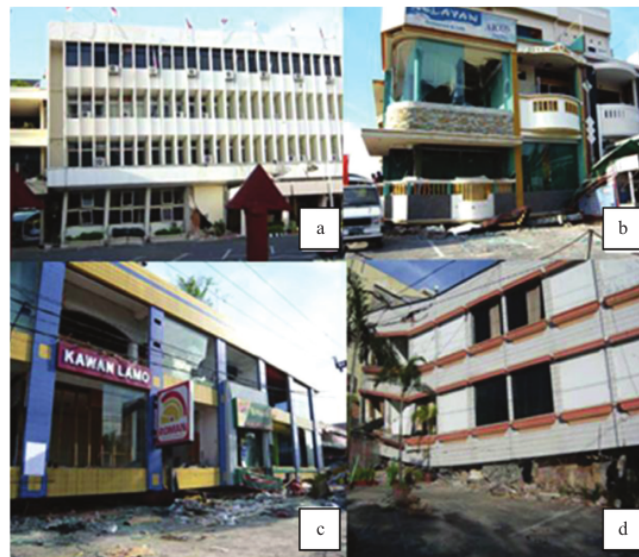
FIGURE 2. The Padang earthquake on September 30 & October 1, 2007: a). The Office of DPU Padang experienced a soft story on the 1st floor but it was still survived, b). The shophouse 3 stories experienced severe a soft story at the 1st floor. This floor collapsed, and the 2nd & 3rd floors fell on it, c). & d). The commercial building experiencing a severe soft story at the 1st floor. This floor collapsed, and the 2nd & 3rd floors fell on it (source: <http://www.perencanaanstruktur.com/2010/10/bentuk-keruntuhan-bangunan-saat-gempa.html>).

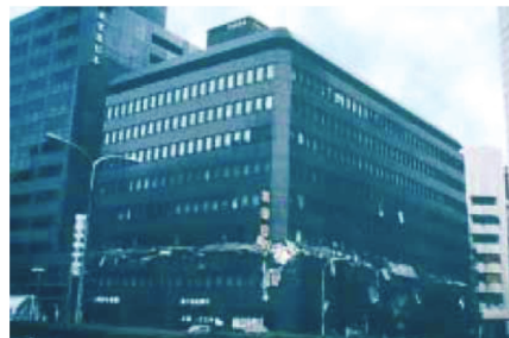
Soft stories often occur on the first floor, but they may also occur at any floor provided the stiffness of a floor is the weakest compared to other floors (Figure 4).

FIGURE 4. The Kobe Earthquake of 1995, the third story of the commercial building was lost and the above stories fell on it (source: Bachmann 2003).

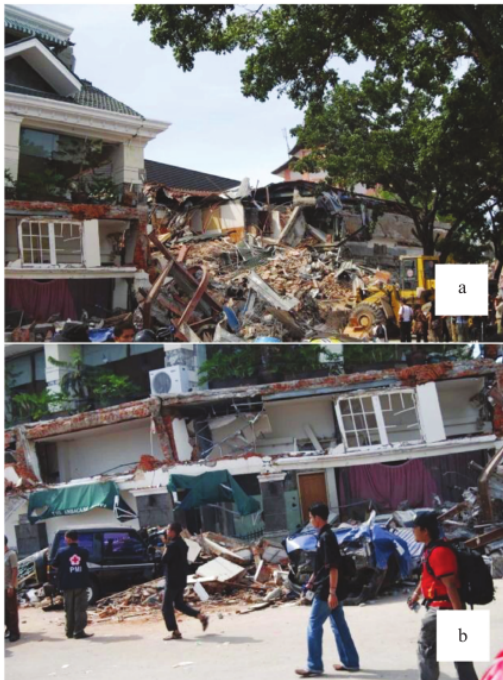
One of the most controversial cases was the collapse of Hotel Ambacang that killed 200 people. The hotel possibly suffered 'sandwich' collapse because of the soft story. In this case, the first and second floors were made of reinforced concrete material while the third floor above them was made of steel material (Figure 5). The difference of stiffness between the two materials had caused the steel structures suffered structural failure due to poor detailing, and then they fell onto the lower concrete structures.

FIGURE 5. West Sumatra Earthquake in 2009, Hotel Ambacang suffered 'sandwich' collapse (source: <http://xa.yimg.com/kq/groups/17587015/808630997/name/Kerusakan+Gedung+-+GB+Padang.pdf>).

The case above can be minimized by creating the steel structure having the same stiffness as the stiffness of the concrete structure such as adding bracing and improving the

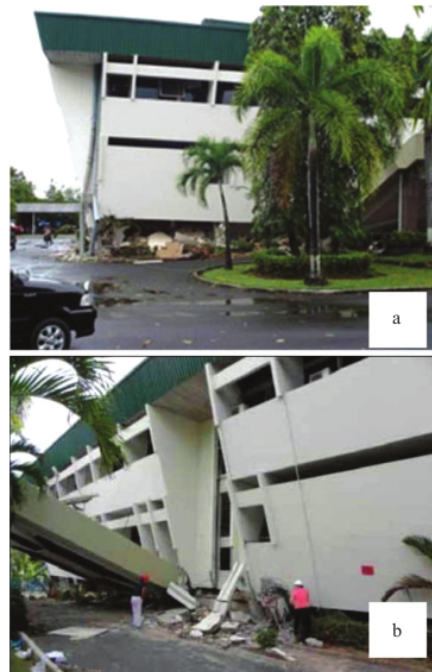
This building consisted of three floors and made of reinforced concrete. Soft story occurred on the first floor had caused the floor to collapse while the second floor above was relatively intact (Figure 7). The shape of the building, like reversed pyramid, had caused a weak story at the first floor. In addition, the quality of concrete was also inadequate.

FIGURE 7. West Sumatra Earthquake in 2009. The first floor of BAPPEDA Office collapsed, but the second floor above it was relatively intact (source: Wilkinson et al. 2012).

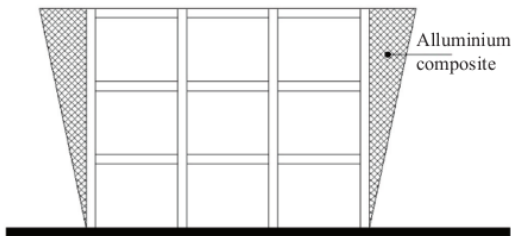
FIGURE 8. Weak story due to reversed pyramid form can be minimized by using flexible and light materials like aluminum composite

Weak story in the aforementioned case happened when shear capacity increased because of the use of concrete planks and other concrete elements that formed a reversed pyramid and made the shear capacity and stiffness at the first floor smaller than other floors which then led to soft story. This case can actually be solved by forming wings of the reversed pyramid from flexible and light materials such as aluminum composite (ACP), so the increase of its shear capacity and stiffness is not so significant (Figure 8).

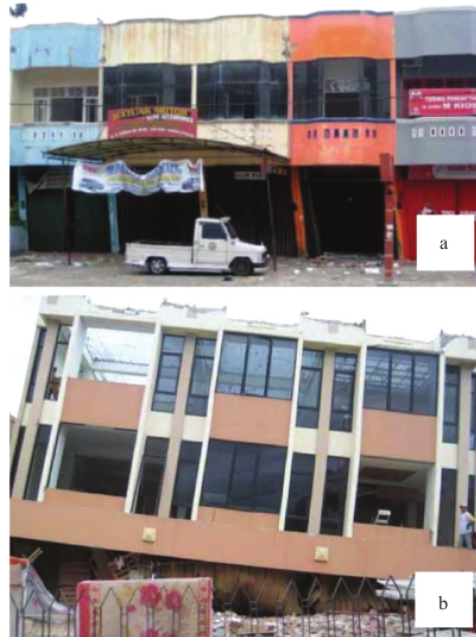
Ruko (rumah toko)/ a shophouse is a commercial building that dominates cities in Indonesia including in earthquake-prone cities such as Banda Aceh, Bengkulu and Yogyakarta. Generally they have typical square shape where the facade has rolling gates and large windows, and shophouse units are separated by brick walls and structures made of reinforced concrete. This condition makes the shop's transversal direction more rigid than its longitudinal direction. When there is earthquake's lateral shaking, the first floor experiences a 'sway mechanism' in the direction of the longitudinal axis. Inadequate column shear capacity which is worsened by the habit of planting utility pipes in the column (Figure 10b), lack of column ductility, and poor construction have caused the residual drift (Figure 9a). If the shophouse unit is single or less, the sway mechanism on the first floor can cause 'sandwich' collapse (Figures 9b & 10a).

FIGURE 9. West Sumatra Earthquake in 2009, a). Ruko/ shophouses undergoing residual drift, b). The first floor of the shophouses collapsed (source: Wilkinson et al. 2012).

The previous case can be minimized by increasing the stiffness of the first floor, that is utilized as a living space, with room's partitions from brick walls while the upper floor is utilized as commercial unit.

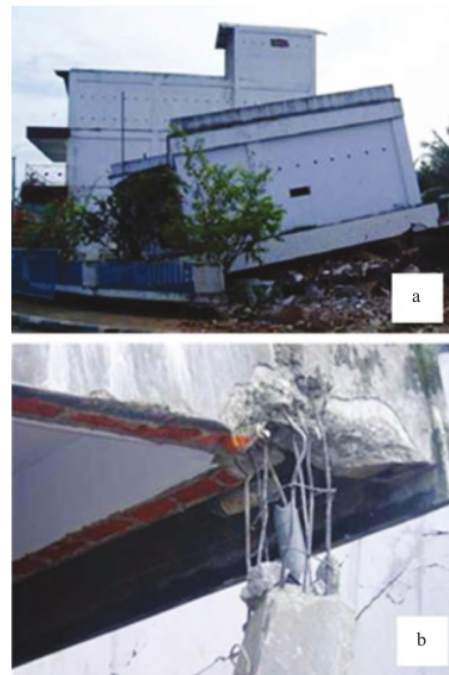
FIGURE 10. Bengkulu Earthquake in 2007, a). The collapsed shophouses, b). Planting utility pipes in the column (source: Boen 2007a).

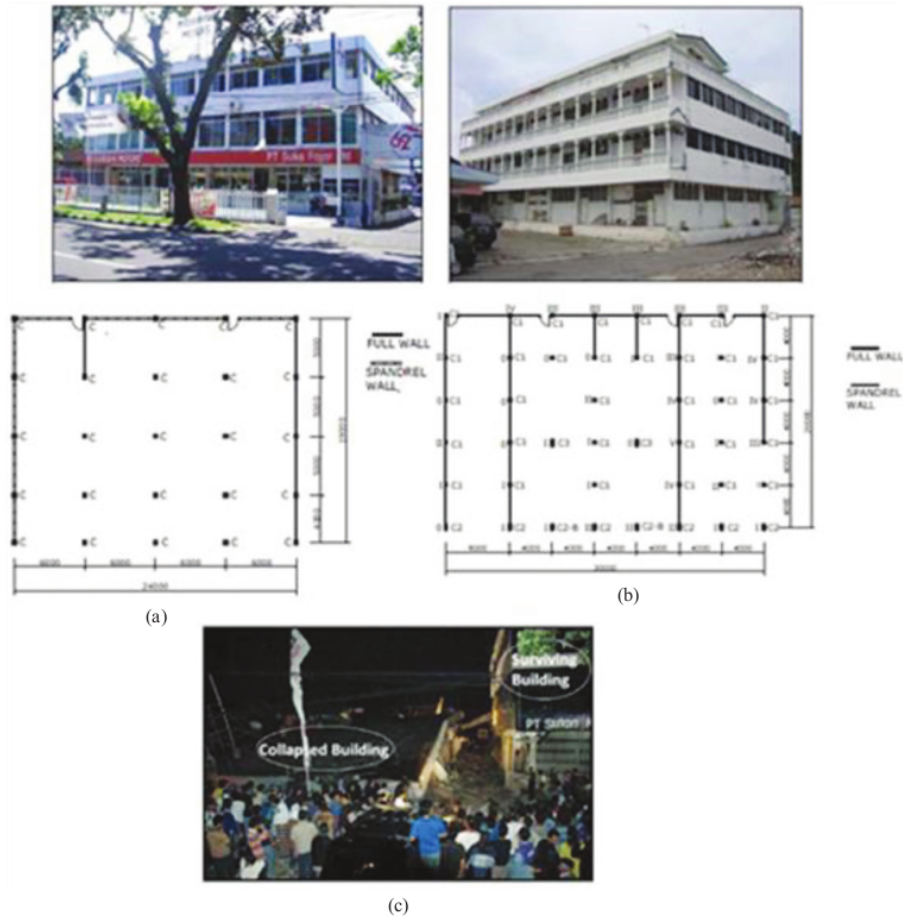
Motorcycle Show Room

Maidiawati (2013) investigated the effect of wall infill towards the soft story in buildings. The study was conducted in two showrooms buildings experiencing the 7.6 M_v scale earthquake on September 2007 at Padang. Although both showrooms had the relatively same shape, they experienced different conditions. The first showroom underwent 'sandwich' collapse (Figures 11a & 11c) while the second showroom still stood though suffering moderate damage (Figures 11b & 11c).

Maidiawati's dissertation concludes that the first showroom experienced 'sandwich' collapse condition due to the softstory on the first floor. This condition is caused by the difference of wall infill where the first floor was only 0.15% while the upper floor was more than 1%. This condition then created significant stiffness difference, so when a strong earthquake occurred, the first floor was not strong

enough to hold it. On the other hand, the second showroom still stood even though suffering moderate damage because the wall infill was more than ($>$) 1% in every floor and its distribution among the floors was relatively even. When the strong earthquake occurred, all the floors were able to collectively withstand it.

FIGURE 11. Padang Earthquake in 2007, a). The collapsed showroom, b). The surviving showroom, c). The picture of both collapsed and surviving showrooms (source: Maidiawati 2013).

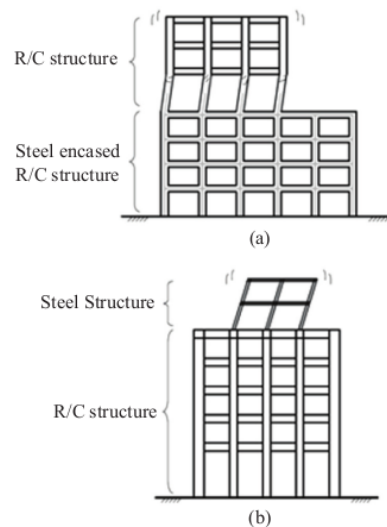
- Combining materials with different stiffness as the main structure of a building (Figures 12a & 12b). In figure 12b, parts of the building made of steel can still function as a service unit and not as a living unit.
- Inadequate structural ductility and poor construction.

FIGURE 12. Buildings having different materials can cause soft story (source: JIA and JASO 2012)
