Failure Analysis of 304 Stainless Steel Tubes of Intercooler Carbon Dioxide Compressor

Abstract— The annual inspection of the petrochemical plant revealed that SS 304 tubes at Intercooler CO₂ Compressor have failed. Some heat exchanger tubes were found during inspection with circumferential cracks. Some analysis methods were performed to investigate heat exchanger tube failures, such as X-Ray diffraction analysis, XRF (X-ray fluorescence) analysis, hardness test, morphology analysis, and numerical analysis. Investigation results revealed that pitting corrosion has been found on the inner surface of the tube that an essential factor in initiating cracks. Moreover, some porosities were observed spread distributed on the surface sample, which is believed to reduce the mechanical and physical value of the material. The corrosion and the fact that cracks were initiated in the relatively small tensile loads sites suggest that the component failure resulted from chloride-induced stress corrosion cracking. Investigation results for heat exchanger parameters, chloride content, and temperature operation have become the main factor in initiating chloride stress corrosion cracking (CSCC). The

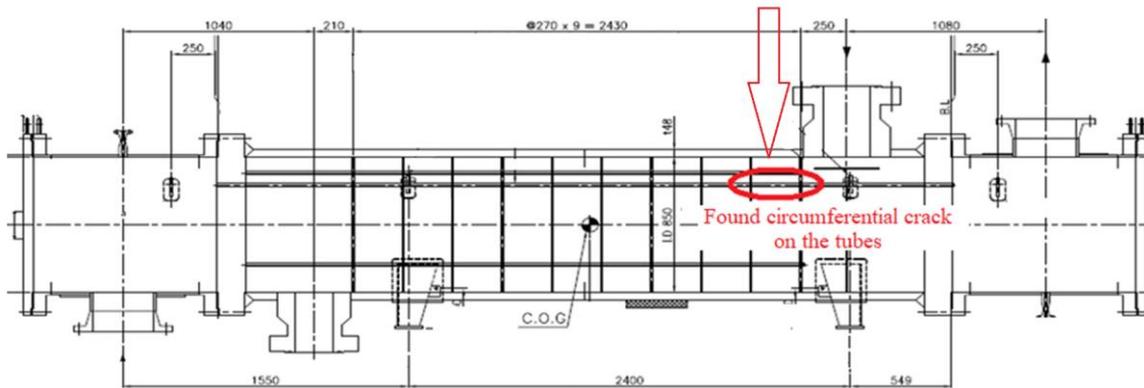
An annual inspection of a petrochemical plant revealed that the Intercooler CO₂ Compressor's SS 304 tubes had failed. Clogged heat exchanger tubes will be due to a decrease in the performance of the heat exchanger. The circumferential crack position in the heat exchanger system can be shown in Figure 1. Around 94 tubes on the upper side were clogged with deposits, as shown in Figure 2. Commonly, clogged tubes are on the top tube of the heat exchanger.

Fig. 1. Circumferential crack position in heat exchanger system.

Some tubes were removed from the bundle to analyze the leaking tubes. Visual observation shows that some circumferential cracks were observed on tubes. Furthermore, a dye penetrant test was carried out to investigate the tube's outer deeply. Circumferential cracks occur on the south tube sheet's 700–900 mm range. Moreover, the other tube occurred 900 and 1200 mm from the south when pulled out.

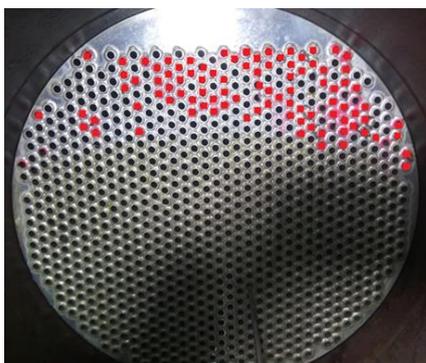
Fig. 2. Deposits of material-clogged SS 304 tubes on the top side

In this work, the analysis begins by analyzing the deposits contained in the SS 304 tubes. Deposit material composition in clogged pipes can be shown in Table 1. the main composition of the deposited material is silicon dioxide (31.88%). Based on the analysis results, the water used is believed to have been polluted by fly ash from the generator located near the heat exchanger system. The high content of SiO₂ evidences this. SiO₂ is the main constituent component of fly ash.

Mechanical removal was conducted to clean the deposited material in Stainless steel 304 tubes. Furthermore, a leak test was conducted to investigate the tube leaks. One hundred forty-nine tubes were found in leaked condition after testing using compressed air at 7 kg/cm² on the middle area.

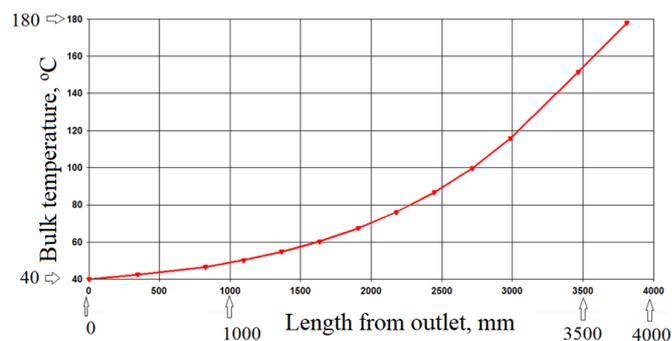
Figure 4. shows the numerical analysis result of the temperature gradient shell of the heat exchanger. Shell temperature increases significantly from the outlet heat exchanger. Moreover, the temperature gradient tube rises with increasing distance from the outlet, as shown in Figure 5.

Fig. 4. Temperature gradient shell side

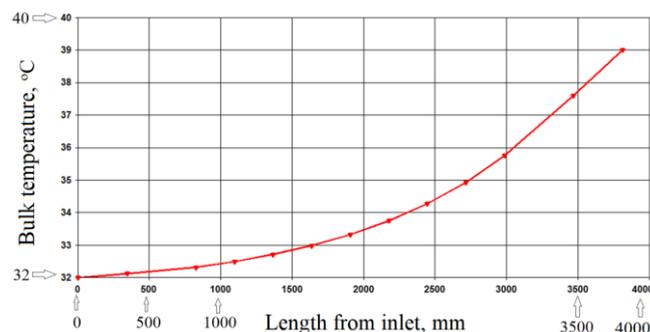
Fig. 5. Temperature gradient tube side

Circumferential cracks positioned on the tube were found between 3480 to 3750 mm. Let's take the length of 3500 mm as a sample position. According to Figures 4 and 5, at the current position, the bulk temperature of the shell side is 155 °C, and the tube side is 37.7 °C. It is assumed that the heat transfer convection coefficient of water flowing in the tube is approximated at 500 to 1200 W/m²K and 10 to 350 W/m²K for gas flow between tubes. The temperature distribution inside the tube wall between 77.7 to 82.6 °C is seen in Figure 6.

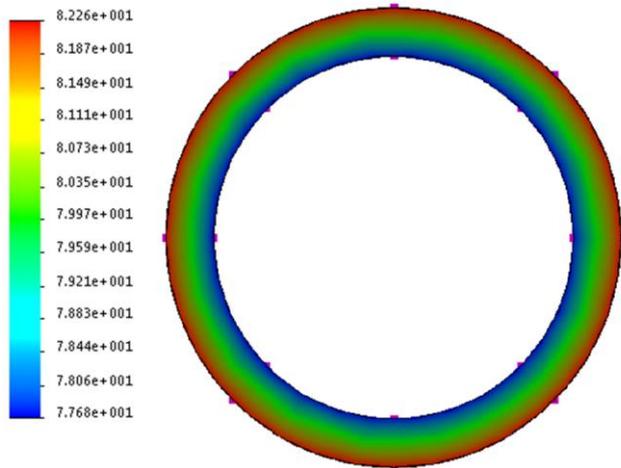
Fig. 6. Temperature distribution inside tube wall

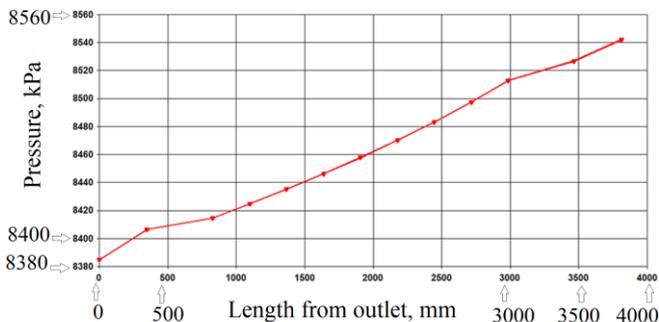
Fig. 7. Pressure Gradient shell side

Figure 7 shows that the pressure increases with the length; at 3500 mm, the pressure was obtained at 8530 kPa. On the other hand, the pressure tube side decreases with the length, as shown in Figure 8. At a position of 3500 mm, a stress analysis is performed with the higher stress distribution located inside the tube wall, as shown in Figure 9.

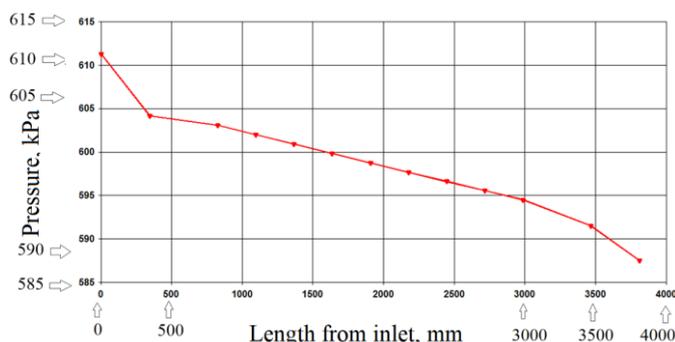
Fig. 8. Pressure Gradient tube side

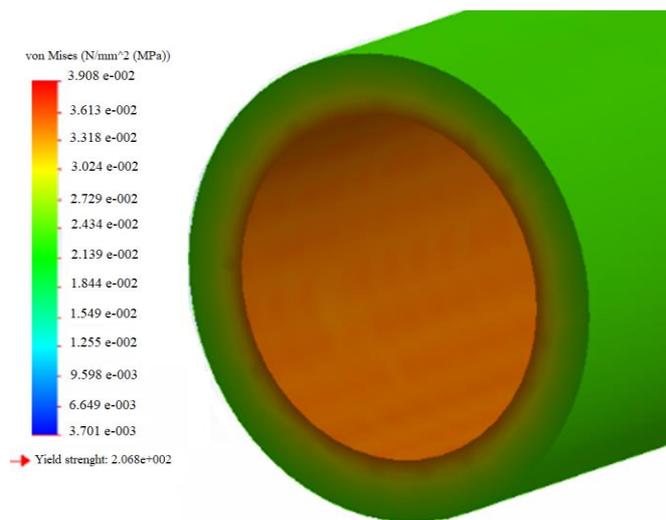
Fig. 9. Stress analysis tube side

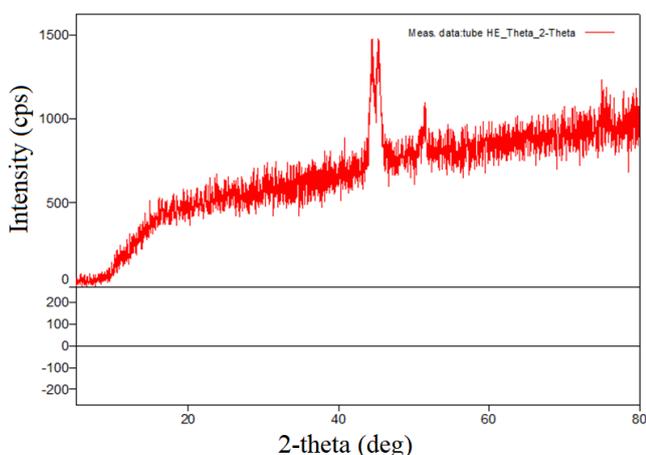
X-ray diffraction analysis is a common means to determine the structure and relative configuration of solid compounds in a certain way. XRD result of the tube material is shown in Figure 10. XRD analysis shows another peak in the tube material sample was not found. Regarding this result, the transformation phase is not occurring on tube material. In other words, the material does not experience a state where it can change its phases, such as high temperatures or mechanical processes.

Fig. 10. X-ray diffraction result for tubes material

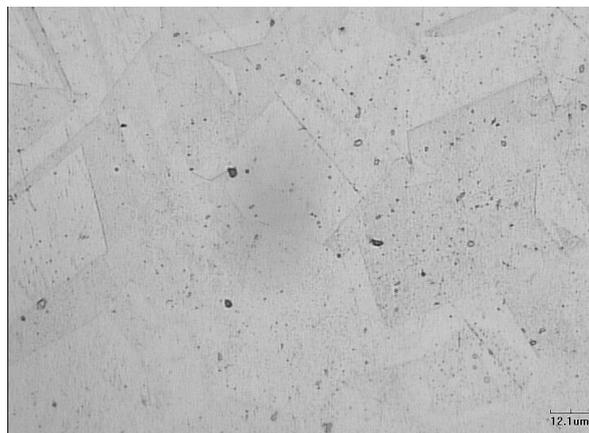
Fig. 11. Microstructure of austenitic stainless steel 304 tube

Morphology observation was carried out utilized by the digital microscope and optical microscope. Figure 11 revealed an austenite structure, characterized as austenitic stainless steel 304.

Moreover, porosities and pitting corrosion were evenly distributed on the surface sample, as shown in Figures 11 and 12. The occurrence of porosity was believed to be due to manufacturing results. On the other hand, pitting corrosion occurs due to unsuitable conditions for SS 304.

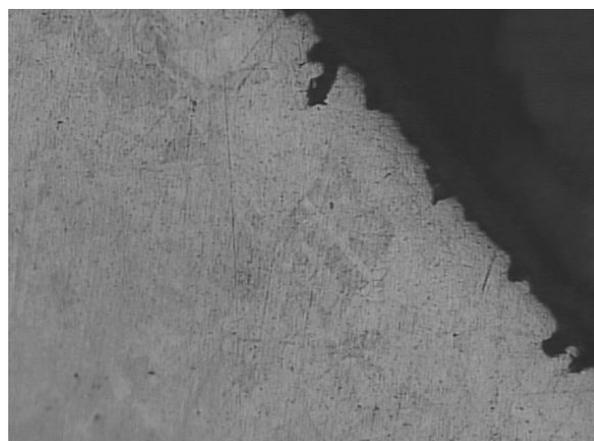
Fig. 12. Microstructure of austenitic stainless steel 304 with some porosity on the surface.

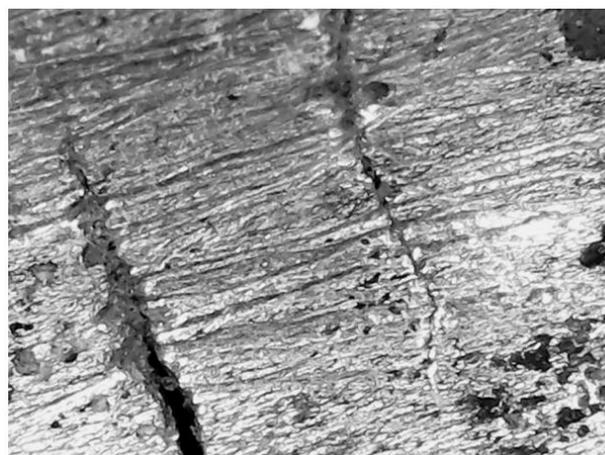
Figure 13 show some cracks found on the tube's inner surface, which were believed to be stress corrosion cracking. All of the cracking has a similar pattern (circumferential crack).

Fig. 13. Inner surface morphology of tube

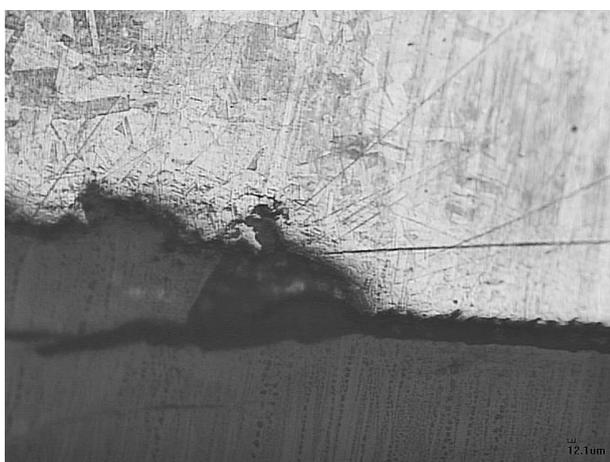
If the required electrochemical, mechanical, and metallurgical conditions are fulfilled, cracks may initiate already-existing surface flaws, or corrosion processes may generate a surface imperfection through pitting or localized corrosion. Pits, manufacturing defects, and intergranular corrosion, which all contribute to SCC start, are visible and identifiable, as demonstrated in Figure 14 pitting corrosion in an inner tube.

Fig. 14. Cracks start from corrosion pits.

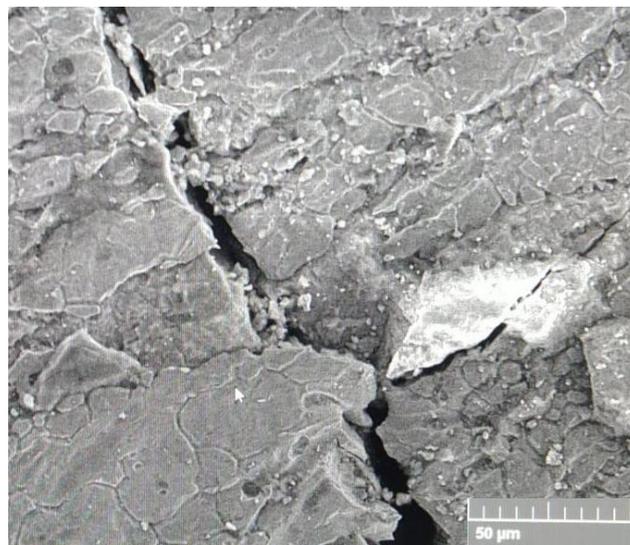
Figure 15 shows SEM analysis of the crack on the inner surface of the tube. Morphology analysis for the cracks revealed that the fracture surface is characterized as transgranular fracture, which is the crack propagation along grain boundaries.

Fig. 15. SEM micrographs of Chloride stress corrosion cracking.
