# WATERWALL TUBE BOILER DAMAGE ANALYSIS IN A 150 MW STEAM POWER PLANT

Lugantha Perkasa<sup>1</sup>, Agung Mataram<sup>2</sup> & Irsyadi Yani<sup>3</sup>

<sup>1,2,3</sup>Mechanical Engineering, Sriwijaya University

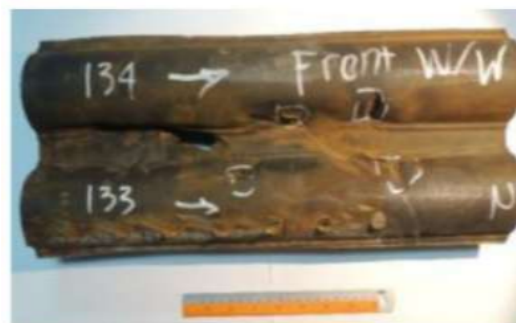
Figure 3. Waterwall Tube Boiler

Figure 3. Below is the material used in the research in the form of a waterwall tube cut in a CFB (Circulating Fluidized Bed) boiler at a steam power plant in South Sumatra that has failed. Prior to the testing process, the material will be subjected to a size reduction process using a wire cut machine.

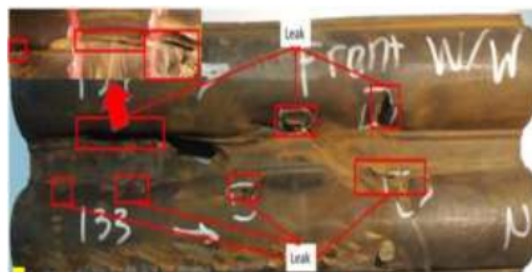
Figure 6 below is a part of the boiler tube waterwall that has failed and which will be carried out a microstructure analysis

**Figure 6. Indication of leakage of boiler tube waterwall**

Based on Figure 6, the leak is clearly indicated on the boiler tube. Most of the waterwall tube leakage comes from the welded joints between the plate and tube / tube. Leakage can also be observed from the outer diameter and the inner diameter of the tube as shown in Figure 7b and Figure 7c. Whereas in Figure 7a, you can see the erosion path in the waterwall tube that is leaking and the direction of the erosion comes from the position of the waterwall tube boiler which is leaking.

Based on figures 6 and 7 above, it can be observed that the inner surface of the boiler tube waterwall has no crust and no signs of erosion. However, other leaks are caused by thinning walls due to erosion. This thinning of the tube walls is caused by cracks that open causing the discharge of high velocity fluids to hit the surrounding surface creating erosion failure.

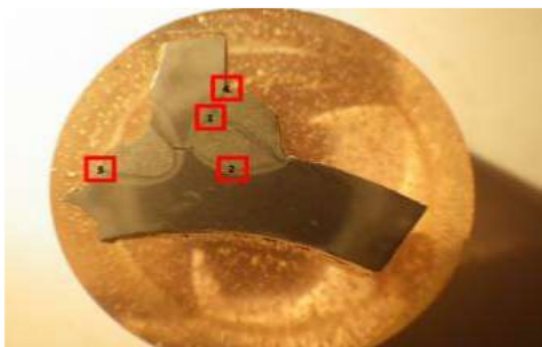
**Figure 8. Waterwall Tube Metallographic Test Specimen 1**

Waterwall tube boiler specimens were prepared for metallographic testing. Preparation for metallographic testing begins with mounting, grinding, polishing, etching, and observation. Etching is carried out using a nital solution to reveal the microstructure of the material. Metallographic testing is carried out on the welded waterwall tube joint because it is the origin of the leak.

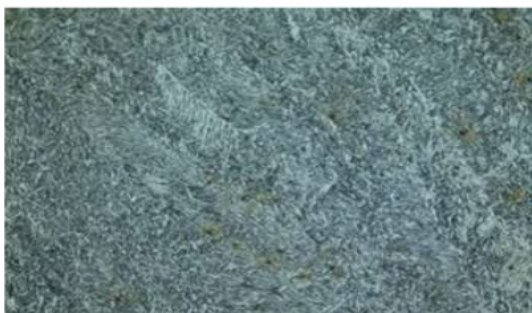
**Figure 9. Micro Structure of Water Wall Tub at location 1 - Welding metal with 500X magnification**

Microstructure analysis of boiler tube waterwall using metallographic testing was carried out in the area of the weld joint between the plate and tube because this area was the most leaking area. The analysis was carried out on the base metal, weld metal, and the heat affected zone (HAZ). The analysis showed that the metallographic structure of the weld joint was ferrite-pearlite, normal structure of 20G. This shows that the boiler tube waterwall is not induced by excess heat (Du et al., 2014).

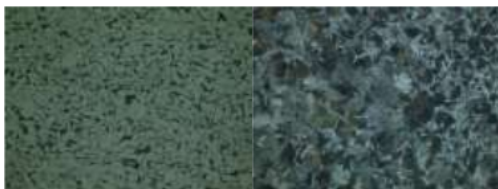
**Figure 10. Micro Structure of Water Wall Tube 1 at location 1 - Base and HAZ with magnification 500X**

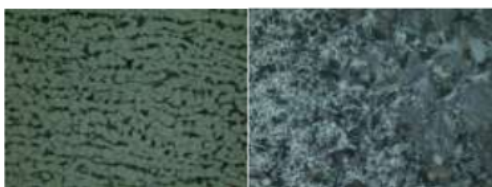
**Figure 11. Micro Structure of Water Wall Tube 1 at location 2 - Base and HAZ with magnification of 500X**

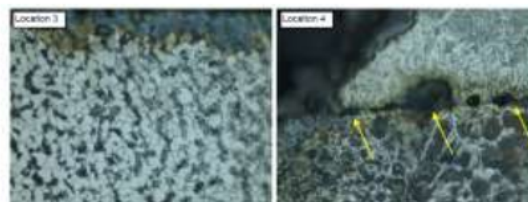
**Figure 12. Micro Structure of Water Wall Tube 1 at locations 3 and 4 with a magnification of 500X.**

Figure 12 shows the microstructure of the weld joint. The lack of fusion in the side wall of the boiler tube waterwall weld connection has

the potential to be the cause of the initial crack or the beginning of the crack. Under the influence of cyclic loads such as cyclic thermal, this fusion deficiency can propagate if the waterwall tube boiler is exhausted.

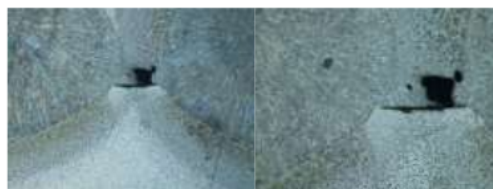
**Figure 14. Waterwall tube microstructure with magnification of 100X and 500X**

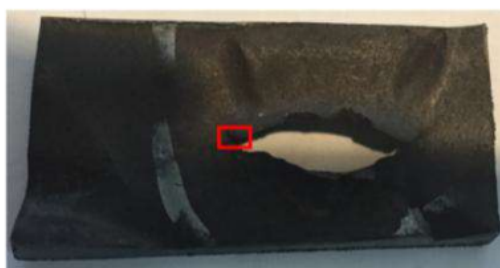
Figure 15. SEM test specimens for boiler tube waterwall

Scanning Electron Microscopy (SEM) observations were taken on the surface area of the waterwall tube boiler leak fracture as shown in Figure 15.

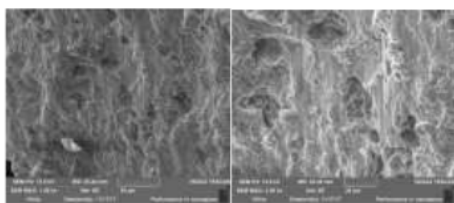
Figure 16. SEM observations of waterwall tube with 1000X and 2000X magnification

The surface in Figure 16 is covered by oxides due to corrosion. A little indication of dimple was found under observation with 2000X magnification. Dimple in tube failure usually associated by thinning rupture occurred on the tube. EDS analysis was not performed due to lack of corrosion product found on the surface of area of failure.
