# Failure Analysis of 304 Stainless Steel Tubes of Intercooler Carbon Dioxide Compressor

Amir Arifin, *Member, IAENG*, Gunawan, Irsyadi Yani, and Hengki Irawan

**Index Terms**—SS 304, chloride stress corrosion cracking, heat exchanger tube, failure analysis.

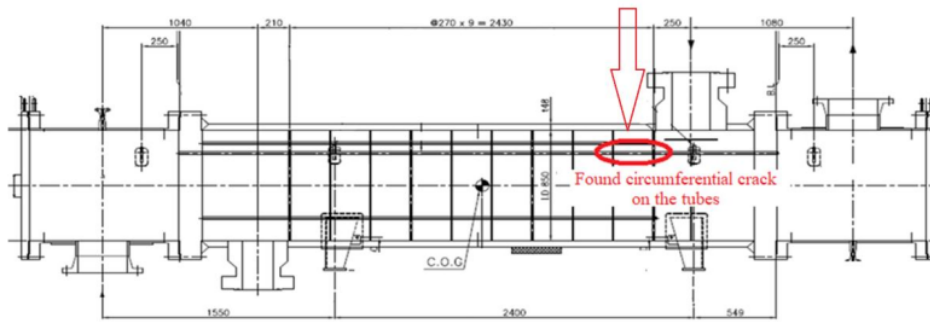
An annual inspection of a petrochemical plant revealed that the Intercooler CO<sub>2</sub> Compressor's SS 304 tubes had failed. Clogged heat exchanger tubes will be due to a decrease in the performance of the heat exchanger. The circumferential crack position in the heat exchanger system can be shown in Figure 1. Around 94 tubes on the upper side were clogged with deposits, as shown in Figure 2. Commonly, clogged tubes are on the top tube of the heat exchanger.

Fig. 1. Circumferential crack position in heat exchanger system.

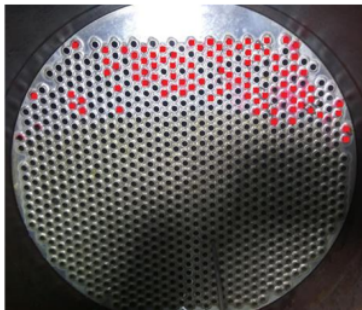
Fig. 2. Deposits of material-clogged SS 304 tubes on the top side

In this work, the analysis begins by analyzing the deposits contained in the SS 304 tubes. Deposit material composition in clogged pipes can be shown in Table 1. The main composition of the deposited material is silicon dioxide (31.88%). Based on the analysis results, the water used is believed to have been polluted by fly ash from the generator located near the heat exchanger system. The high content of SiO<sub>2</sub> evidences this. SiO<sub>2</sub> is the main constituent component of fly ash.

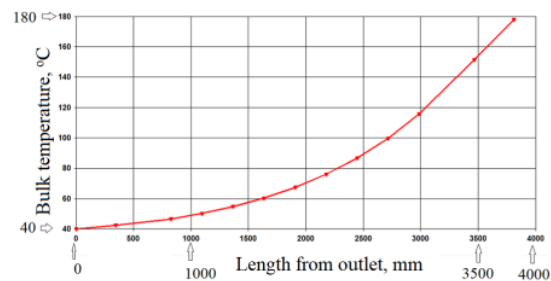
Figure 4. shows the numerical analysis result of the temperature gradient shell of the heat exchanger. Shell temperature increases significantly from the outlet heat exchanger. Moreover, the temperature gradient tube rises with increasing distance from the outlet, as shown in Figure 5.

Fig. 4. Temperature gradient shell side

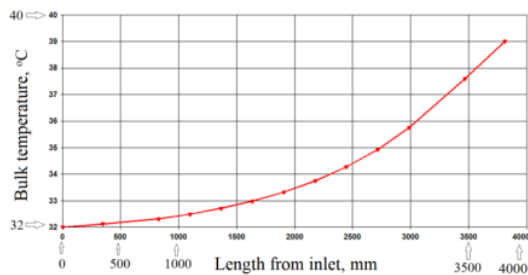
Fig. 5. Temperature gradient tube side

Circumferential cracks positioned on the tube were found between 3480 to 3750 mm. Let's take the length of 3500 mm as a sample position. According to Figures 4 and 5, at the current position, the bulk temperature of the shell side is 155 °C, and the tube side is 37.7 °C. It is assumed that the heat transfer convection coefficient of water flowing in the tube is approximated at 500 to 1200 W/m<sup>2</sup>K and 10 to 350 W/m<sup>2</sup>K for gas flow between tubes. The temperature distribution inside the tube wall between 77.7 to 82.6 °C is seen in Figure 6.

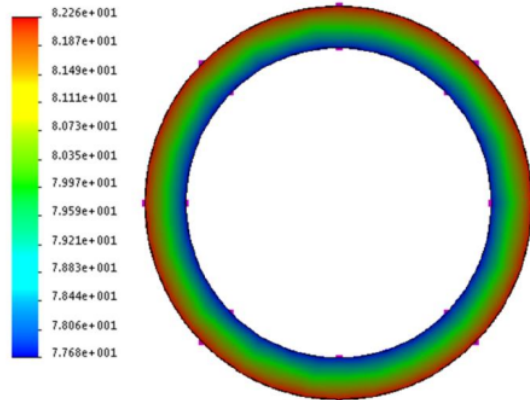
Fig. 6. Temperature distribution inside tube wall

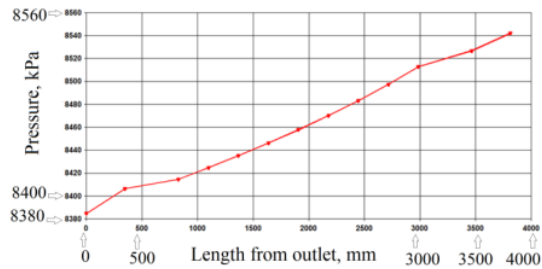
Fig. 7. Pressure Gradient shell side

Figure 7 shows that the pressure increases with the length; at 3500 mm, the pressure was obtained at 8530 kPa. On the other hand, the pressure tube side decreases with the length, as shown in Figure 8. At a position of 3500 mm, a stress analysis is performed with the higher stress distribution located inside the tube wall, as shown in Figure 9.

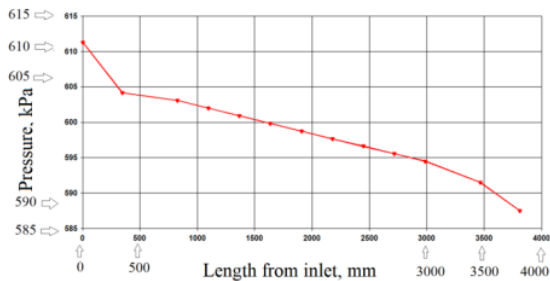
Fig. 8. Pressure Gradient tube side

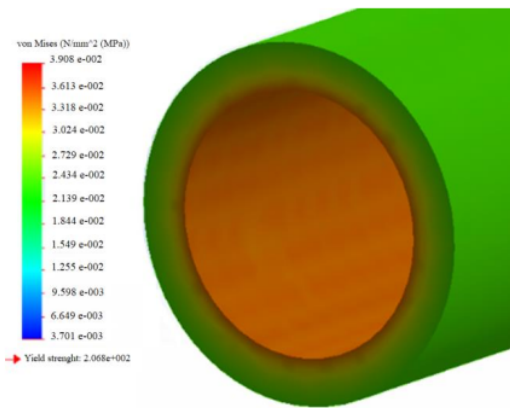
Fig. 9. Stress analysis tube side

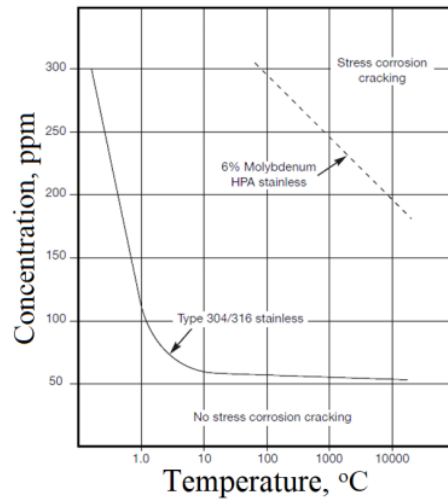
In the austenitic stainless-steel case, some factors significantly determine failure modes, such as stress, temperature, chloride concentration, and pH. Figure 10 shows the effect of temperature parameters and chloride concentration for stress corrosion cracking.

Fig. 10. Effect temperature and chloride concentration for stress corrosion cracking stainless steels [18].

In this case, chloride content in the water of the tube heat exchanger is around 44-68 ppm, and the maximum temperature operation is about 170°C, as shown in Table 3. Based on Figure 10, conclusions can be drawn that tube

43 hanger operation in the critical zone has passed the A Chloride stress corrosion cracking (CLSCC) thresholds of 304 stainless steels.

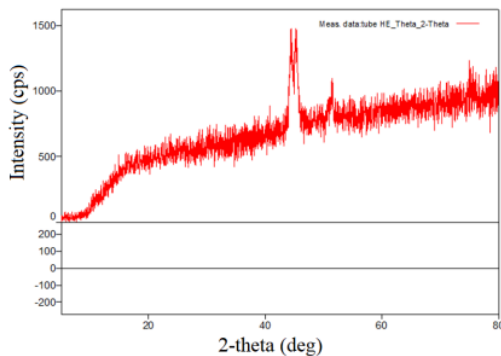
24 X-ray diffraction analysis is a common means to determine the structure and relative configuration of solid compounds in a certain way. XRD result of the tube material is shown in Figure 11. XRD analysis shows another peak in the tube material sample was not found. Regarding this result, the transformation phase is not occurring on tube material. In other words, the material does not experience a state where it can change its phases, such as high temperatures or mechanical processes.

Fig. 11. X-ray diffraction result for tubes material

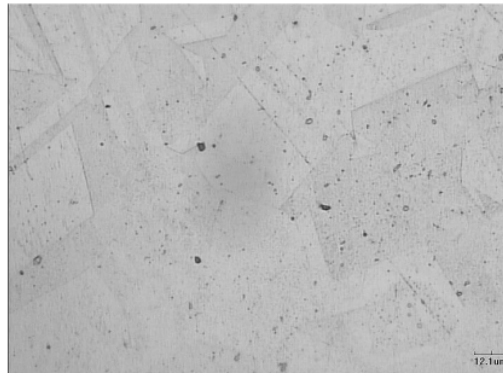
Fig. 12. Microstructure of austenitic stainless steel 304 tube

Morphology observation was carried out utilizing by the digital microscope and optical microscope. Figure 12 revealed an austenite structure, characterized as austenitic stainless steel 304.

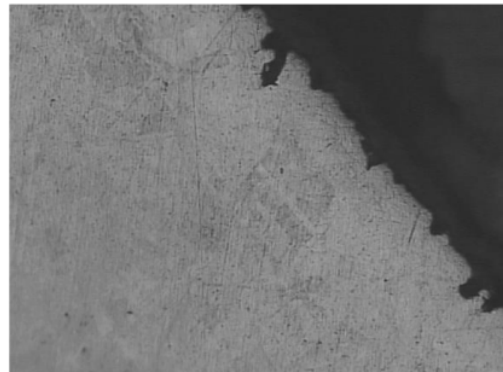
Fig. 13. Microstructure of austenitic stainless steel 304 with some porosity on the surface.

Moreover, porosities and pitting corrosion were evenly

distributed on the surface sample, as shown in Figures 12 and 13. The occurrence of porosity was believed to be due to manufacturing results. On the other hand, pitting corrosion occurs due to unsuitable conditions for SS 304.

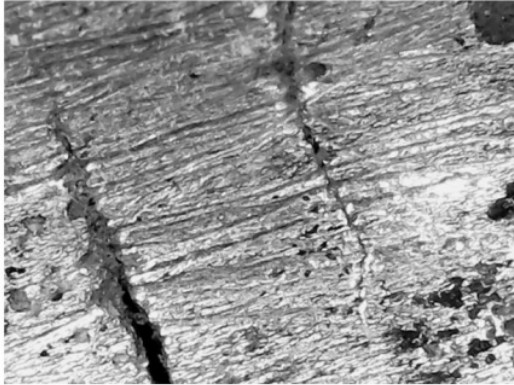
Figure 14 show some cracks found on the tube's inner surface, which were believed to be stress corrosion cracking. All of the cracking has a similar pattern (circumferential crack).

Fig. 14. Inner surface morphology of tube

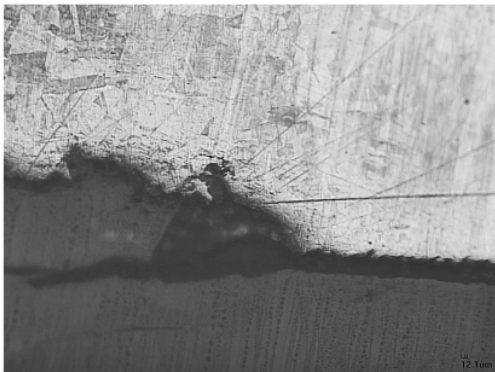
If the required electrochemical, mechanical, and metallurgical conditions are fulfilled, cracks may initiate already-existing surface flaws, or corrosion processes may generate a surface imperfection through pitting or localized corrosion. Pits, manufacturing defects, and intergranular corrosion, which all contribute to SCC start, are visible and identifiable, as demonstrated in Figure 15 pitting corrosion in an inner tube.

Fig. 15. Cracks start from corrosion pits.

Pitting corrosion is critical in initiating failure, especially under complex conditions such as pressure and temperature. In this case, some cracks were found in the inner surface of the tube. Crack initiation and propagation are different but highly related processes; when the crack has been initiated, it propagates.

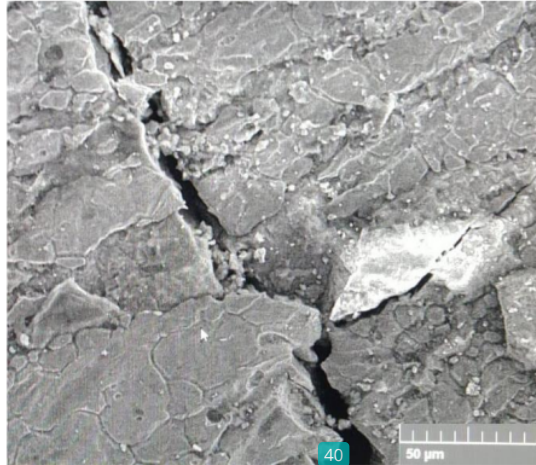
Fig. 16. SEM micrographs of Chloride stress corrosion cracking.

Figure 16 shows SEM analysis of the crack on the inner surface of the tube. Morphology analysis for the cracks revealed that the fracture surface is characterized as transgranular fracture, which is the crack propagation along grain boundaries.
