ASSESSMENT MATERIAL SELECTION FOR CHAIN - SUBMERGED SCRAPER CONVEYOR

ABSTRACT: Chain-submerged scrapper conveyor bottom ash handling in the petrochemical industry has failed several times and was repaired with AISI 420, which can only operate for three months. AISI 420 is recommended in applications requiring moderate corrosion resistance, high hardness, excellent wear resistance, and good edge retention in cutting surfaces. The initial cracks and fractures occur in the pin-link joint hole, which causes chain failure. Some evaluation has been performed for both as-received and failed links. It can be concluded that chain link failure occurs due to fatigue failure with low-stress levels. Microstructure observation, XRD, and hardness properties showed no significant difference in both as-received and failed links. Since the operating conditions of the chain are in a corrosive environment, experiencing dynamic loading and working temperatures between 23 °C and 60 °C, the selection of HSL materials such as AISI 4140 should be considered.

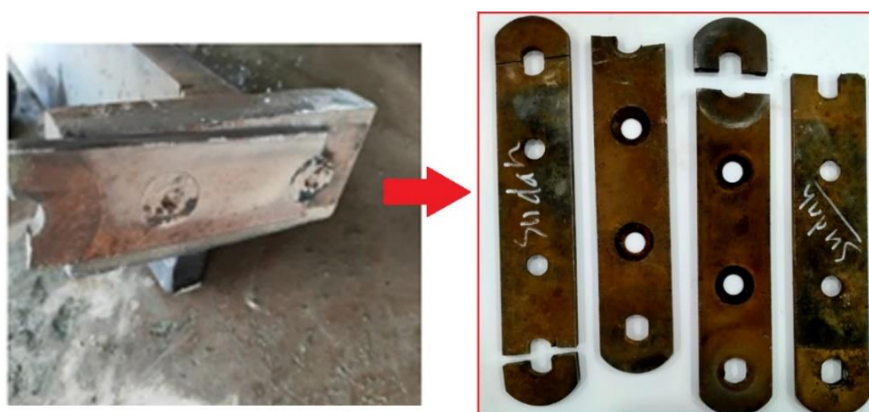
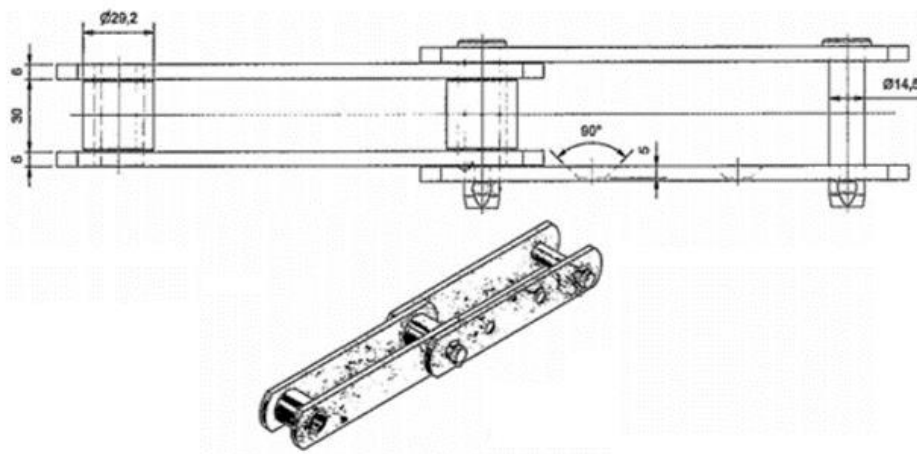
Fig. 1. Failure part of chain scrapper.

The fracture occurs in the pin-link joint hole in one or both end holes. The initial cracks were identified from the corrosion color, which was more concentrated than in other areas. There are two main areas where crack initiation occurs; first, in the area that experiences higher residual stresses due to changes in dimensions that are not streamlined (notch root); the second initial cracks occur in the middle of the pinhole. In both cases, in terms of loading condition, it is believed that the cracks occurred due to the influence of the interference fit pin-links joint assembly and cyclic loading. The failure of the chain-submerged scrapper conveyor can be seen in Fig. 1.

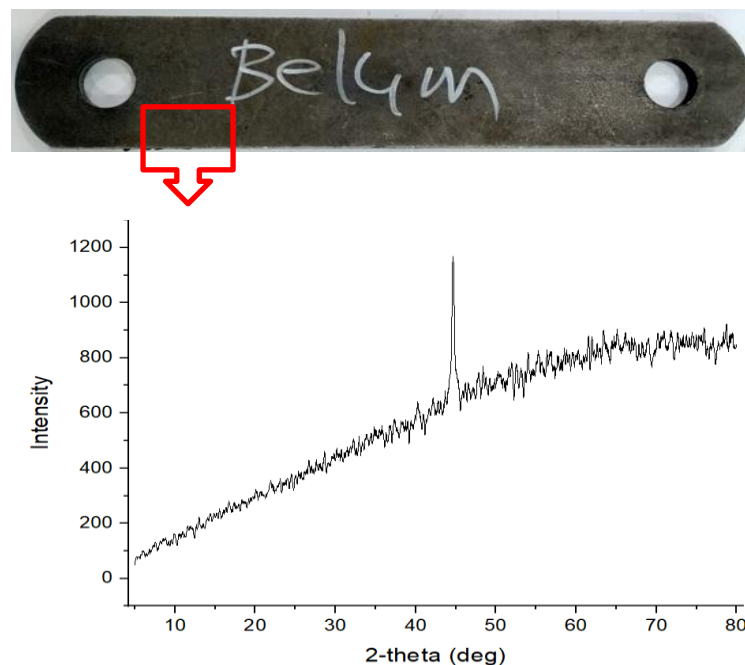
Fig. 2. XRD result of chain scrapper

X-Ray diffraction analysis is a typical means to determine the structure and relative configuration of solid compounds in an unequivocal way. X-Ray Diffraction (XRD) testing on Rigaku MiniFlex 600 with a Cu K α X-ray tube ($\lambda = 0.17889$ nm) in the Bragg–Brentano configuration. XRD result of chain material is shown in Fig. 2. XRD analysis shows there was not found another peak in the material sample.

The highest presents one peak (at 2θ angle of 44.9°) attributed to the martensite phase. The remaining peaks occurring at 37.2° , 39.3° , 40.3° , 42.5° , 43.3° , 45.6° , 48.8° , 51.5° , 55.7° and 57.7° correspond to the Fe_3C phase. The occurrence of the Cr_7C_3 and Cr_{23}C_6 phases could be suggested in the present case. Diffraction peaks occurred for 2θ angles of 37.2° , 39.3° , 43.3° , 48.8° , and 51.5° , but it should be noted that such peaks could also be indexed for the Fe_3C phase.

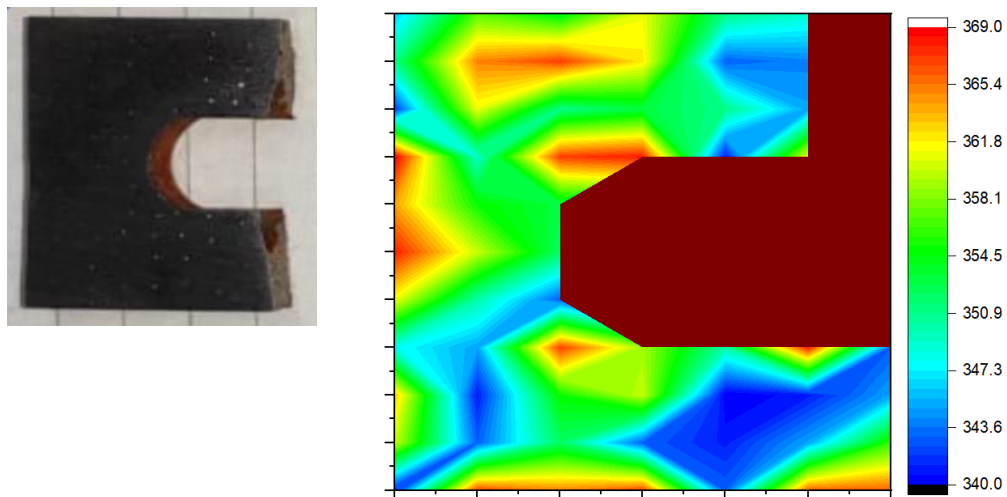
Fig. 3. Contour Vickers hardness test of surface fail link

Typically hardness distribution at various positions using Vickers (VHN) and Rockwell C (HRC) can be seen in Fig. 3. Vickers hardness contour on the link surface is in the range of 340 – 369 VHN. Referring to contours analysis, there is no specific pattern of VHN hardness on the sample surface. High VHN values can be found not only on the edge surface but also on the surface far from the edge.

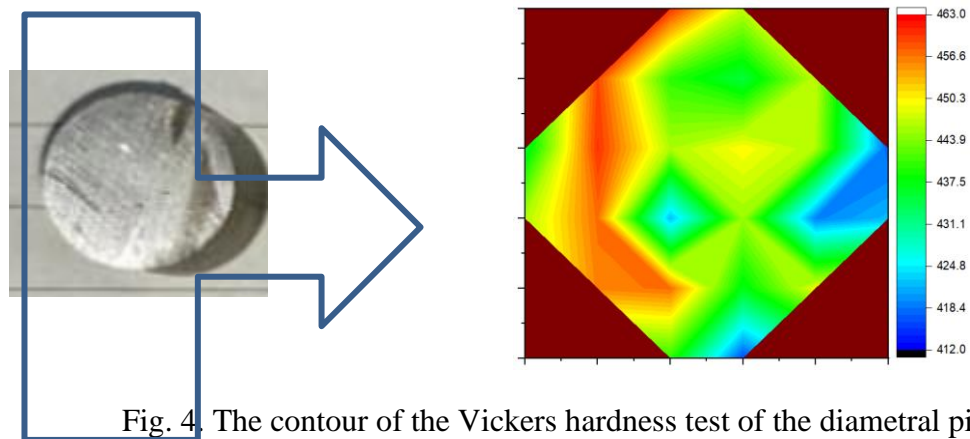
Fig. 4. The contour of the Vickers hardness test of the diametral pin

Random VHN patterns are also found on the pin surface in Fig. 4 in the 412 – 463 VHN. The VHN pin hardness value is relatively higher than that in the link surface. Even in the as-received sample detected using the HRC test (Fig. 5.), the random patterns found on the HRC hardness value indicate the surface hardness of the failed sample, and the as-received sample does not experience a significant change in pattern.

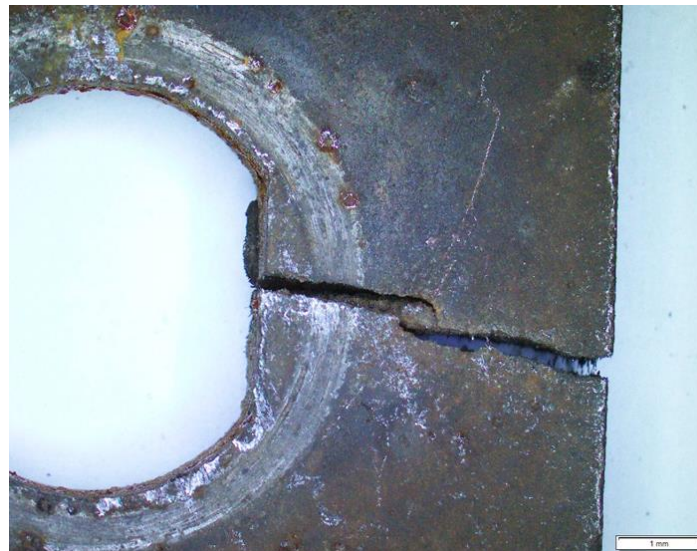
Fig. 6. Typically fractured chain link

Fig. 6 shows the type of failed link. The fracture occurs in the pin-link joint hole in one or both end holes. The initial cracks were identified from the corrosion color, which was more concentrated than in other areas (Fig. 7). There are two main areas where crack initiation occurs; first, in the area that experiences higher residual stresses due to changes in dimensions that are not streamlined (notch root) as depicted in Fig. 7; second initial cracks occur in the middle of the pinhole. In both cases, in term of loading condition, it is believed that the cracks occurred due to the influence of the interference fit pin- links joint assembly and cyclic loading.

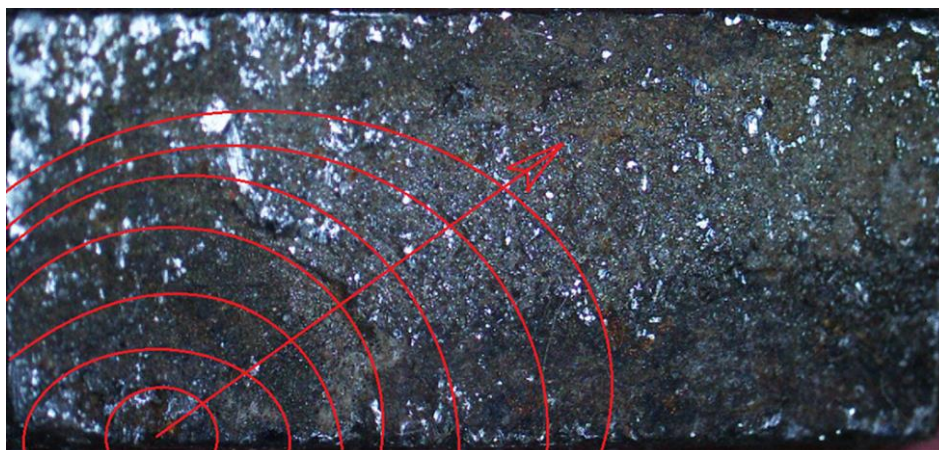
Fig. 7. Initial crack location and crack growth direction on the cross-section of the chain failed

Macrostructure fractographic results are illustrated in Fig. 8; as shown, all specimens have negligible plastic deformation. However, there are some plastic deformation places and microvoids in specimens. A mixture of ductile and brittle mechanisms is visible in these specimens. The fracture appearance appears mainly as the cleavage and river pattern or brittle features mixing with a little ductile region. In addition, some voids are present in the fracture surface, probably formed at the matrix/carbide interfaces. Metallography observations also showed. Generally, the fracture was observed on vertex holes. The fracture surface consists of the initiation zone, the fibrous zone, the unstable zone, and the shear lips zone. Fig. 7. shows the profile of crack propagation across the initiation zone and fibrous zone.

Fig. 7 illustrates crack growth based on fractographic patterns and surface contours. Although the beach mark pattern as a general indication of fatigue failure is not visible, the relatively smooth surface contour with a circular pattern, as shown in Fig. 7, indicates the cracks propagate due to cyclical loading. A smooth fatigue fracture surface contour also indicates a very low load level compared to the material's tensile strength. Another evidence of a fatigue fracture mode can be seen in Fig. 8, where the link fails on both sides, but still, parts are connected. The fracture pattern clearly shows the link does not break apart suddenly due to excessive loads that exceed the tensile stress limit. However, fracture occurs slowly and gradually at low-stress levels.

Since the operating conditions of the chain are in a corrosive environment, experiencing dynamic loading and working temperatures between 23 and 60 °C, the selection of HSL materials such as AISI 4140 should be considered.

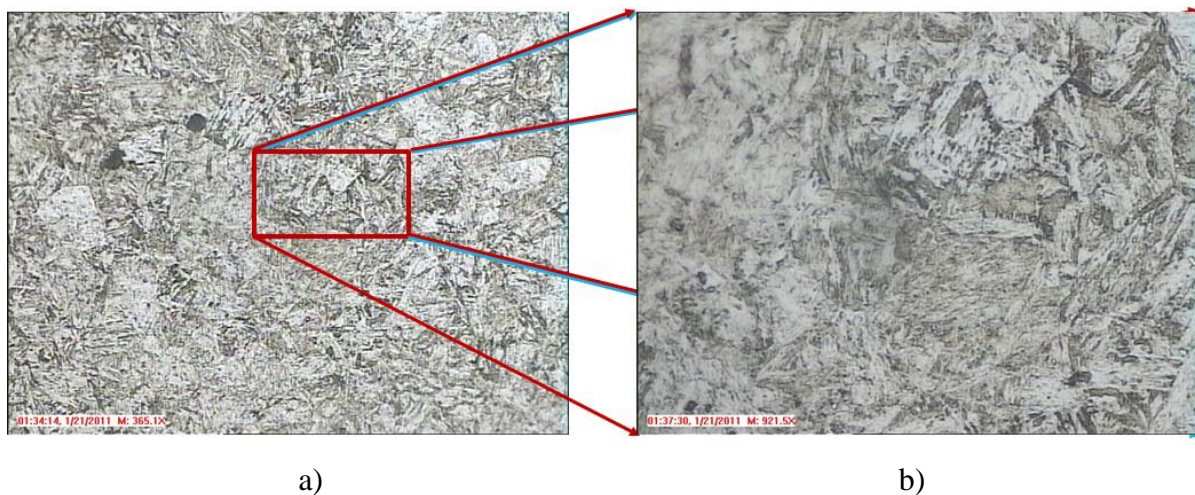
Fig. 8. Microstructure of failed link chain in the middle area

The prior heat treatment done on the steel has a major influence on the final microstructure of AISI 420, which typically comprises martensite, un-dissolved and re-precipitate carbides, and retained austenite. The precipitation of carbides in the alloy during tempering is time-dependent, which involves precipitation of M_3C followed by M_7C_3 and then $M_{23}C_6$ type alloy carbides. Fig. 9. shows the fail link chain microstructure, which depicts large and small carbides inside the lath martensite associated with M_7C_3 and $M_{23}C_6$, respectively.

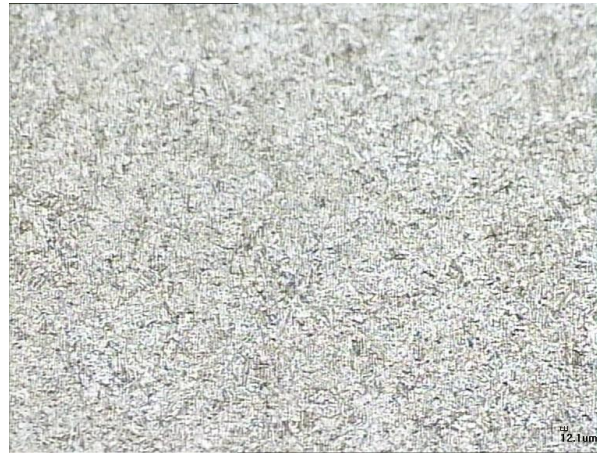
Fig. 10. Microstructure of as-received surface link chain in the middle area

The material hardness, either as-received or failed link, did not show a significant difference in the hardness value and the pattern of hardness distribution. This is due to an inhomogeneous distribution of carbides in the microstructure. Then, the presence of retained austenite within lath martensite, which usually has a detrimental effect on hardness, is shown in Fig.s 10 and 11. As previously explained, inhomogeneous distribution was also detected on the as-received link of large and small carbides inside the lath martensite associated with M_7C_3 and $M_{23}C_6$. $M_{23}C_6$ carbide was found in colonies with the irregular shape of individual carbides. These carbides have very large sizes ranging from 15 to 20 microns.

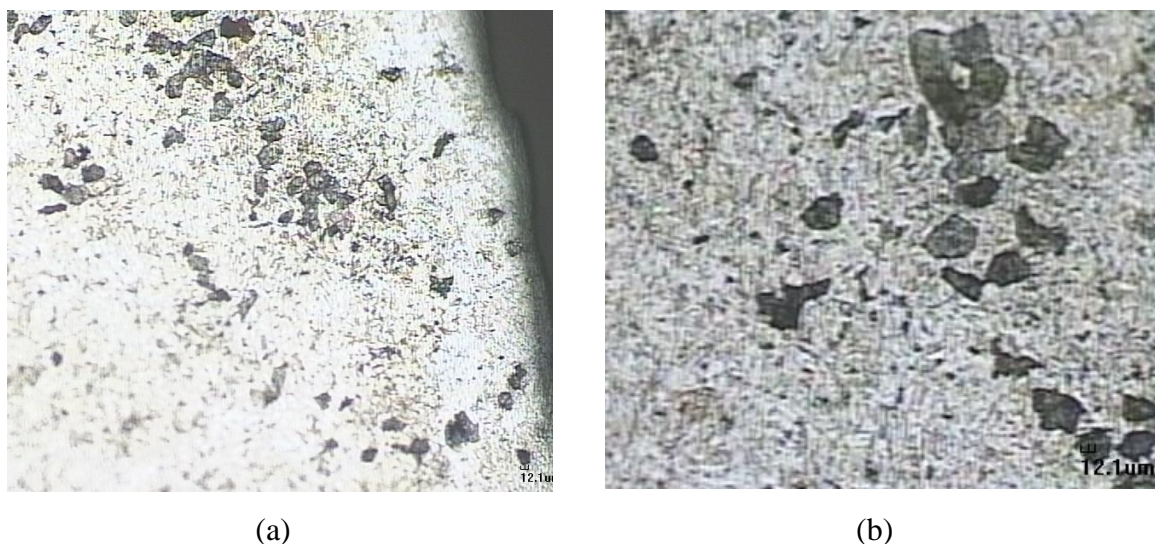
Fig. 11. Microstructure of as-received surface link chain: (a) near the edge, and (b). middle area

The tempered martensite microstructure of normalized-and-tempered ferritic/martensitic steels is more complicated than a solid solution, as shown (Fig. 11). During the normalization treatment, the steel is heated above the AC_3 temperature to transform the ferrite to a solid solution of austenite that transforms into body-centered tetragonal (BCT) martensite when it is air cooled.
