**ANALYSIS OF LANDSLIDE AT OUTSIDE DUMPING AREA
AIR LAYA COAL MINING SITE, INDONESIA**

ABSTRACT

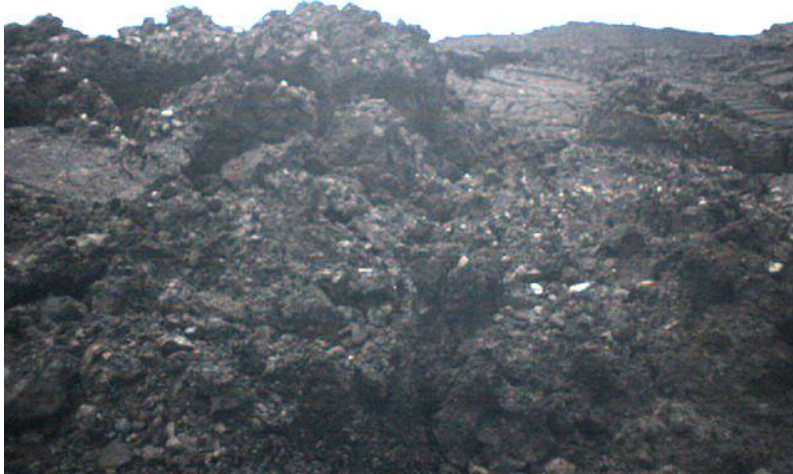
A rapid soil movement occurred on the dawn of 27 November 2002 at final fill slope outside dump Air Laya coal mining site at Bukit Asam, South Sumatra, Indonesia (Figure 1). The incident resulted in the fall down of an electrical tower supplying electrical current to the neighboring area. It has also destroyed some mud collecting facilities and dikes, as well as agriculture land along the toe of the slope. It was fortunate that there were no fatalities and serious injuries in the accident.

Figure 1 Soil Movement on the fourth day of the landslide

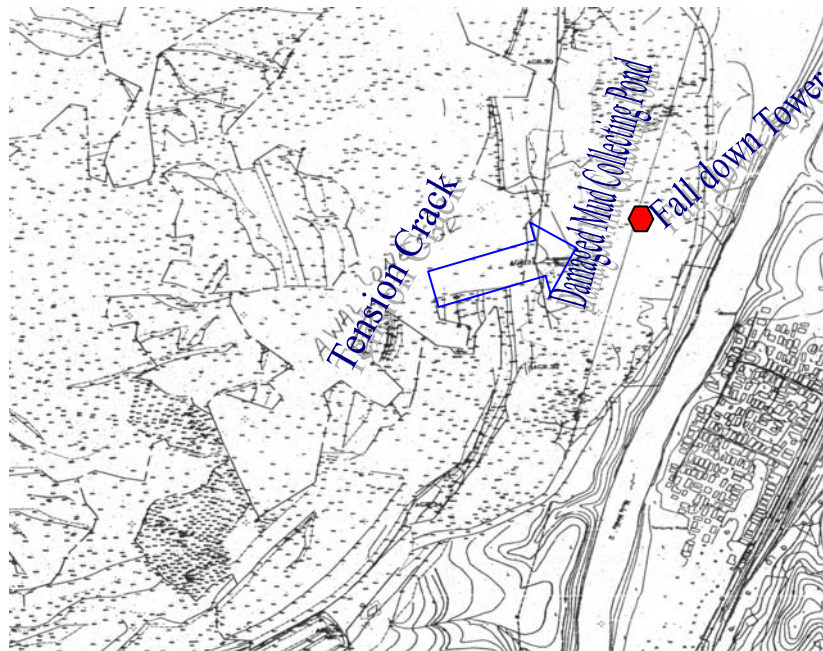
The landslide involved a translation movement of soil fill as long as 1.5 km towards the river and several rotational slope failures along the movement (Figure 2). The failed part was 72 hectares or about 11% of the total dumping area. Rapid movement of soil has lasted for about 4 days i.e. between 27 and 30 November 2002. The highest rate of movement was 724 mm/hour took place on the second day and this movement was gradually diminished within the next 10 days.

Figure 2 Situation of landslide

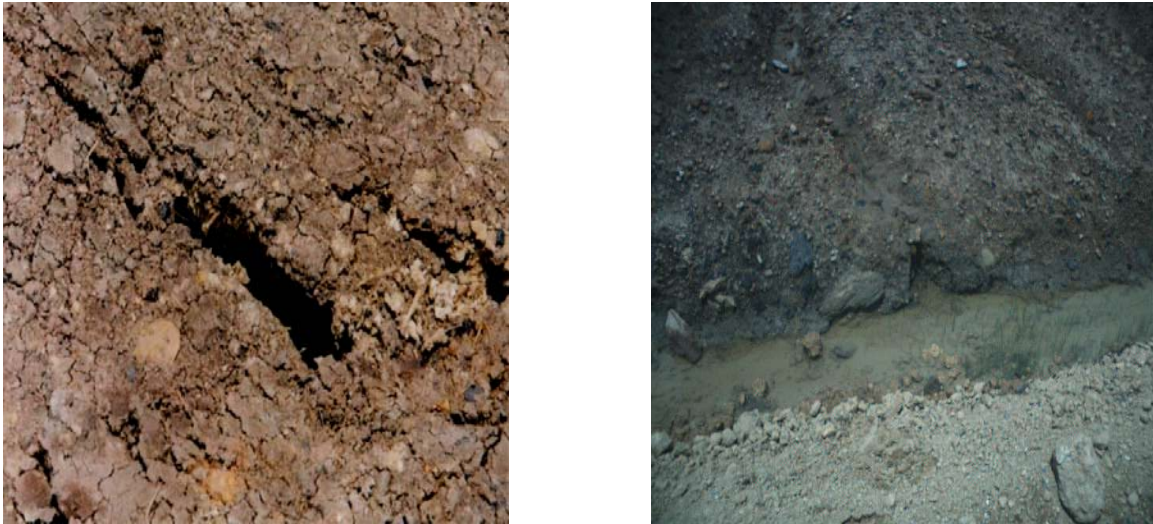
Movement was observed for the first time at the end of year 2001 when the maximum thickness of dumped fill soil has reached 80 m. Some measured have been made to control the situation from becoming worse such as by removing the dumped material to other sites and by smoothing the surface. However, an observation made on 17 October 2002 has revealed clear signs of distress including the formation of deep tension cracks parallel to Enim River, the presence of water on the surface of the fill despite of dry condition (Figure 3), and some surface movements on the upper part of the slope.

Figure 3 Signs of distress at fill surface prior to landslides

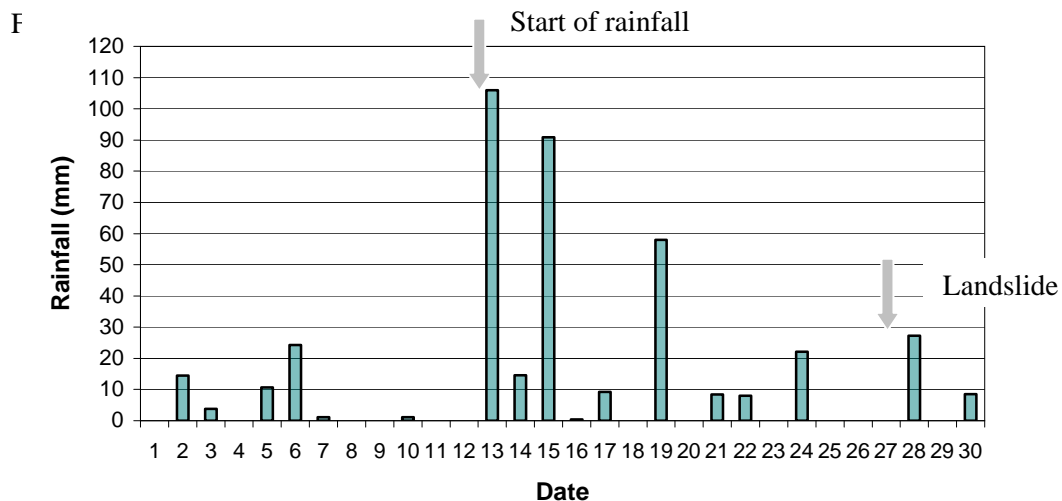
The ground failure occurred after periods of heavy rainfall that started on 13 November 2002 after a period of a very dry season that last for about six months. This condition suggested that rainfall might play a contributory part into the landslide. A rainfall of more than 100 mm took place within 2 hours in November 13 followed by periods of rain continued until November 24 with cumulative rainfall of 318 mm (Figure 4, and 5). Analysis of rainfall data based on 20-year return period showed that the rainfall after November 13 was on the highest rating for 3, 5, and 7 day-rainfall data.

Figure 4 Daily rain-fall in November 2004

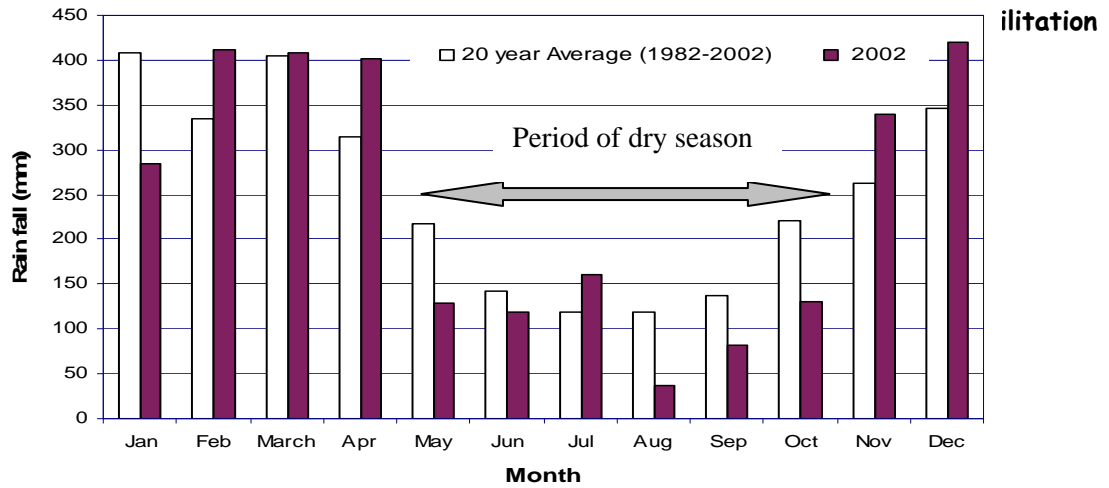
Figure 5 Monthly rain-fall in 2002 compared to 20 year average monthly rainfall

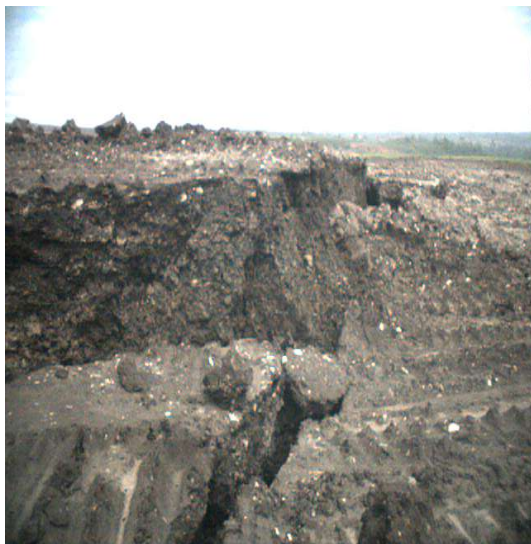
a. Tension crack at the crest of failure

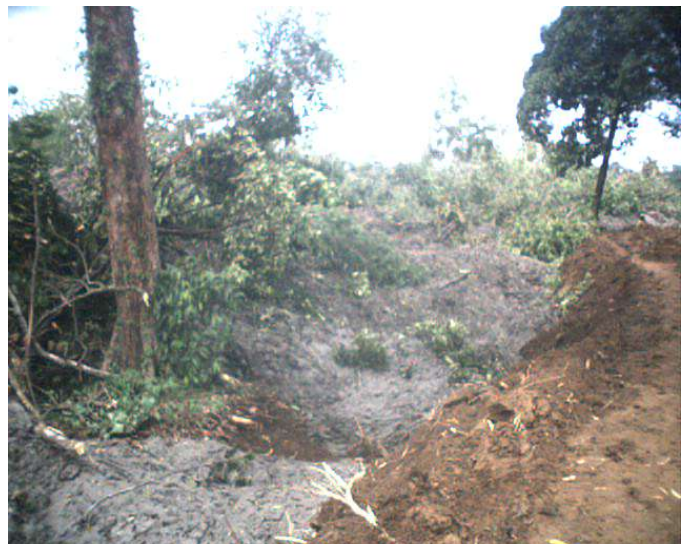
b. One view at the toe of the failure

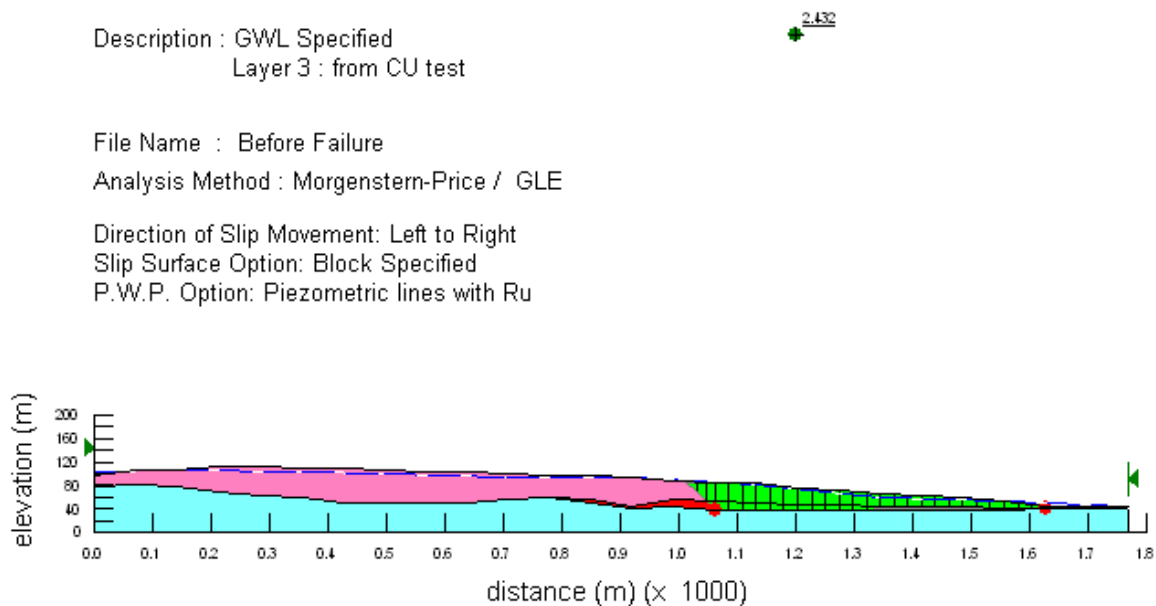
For case 1, shear strength parameters obtained from Triaxial CU test were used for all layers. In this case, perched groundwater table presents at specified level obtained from boreholes prior to failure. This is done to show that the design of fill is safe as long as the conditions did not deviate from the original plan. The output of SLOPE/W for case 1 is shown in Figure 9. The factor of safety obtained for this case is 2.432.

Figure 9 Output of SLOPE/W for original condition (before failure)

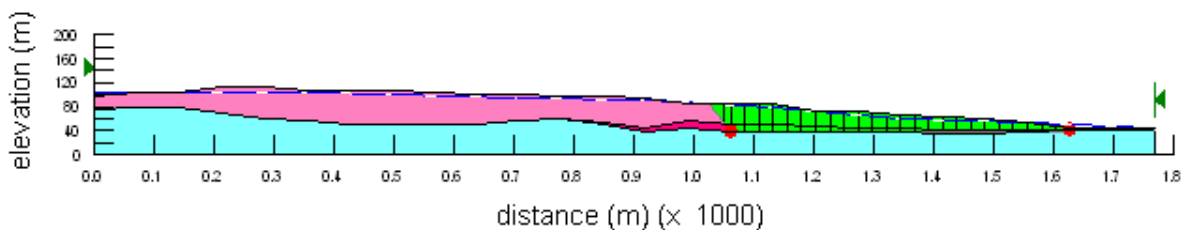
Case two simulates the condition at failure. Unconsolidated undrained shear strength is used for layer 2, while shear strength data from Triaxial CU test were used for layer 1 and 3. In this case, water level was at the ground level and tension crack was filled with water. The factor of safety was found to be 0.495 which is much lower than Case 1. The output of SLOPE/W for case 2 is shown in Figure 10.

Figure 9 Output of SLOPE/W for “at-failure” condition

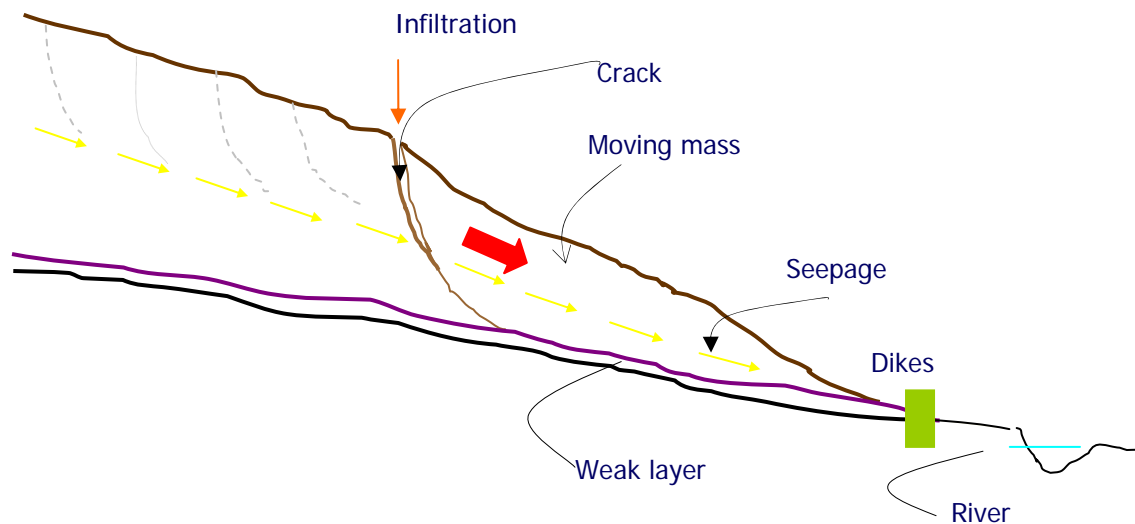
Based on the facts mentioned above, the investigation has established evidence that the soil movement was actually has started long before the landslide occurrence. It started as a development of some surface cracks. Due of its position, several cracks has developed and propagated into deeper soil layer. This crack was filled with water through seepage that flows through voids within the fill itself. The saturation process eventually caused the reduction of the shear strength of soil both within the fill and the interface layer. This process was accelerated by the prolonged and high intensity rainfall that started on November 13.

The likely mechanism agrees well with the observation made on the site. The failure has started at a tension crack, followed by some rotational failures along the movement (Figure 10) and end at the mud collecting pond at the toe of the slope. This landslide can be classified as multiple retrogressive failures (Anderson and Richards, 1987).

Figure 10 Mechanism of Failure

Furthermore, the investigation also indicates that the landslide was localized and will not affect the surrounding area. Continued monitoring showed that no subsequent movement was observed after the landslide. Nonetheless, some safety precautions have been done for example the reconstruction of the mud collection ponds and dikes, as well as termination of dumping on the failed area.
