Damage Analysis of Moldboard Plow

Diah Kusuma Pratiwi¹, Hendri Chandra^{1*}, Nurhabibah Paramitha Eka Utami¹, Okta Irawan¹, and Arman Natal Purba¹

¹Department of Mechanical Engineering, Universitas Sriwijaya, 30662, Indralaya, South Sumatera, Indonesia

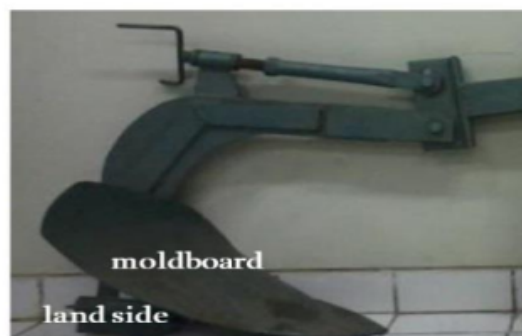
Fig. 2. The bottom of moldboard plow

Currently, multiple moldboard plows are used as shown in Figure 1 (a) and (b) show the bottom of the moldboard plow. The edge of the moldboard is the most easily cracked, broken, or deformed plastic part.

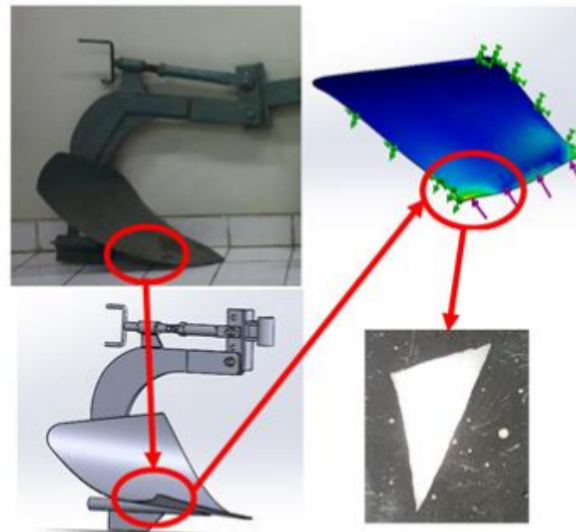
Fig. 5. The stress simulation of moldboard plow

From simulation shown that the critical area is at the edge tip in the corner. This area gets greater stress than other areas i.e. 713 MPa. While tensile strength material is 403 MPa.

The result of the stress analysis simulation is that the load received during the plowing process is greater than the tensile strength of the material. This suggests that the material is very susceptible to plastic deformation which will cause a deformation. Hence, moldboard material will easily experience cracks that cause damage.

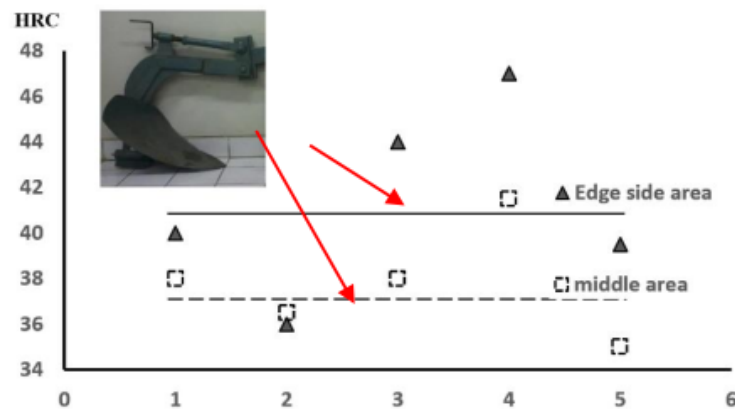
Fig. 6. Hardness graph by position tested

The graph in Figure 4 indicates that the average of the harness in the middle moldboard 37.8 HRC and in the edge side 41.3 HRC. The difference of the hardness value between that area is not very significant.

Hardness test by Rockwell C shows that material has low HRC value i.e. 35 to 47. It is mean that tensile strength moldboard material only around 400 MPa. This reality has shown that why the moldboard easy to be damaged.

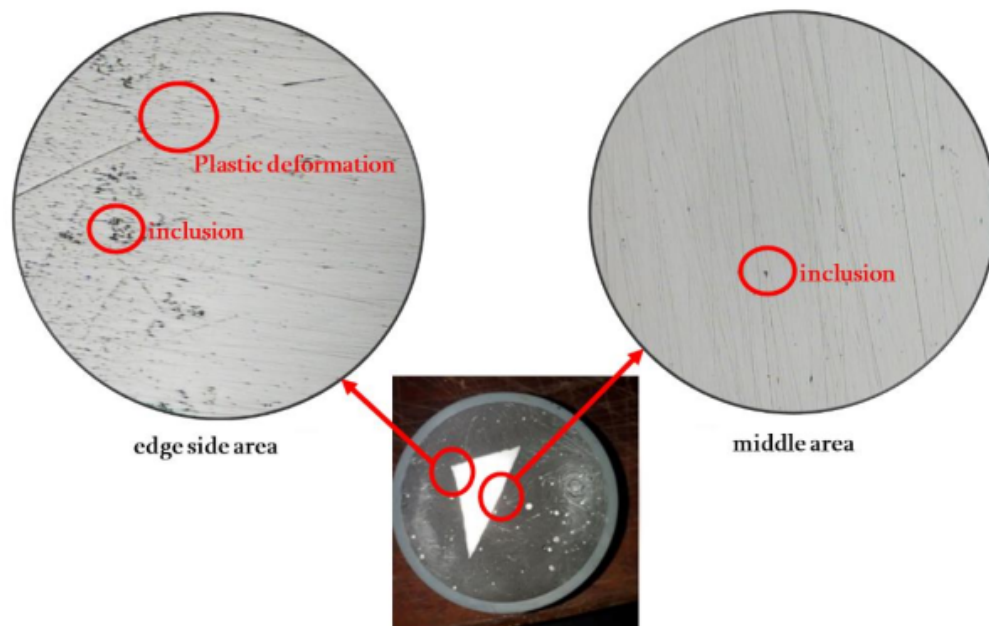
Fig. 7. The microstructure of the non-etch specimen, magnification 200x There are many inclusions and plastic deformation in the edge side more than in the middle side.

Non-etch microstructure analysis indicates that the edge side has inclusions denser than at the middle area. In the edge side area, inclusions are concentrate in many places. The inclusions inside to the moldboard material by diffusion from soil during plowing process. Meanwhile, impact forces from soil and matters contained in it cause plastic deformation in the edge side of the moldboard.

In the center of the moldboard, inclusion is not as much on the edge. This is because the interaction between the material and the surrounding soil is not accompanied by impact force at the edge side. Hence, the plastic deformation experienced is also not so great. However, it appears that the scratches on the surface of the specimen are due to the presence of manganese that forms the martensite phase.

The cause of the damage is because the composition of carbon is too low and on the outside surface is not done heat treatment on the surface of the moldboard so that no martensite phase. should the material used to make the moldboard plow has been done the addition of carbon composition on the surface through carburization process that will form martensite phase plated outside the bottom plow.

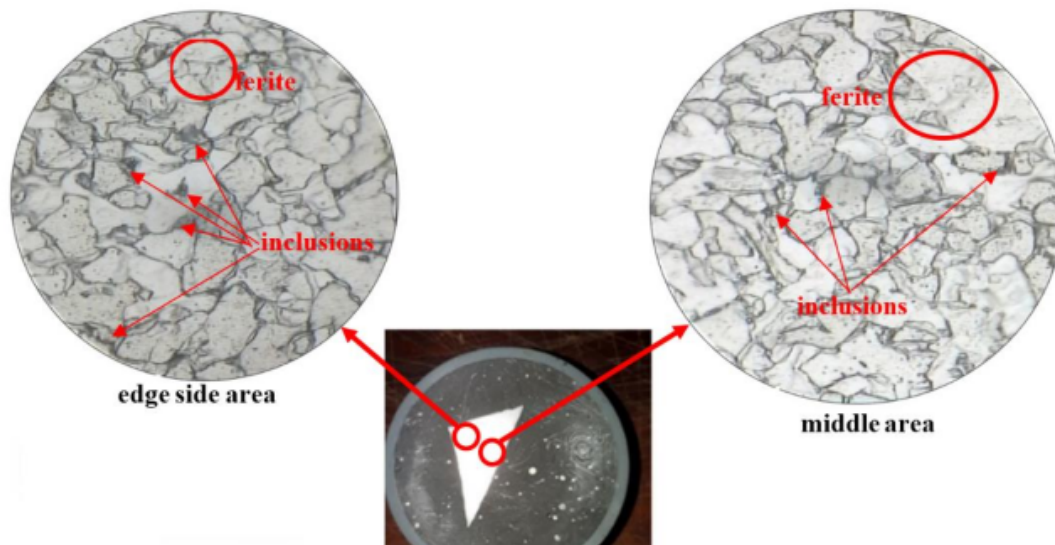
Fig. 8. Phase structure in moldboard material indicate inclusions and ferrite in a different size, magnification 1000x

Inclusion is more dense on the edge of the moldboard than in the middle area. inclusion on the edge of the moldboard is more dense and more than in the middle area. In addition, the ferrite grain size is smaller because it is influenced by the moldboard manufacturing process.

Microstructure feature reveals that grain size on the edge side is little than the middle area. this show that the hardness value in the edge side slightly higher than in the middle.
