FATIGUE FAILURE ON DRILLING PIPE THREAD: A CASE STUDY ON DRILL PIPE SS105

AFRIANSYAH^{1,2*}, HENDRI CHANDRA,¹ DIAH KUSUMA PRATIWI¹, ANEKA FIRDAUS¹

¹PT. Pertamina Drilling Project South Sumatera, Prabumulih, South Sumatera, Indonesia

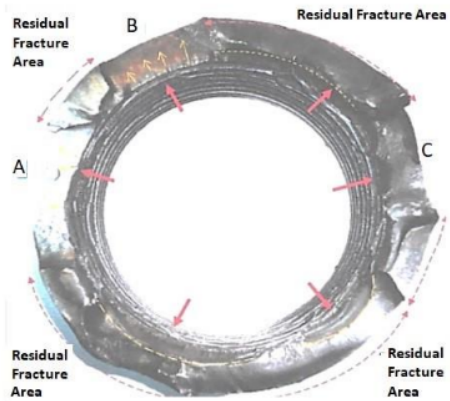
Fig. 1. Macro mapping frictional drill pipe

Fig. 1 shows that the failure occurs in the area close to the drill pipe thread. Besides, on the inner surface of the fault appears fatigue fracture at various points occurring up to $\frac{3}{4}$ of the

thickness, which the remaining part is a static fracture. This is located outside and marked with a groove residual example of A, B, and C.

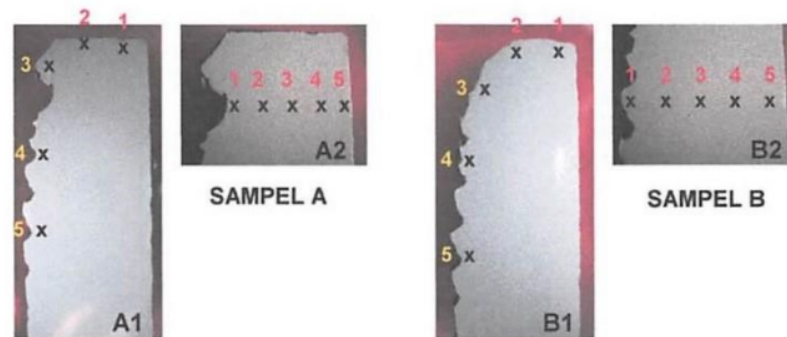
Fig 2. Sample for hardness test

From Fig. 2, we conduct a hardness test for the part of failure with the Rockwell hardness test and tensile test. Before the test, we separate material into two samples are sample A and B, each sample we conduct test hardness test, Hardness testing is carried out with two tests, namely carried out on the edge of the fault and in the middle of the fault, each of which is carried out five points.

The result showed based on table 3, for sample A1 found average Hardness number is 32.5 HRC with maximum hardness at point 1 (at the top sample). For the sample, A2 found the average hardness number is 33.7 with maximum hardness at point 5 (at edge sample). For sample, B1 found average hardness number is 32.2 with maximum hardness at point 1 (at the top sample) and for sample, b2 found average hardness number is 32.6 with maximum hardness at point 5 (at edge sample). In conclusion, the hardness of the fractured part is more than the hardness standard material. It is related to the % C material from the composition test before.

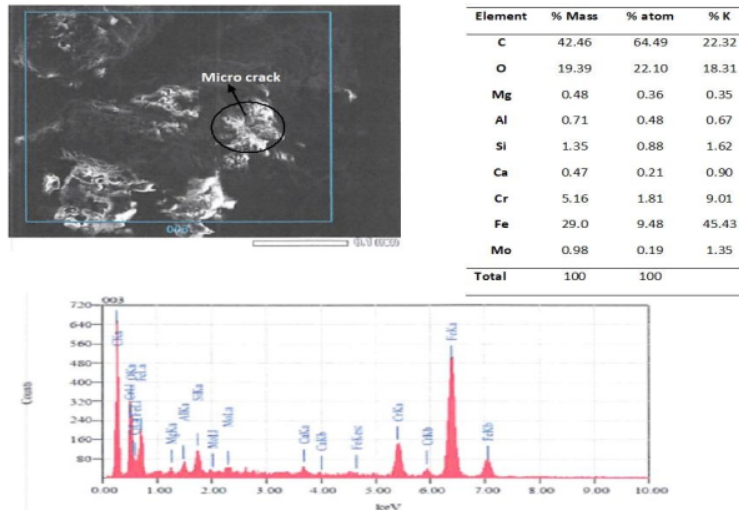
Fig. 3. SEM and EDX at the surface fracture

Fig. 3 showed SEM and EDX results on the surface fracture drill pipe. The image clearly shows the “white area” is ferrite. Based on the EDX spectrum, value Fe, C, and O is the highest value on the surface fracture. On the surface, fracture showed there are micro-cracks. Furthermore, there is an iron oxide (FeO) on the surface fracture. It can be formed by element Fe and element O based on EDX analysis.

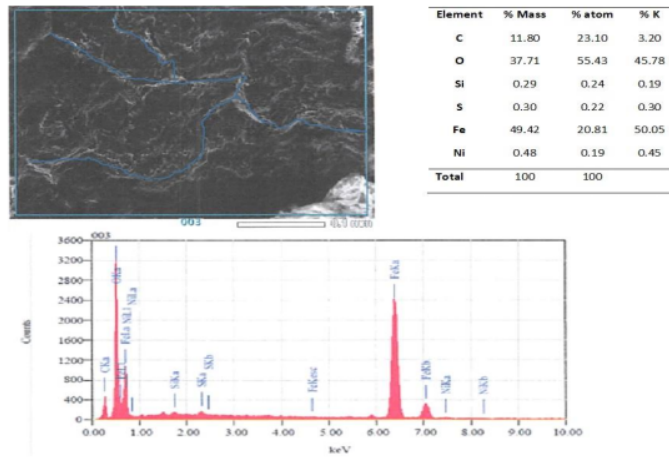
Fig. 4. SEM and EDX Inner Surfaces fracture

Fig. 3.4 showed SEM and EDX results on the inner surface fracture drill pipe. There are SEM images and EDX graphic charts that showed an element of inner surface fracture.

The image clearly shows a crack along the grain boundary. Based on the EDX spectrum, value Fe, C, and O are the highest value on the inner surface fracture (thread drill pipe). The crack surface is flat and has a grainy texture as a result of changes in orientation of the cleavage planes from grain to grain. Crack propagation is along grain boundaries (intergranular)

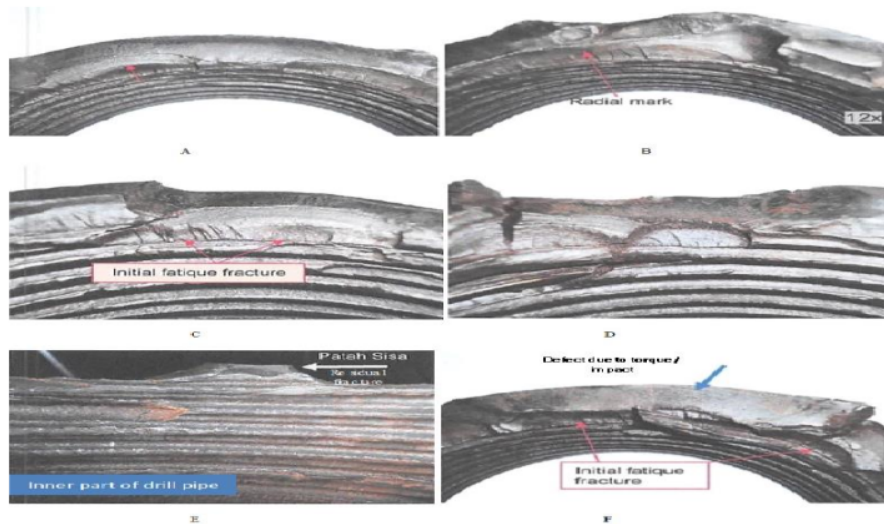
Fig. 5. Result fractography on inner surface drill pipe

The fractographic analysis is carried out on the failure drill pipe. Fig. 5 showed result fractography on the inner surface drill pipe after 25 times the enlargement is conducted to determine the sign from the initial phase of the fault.

Fig. 5. A & B showed a radial mark on the inner surface of the drill pipe. C & D showed initial fatigue fracture on the surface fracture. D showed residual fracture on the inner surface. E showed Initial fatigue fracture and defect due to torque/impact. The macro photo on the

threaded Fig. 5 C, D, and F showed the beginning of the crack starting from the thread's inner leg (C and D). Radial mark on Fig. 5 A and B caused by fatigue fracture. Surface fracture is flat and there is a residual fracture on the surface (Fig. 5E).

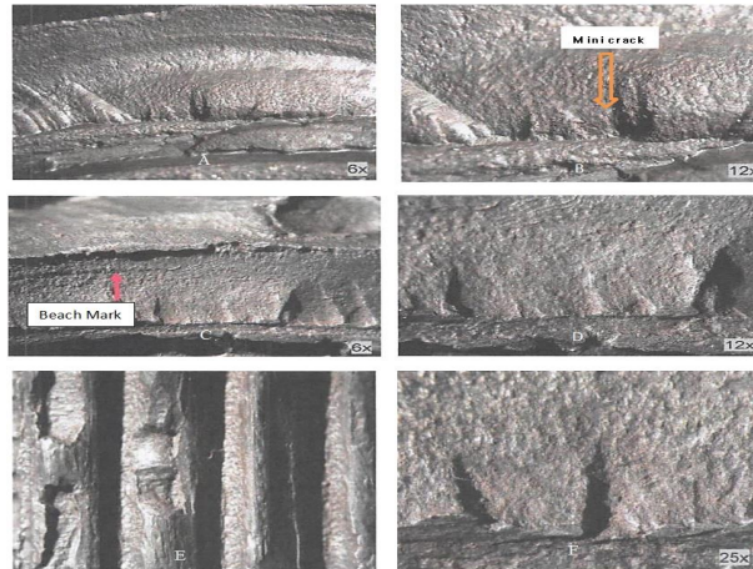
Fig 6. Preliminary Macro Crack Photo (threaded detail)

Fig. 6 showed Preliminary Macro Crack Photo after enlargement 6X and 12X. It showed a thread image on a drill pipe connection that has been a failure.

Fig. 6. A and B showed Preliminary Macro Crack Photo (threaded detail) magnification 6x and 12x. C and D showed the beach mark on surface fracture with magnification 6x and 12x. E and F showed crack on the thread of the drill pipe with magnification 6x and 25x.

Macro photo 6A showed part of threaded. Arrow showed a beach mark area. Fig. 6B showed a mini crack on the thread drill pipe. The surface fracture is flat. Therefore, it is a fatigue fracture. Macro photo from magnification from Fig. 6C and 6D shows the beginning of the fault starting from the threaded leg, marked with visible beach marks on the arrow. Photo 6E and 6F showed condition thread after fracture after enlargement 6X and 25X. It showed a fracture from the Last engaged thread (LET). This condition suitable for McDonald's had found [12].

In this study, the following were analyzed the failure due to fatigue on the drill pipe, especially on the thread section, was caused by the initial micro-cracks and its spread which is usually triggered by the amount load received by the pipe during the drilling process. Besides, the fatigue cracks on the threads usually occur on the first threaded or foot. To avoid similar incidents, the following should be conducted: drill pipe inspection according to DS1 standards and the strength of the drill pipe tool joint need to be increased during the manufacturing process with a heat treatment process such as quenching and tempering to eliminate residual stress in the threaded area.
