4
ANALYSIS OF LANDSLIDE AT OUTSIDE DUMPING AREA
AIR LAYA COAL MINING SITE, INDONESIA

Marwan Asof,
Sriwijaya University, Indonesia

ABSTRACT

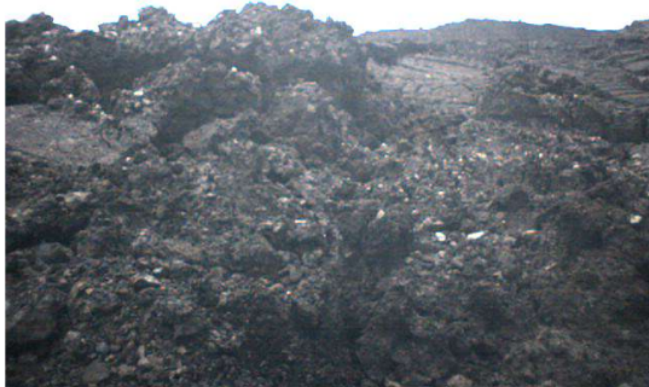
4
A rapid soil movement occurred on the dawn of 27 November 2002 at final fill slope outside dump Air Laya coal mining site at Bukit Asam, South Sumatra, Indonesia (Figure 1). The incident resulted in the fall down of an electrical tower supplying electrical current to the neighboring area. It has also destroyed some mud collecting facilities and dikes, as well as agriculture land along the toe of the slope. It was fortunate that there were no fatalities and serious injuries in the accident.

Figure 1 Soil Movement on the fourth day of the landslide

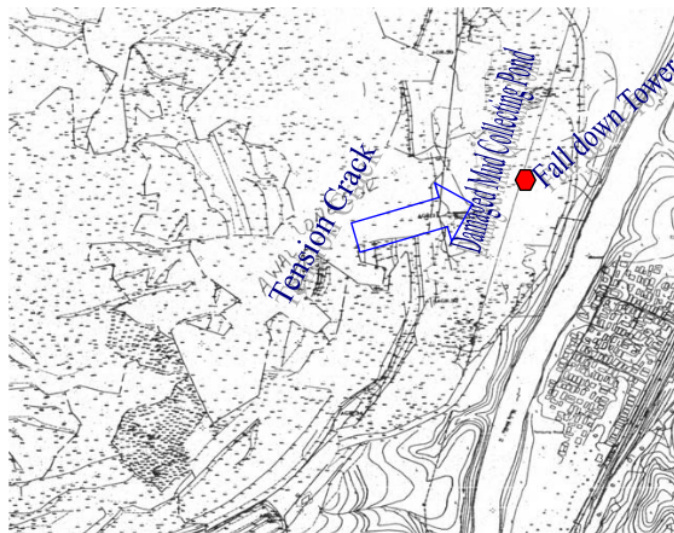
The landslide involved a translation movement of soil fill as long as 1.5 km towards the river and several rotational slope failures along the movement (Figure 2). The failed part was 72 hectares or about 11% of the total dumping area. Rapid movement of soil has lasted for about 4 days i.e. between 27 and 30 November 2002. The highest rate of movement was 724 mm/hour took place on the second day and this movement was gradually diminished within the next 10 days.

Figure 2 Situation of landslide

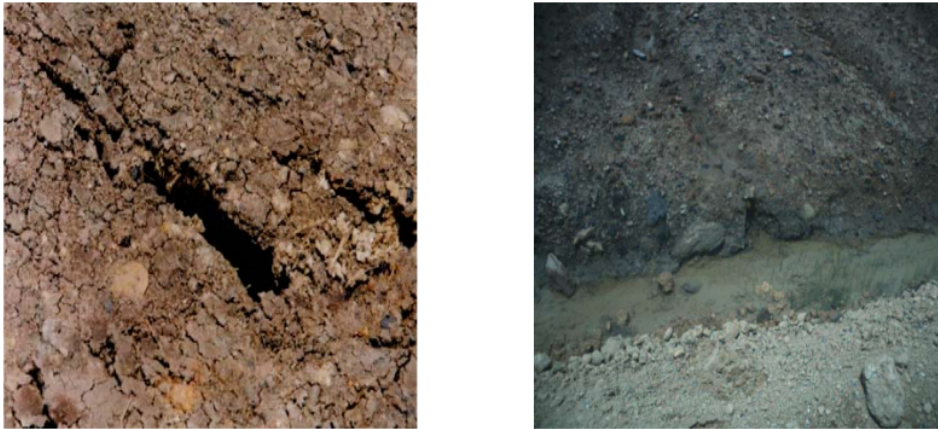
Movement was observed for the first time at the end of year 2001 when the maximum thickness of dumped fill soil has reached 80 m. Some measured have been made to control the situation from becoming worse such as by removing the dumped material to other sites and by smoothing the surface. However, an observation made on 17 October 2002 has revealed clear signs of distress including the formation of deep tension cracks parallel to Enim River, the presence of water on the surface of the fill despite of dry condition (Figure 3), and some surface movements on the upper part of the slope.

Figure 3 Signs of distress at fill surface prior to landslides

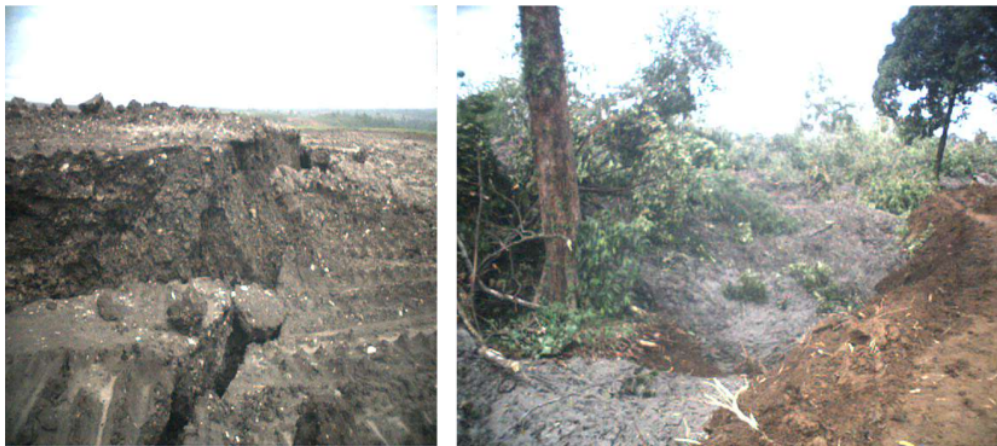
a. Tension crack at the crest of failure

b. One view at the toe of the failure

Figure 8 Views of the crest and toe of the landslide

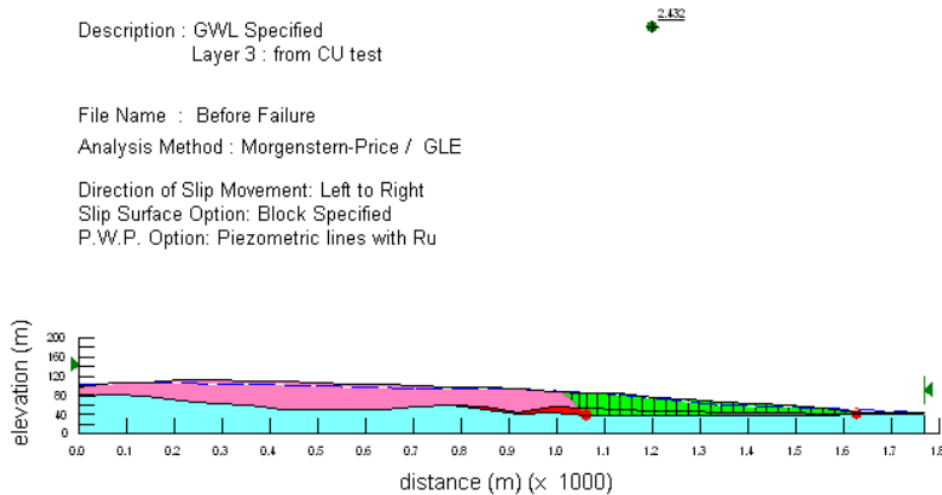
For case 1, shear strength parameters obtained from Triaxial CU test were used for all layers. In this case, perched groundwater table presents at specified level obtained from boreholes prior to failure. This is done to show that the design of fill is safe as long as the conditions did not deviate from the original plan. The output of SLOPE/W for case 1 is shown in Figure 9. The factor of safety obtained for this case is 2.432.

Figure 9 Output of SLOPE/W for original condition (before failure)

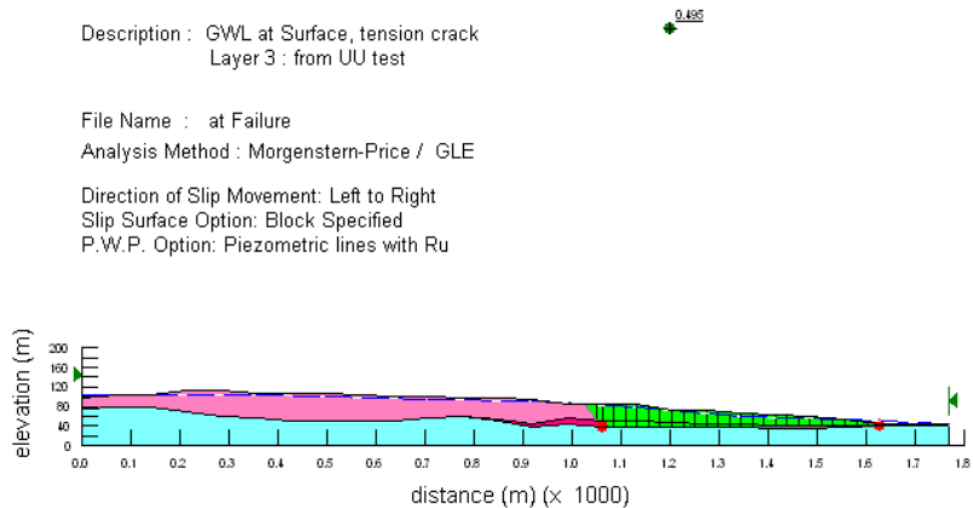
Case two simulates the condition at failure. Unconsolidated undrained shear strength is used for layer 2, while shear strength data from Triaxial CU test were used for layer 1 and 3. In this case, water level was at the ground level and tension crack was filled with water. The factor of safety was found to be 0.495 which is much lower than Case 1. The output of SLOPE/W for case 2 is shown in Figure 10.

Figure 9 Output of SLOPE/W for “at-failure” condition

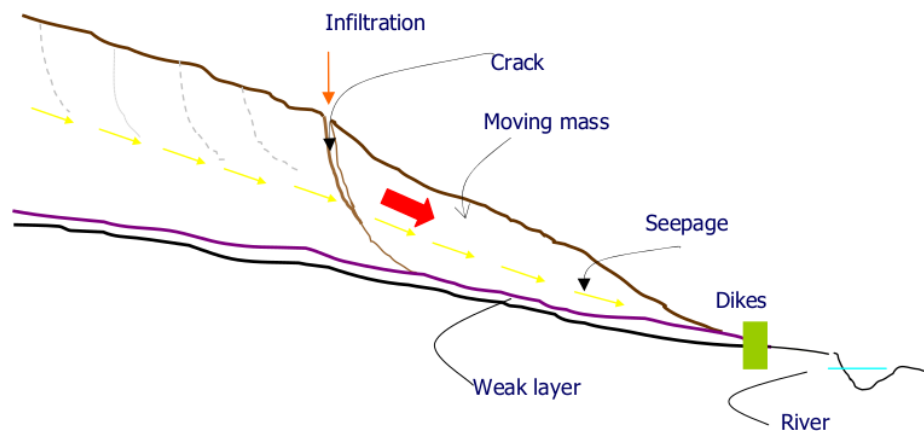
Based on the facts mentioned above, the investigation has established evidence that the soil movement was actually has started long before the landslide occurrence. It started as a development of some surface cracks. Due of its position, several cracks has developed and propagated into deeper soil layer. This crack was filled with water through seepage that flows through voids within the fill itself. The saturation process eventually caused the reduction of the shear strength of soil both within the fill and the interface layer. This process was accelerated by the prolonged and high intensity rainfall that started on November 13.

The likely mechanism agrees well with the observation made on the site. The failure has started at a tension crack, followed by some rotational failures along the movement (Figure 10) and end at the mud collecting pond at the toe of the slope. This landslide can be classified as multiple retrogressive failures (Anderson and Richards, 1987).

Figure 10 Mechanism of Failure

Furthermore, the investigation also indicates that the landslide was localized and will not affect the surrounding area. Continued monitoring showed that no subsequent movement was observed after the landslide. Nonetheless, some safety precautions have been done for example the reconstruction of the mud collection ponds and dikes, as well as termination of dumping on the failed area.
