**DATABASE OF TRAFFIC ACCIDENT
FOR HANDLING BLACKSPOT AREA
(STUDY CASE NATIONAL ROAD FROM
THE BORDER OF PALEMBANG CITY
UNTIL THE BORDER OF JAMBI
PROVINCE)**

Intan Permata Sari*, Joni Arliansyah, Erika Buchari

Master Program in Civil Engineering, Faculty of Engineering, Universitas Sriwijaya, Palembang

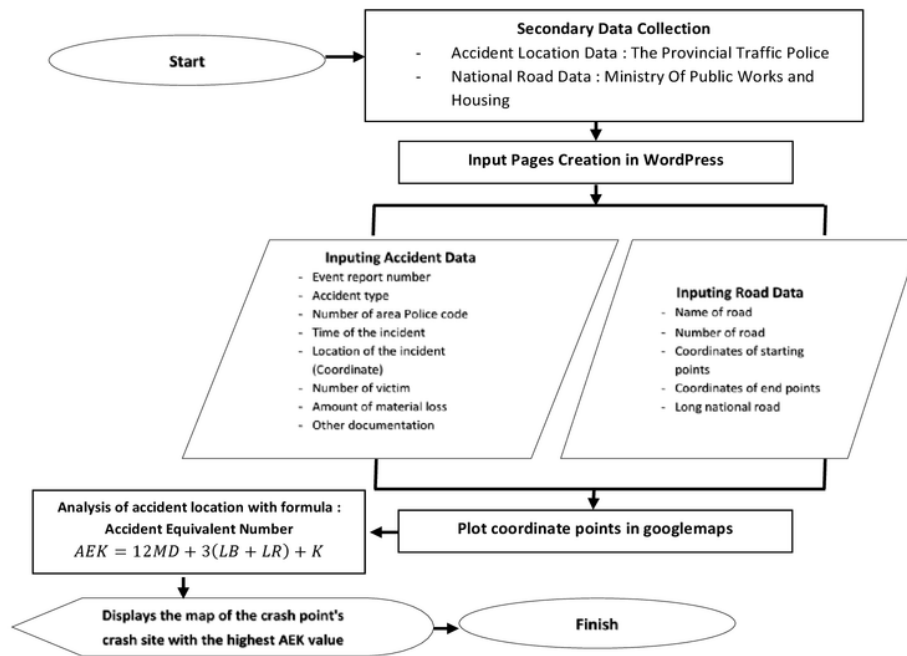
Figure 2. Roadmap of Database

In the database, input data in the form of coordinate points of accident-prone locations as well as the starting and ending points of roads are inputted in the googlemaps map. Database outputs are accident rate data, number of casualties, total loss, accident type, location map as shown in Figure 2.

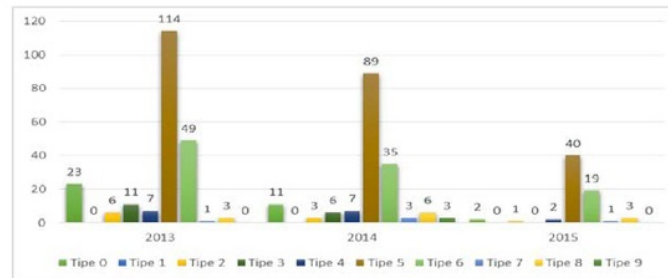
Figure 4. The Accident Base on The Type of The Accident

Note: Type 0: pedestrian crossing without Zebra Crossing; Type 1: pedestrian crossing with Zebra Crossing; Type 2: single, 1 vehicle; Type 3: single, with an object; Type 4: between vehicle, perpendicular to each other without turns; Type 5: between vehicles, opposite direction; Type 6: between vehicles, direction of turn movement; Type 7: between vehicles in the same direction with either or both turns; Type 8: between vehicles in the opposite direction with either one or the casting is turning; Type 9: between vehicles, collisions perpendicularly between vehicles with either or both turns.

The outputs of this application include table-shaped databases in PDF and excel formats that can be selected based on the needs. For example, the number of victims, the data based on the type accident as shown in Figure 4, the data based on the time of the accident, as well as data based on the overall accident point, as well as per road segment. From this database, we can analyses the characteristic of accidents based on the number of victims, the type of accident, and the time of the incident at the location of the study. In this application <http://sigblackspot.com>, it is created the crash site calculation program with the highest AEK value (eq.1), which is found that the location of the incident in KM 135 area (Peninggalan – Sei Lilin) with the highest AEK value.

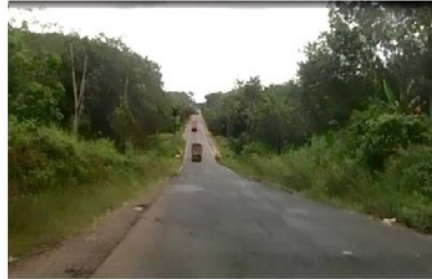
Figure 5. Peninggalan – Sei Lilin National Street (KM 135)

The accident happened in Km 135, it was happened on 24th December 2015 at 03.00AM. The total of the Death Victim (DV) is 4 people, Serious Injuries (SI) about 3 people, and Light Injuries (LI) is 1 person. The equivalent value is 61. Type of accident that happened is type 51, collision between vehicles in the opposite direction, collision when overtaking. From the type of accident that occurred in this KM 135, which is a collision when the vehicle overtakes the vehicle in front of the front-front accident, there are 2 (two) geometric aspects of the role, such as visibility and stop viewing distance of view, while at 4 (four) other aspects have no effect on the incidence of this

accident. So for the victim's fatality assessment, only on the aspect of stopping visibility and visibility to prepare.

According to table 3, the risk value among 125-250 is categorized as Harmful enough (CB) so that the level of priority handling required unscheduled technical handling according to road safety rules. As for the aspect of the width of the traffic lane, the road shoulder elevation, and the shoulder width of the road where the risk value generated by the value of the chance of deficiency multiplied by the impact value, the result of the risk value < 125 , can be categorized as "not harmful". Those the results of the road infrastructure safety audit geometric aspect in the category of "fairly dangerous" as shown in Table 5. The probability of accident occurrence from the aspect of pavement damage condition can be seen in Table 6. There is a pothole along the research area of $< 150 \text{ m}^2/\text{km}$ exceeding the technical standard limit so that the deviation is 50%. According to table 1, for the difference in the field measurements between 40-70% against the standard, the probability values is three. In the rutting aspect based on the measurement encountered $75 \text{ m}^2/\text{km}$, still in the amount of technical safety is $100 \text{ m}^2/\text{km}$, standard deviation. Similarly, from the observation on the pavement, the deformation can be seen in the research location.
