Prompt analysis of condition priority for road improvement planning

E Buchari*¹, D Oktaviansyah¹, D D A P Putranto¹ and N Nawawi¹

Abstract. The need for quick analysis for road pavement survey is inevitable, especially in a developing country. A new data collection method by using small format photo, which is recorded by drone is developed. The function of drone is not only for photographic purposes, but also developed to measure and record road damage. Digital aerial photogrammetric methods are developed faster than before. A small format areal imagery based on pixel size is developed for this study, so that the degree of road damage can be obtained quickly. In order to obtain a maximum pixel size to detect a maximum damage level of 1 cm, the shooting is done at a height of 24 m drone from the road surface. The result of road damage measured by measuring distance through image is then tested based on the measured sample, directly in the field with a trust level of 97.83%. These results show that the accuracy of road damage measurements made above high resolution photo images is very effective for data collection of road damage. Analysis of Condition Priority can be obtained in o

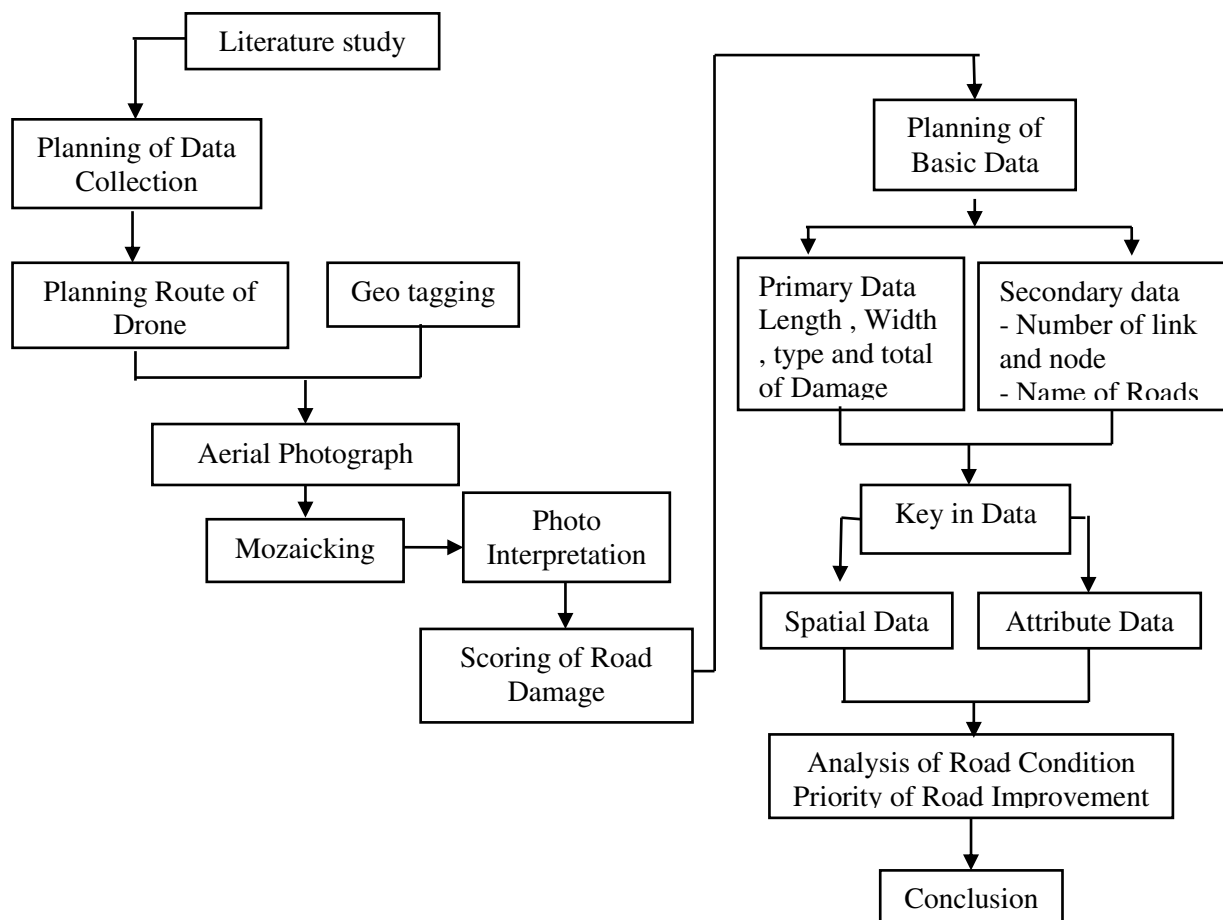
Figure 1. Flow chart of research.

Survey location was at H. M. Noerdin Pandji street, a primary collector road, at Kelurahan Kebun Sayur, kecamatan Alang-alang Lebar, Palembang. The survey is done on March 2017. First, the data was collected by using a drone. A manual data collection was done to confirm the data accuracy. The research programme was carried out according to the flow chart in Figure 1.

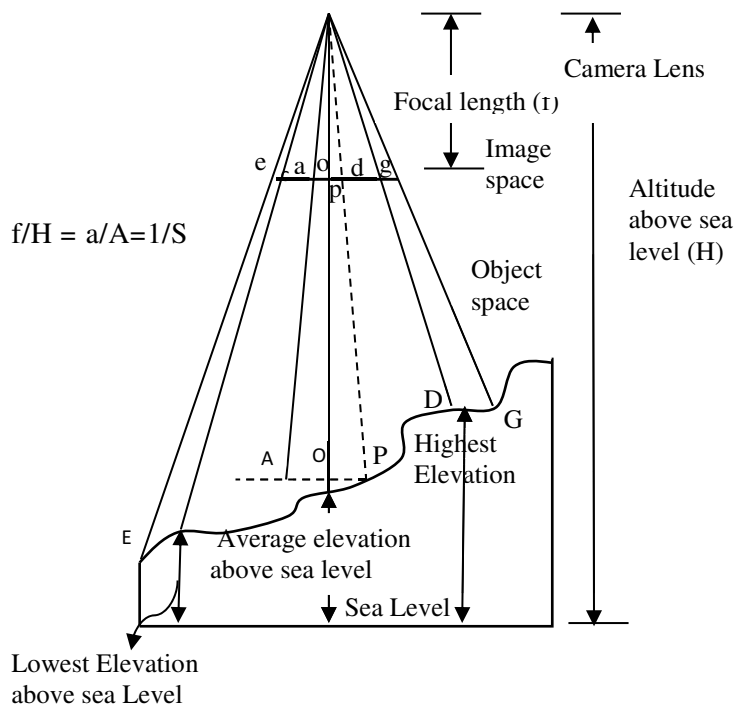
Figure 2. Correlation between Heights of flying, camera focuses and photo coverage.

Camera used for this research has photo format 24 x 36 mm, and length of camera focus (f) 18 mm. That specification is used to achieve the height and to find the minimum designed hole of 1cm [3]. Time needed to fly drone and to record the data is 15-20 minute for 600 meter length of road. The road width is 50 meter. For H.M Noerdin Pandji Street, which has 5200 length, it takes 130 minute to take aerial photo. From the survey experience, it can be concluded that the less wide the road, the faster photo recording on the field. To get sufficient coverage and resolution of spatial photo that is able to do interpretation of measurement, types of holes and road damages then the altitude of flying drone is planned initially as the following Figure 2.

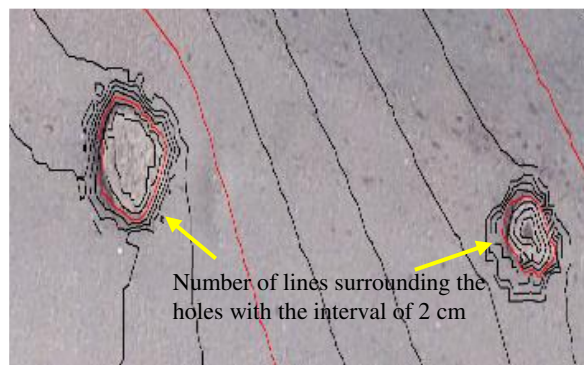
Figure 5. The depth of holes with interval of contour lines.

The depth of potholes are presented and calculated from the picture, as it is described in Figure 5.

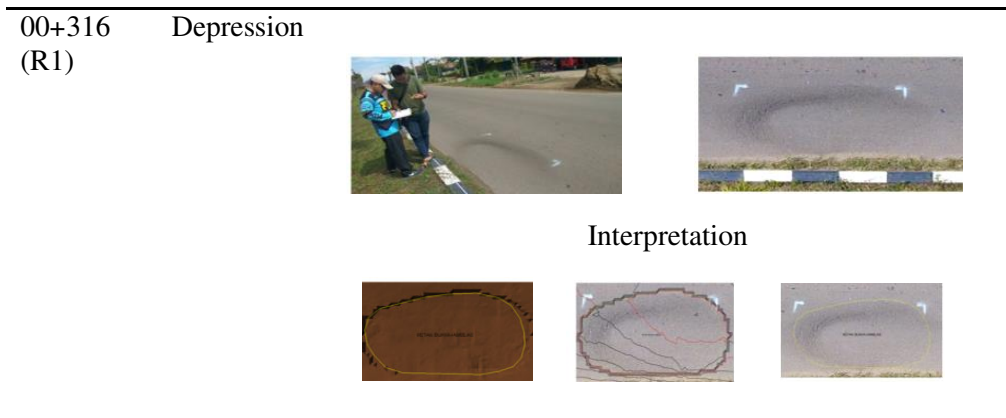
Table 1. Comparison of manual photo and Aerial photo interpretation of potholes.

Station	Type of Damage	Manual photo	Aerial Photo
00+054 (L.2)	Potholes		
00+402 (R1)	Alligator crack

3.2.2 *Types of Potholes.* On station, STA 00 + 054 (left picture) after comparison and validation of manual photo and Aerial photo interpretation of potholes it reveals, the area of potholes is 0.054 m², length is 30 cm and width is 18 cm. The comparison can be seen as the following photo inside the Table 1.

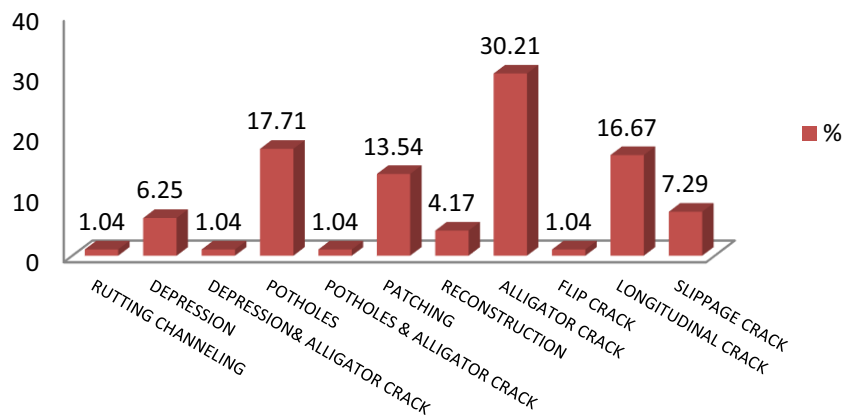
Figure 6. Percentage of number of damages according to damage types.

3.2.3 *Characteristics of damage condition.* Pavement damages in this research are classified into 7 types, namely depressions, potholes, alligator crack, longitudinal crack, slip crack, patching, and reconstruction. Number of damage according to type of damage in the study area is shown in the following Table 2.
