Identification of Slope Stability Analysis

Ika Juliantina[#], Yulindasari Sutejo[#], Ratna Dewi[#], Bimo Brata Adhitya[#], Reffanda Kurniawan Rustam^{*}

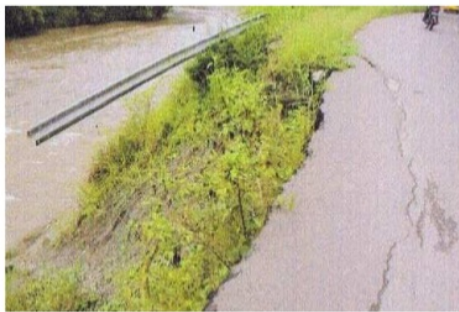
Fig. 6 The research location in SP. Sugihwaras-Muara Enim

The landslide was natural events that most often occur in Muara Enim regency, South Sumatra Province. Fig. 6 and 7 show the situation landslides that had been occurred. Table 5 and 6 describes the location of areas landslides in Muara Enim regency, South Sumatra Province. The landslide location in SP. Sugih Waras-Muara Enim such as: Tanjung Enim, Darma, Matas, Pandaenim, Simpang Meo, Sugihwaras, and Sidodadi. Table 6 described that the formation in Sugihwaras was breccia rock.

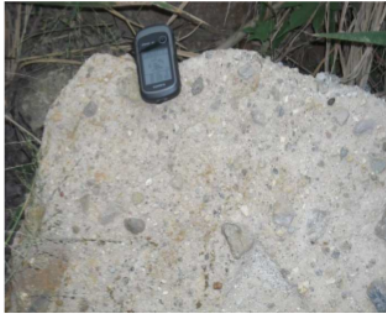
Fig. 8 Breccia rock

One of the causes of landslides was natural factors such as the influence of geological structure. According to the Department of Mines and Energy, Muara Enim regency was igneous rocks of andesite and bentonite. There were also rocky clay sedimentary rocks and breccia derived from the igneous rock fragment precipitated. Figure 8 showed an example of the breccia lithology at the landslide site.

Conditions Muara Enim regency was a category of landslide because it was in an area that has breccia rock types that were not compact and weathered, and bentonite clay that readily absorbs water.
