Factors Causing Landslides on Highways in Ogan Komering Ulu Regency, South Sumatra Province

Anggi Purnama Sari Dewi¹, Maulid M Iqbal², Yulindasari Sutejo^{3*}, Ratna Dewi⁴, Bimo Adhitya⁵

Abstract

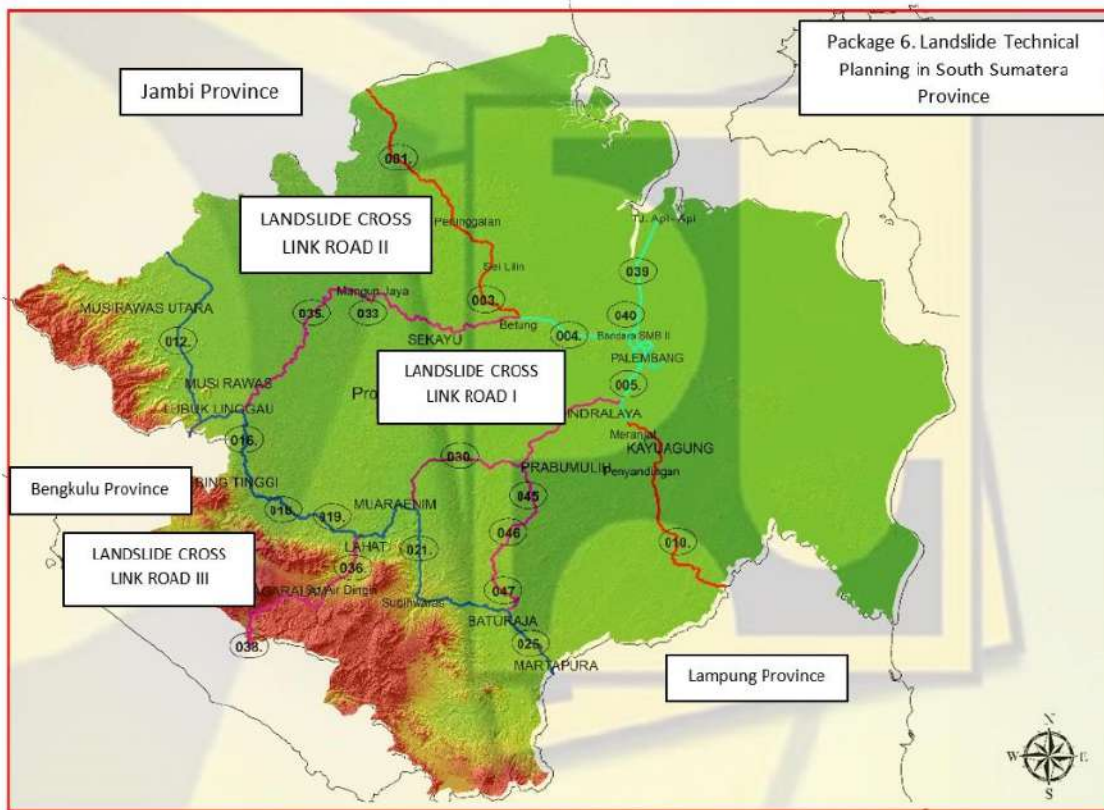
Figure 1. Landslide location in South Sumatra region and geological map of cross-link road III.

Based on BP2JN data for the South Sumatra Region from the Center for National Road Implementation V, Directorate General of Highways, Ministry of Public Works and Public Housing, landslides in the South Sumatra Region were quite frequent. The landslides occurred in multiple areas, such as the cross-link II landslide, covering the Sekayu-Mangun Jaya area at KM. 110+100, KM. 161+000, KM. 161+570, KM. 172+580, and KM. 251+990. The landslide covered the third cross-link area of the Lahat-SP Air Cold KM. Road Section 222+850, KM. 227+700, KM. 229+000, KM. 254+100. Cross-link IV was covered in the area of Jalan Baturaja-Bts Kab.Oku, KM. 190+250, KM. 190+250, KM. 193+000, and KM. 194+420. Figure 1 illustrates (a) the location of the landslide and (b) the geological map of cross-link III [2].

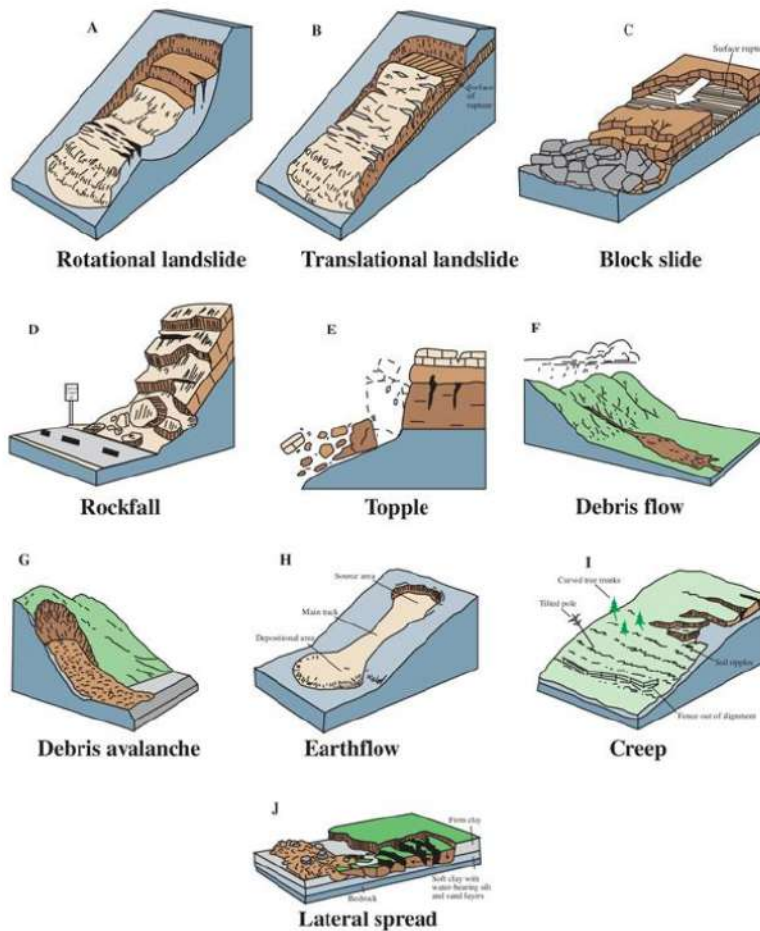
Figure 2. Types of landslides.

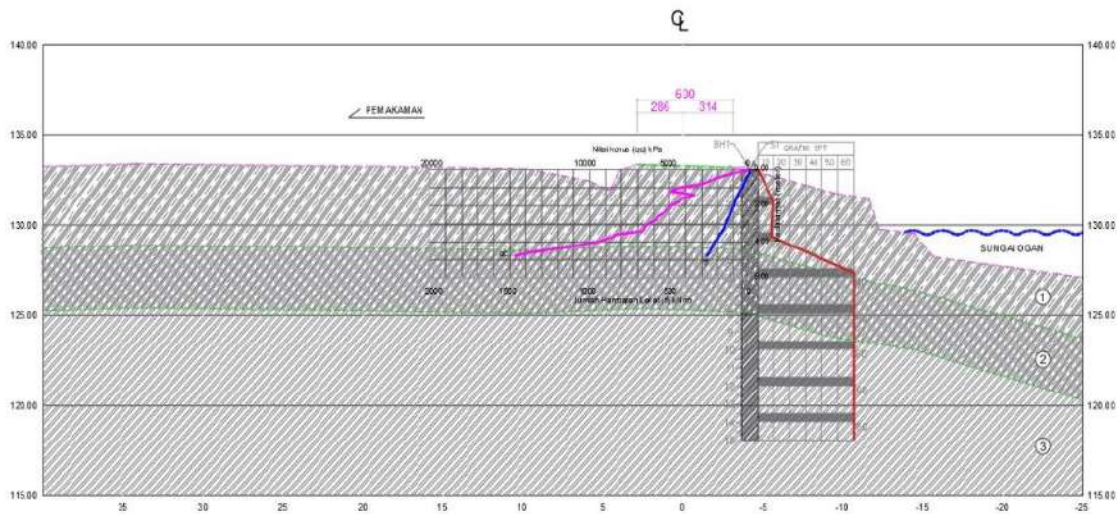
Figure 3.
Soil stratification for case 1.

Figure 3 and Figure 4 [2] describe the cross-sectional shape of the two research case studies. They also show the stratification of the land. Based on the figures, analyses were carried out using the Slope/W computer program. This model relates to geometric representation and input soil parameters, such as cohesion (c), shear angle (ϕ), soil density (γ), and groundwater level. The locations and photos of the landslides in this study are shown in Figure 5 [2]. The stages of calculating slope stability using the Slope/W program are as follows: (a) slope modeling; (b) determining soil parameters such as (soil density, kN/m³), c (cohesion, kPa), and (ϕ , shear angle, °); and (c) determine the ground water table (GWT).

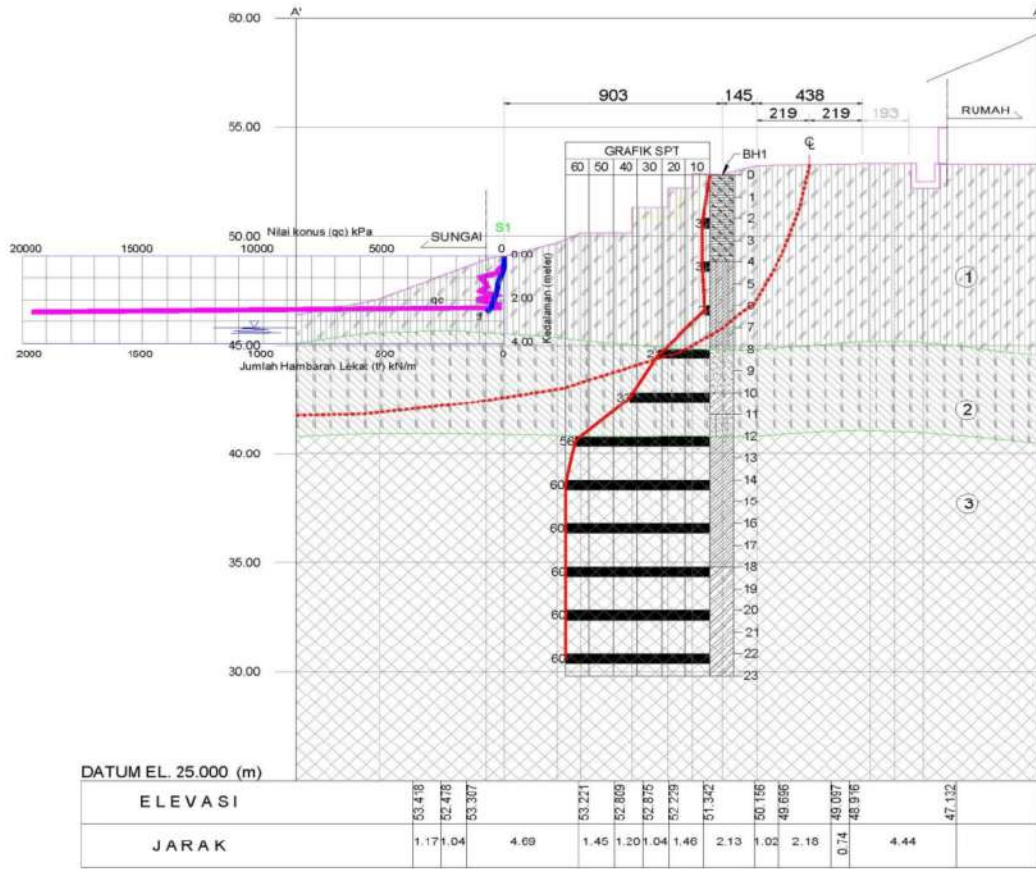
Figure 4. Soil stratification for case 2.

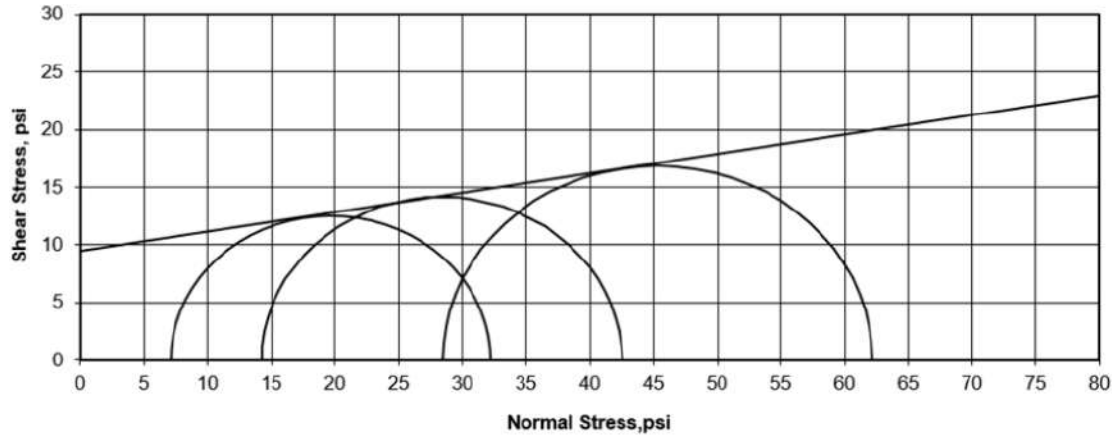
The results of the triaxial test in case study 1 (STA 194+420) are a cohesion (c) value of 19.18 kPa, and an internal shear angle (ϕ) of 19.6°. In addition, in case study 2 on the interconnecting road IV Desa SP. Sugih Waras STA 429+312, a cohesion (c) value of 19.60 kPa was obtained, and an internal shear angle (ϕ) of 8°. The parameter data from the triaxial UU test was used to input soil data in the slope/W program.

Figure 6. Triaxial test results.

The test of the mechanical properties of the soil that was carried out was the Triaxial Test for Unconsolidated Undrained Conditions. This triaxial test was carried out 3 times with cell pressure stresses of 1 kg/cm², 2 kg/cm², and 3 kg/cm², respectively. Each location for soil sampling consisted of 2 points. Therefore, 12 samples were tested in total. The test object was 7 cm high with a diameter of 35 cm. The results obtained from the triaxial testing are shown in Table 3. The graphs of the results of the triaxial testing for the 2 research case studies are shown in Figure 6.

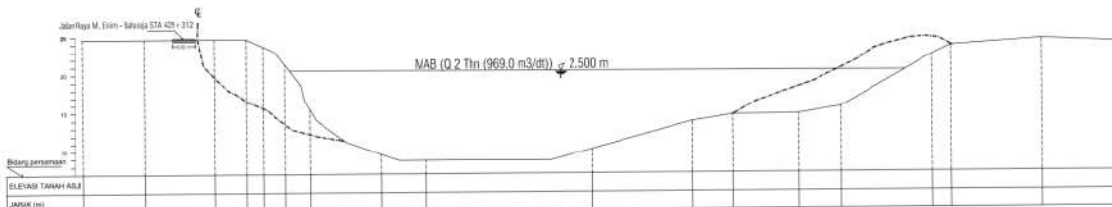
The road segment Sp. Sugihwaras – Bts. Baturaja City Km. 429+312 is the location of the landslide in case study 1 due to the movement of material in the form of clay with gravel inserts, clay, and claystone. The cause of this landslide is that there is a bend in the river channel, so that water continuously scours the slopes of the road, and the subgrade of the road ends up gradually descending. In addition, the soil material in this location is intercalated clay with gravel, clay, and claystone, meaning that the material is easily saturated and erosive. An illustration of the causes of landslides in this location is shown in Figure 7.

Figure 7. Cross-sectional of case study 1.

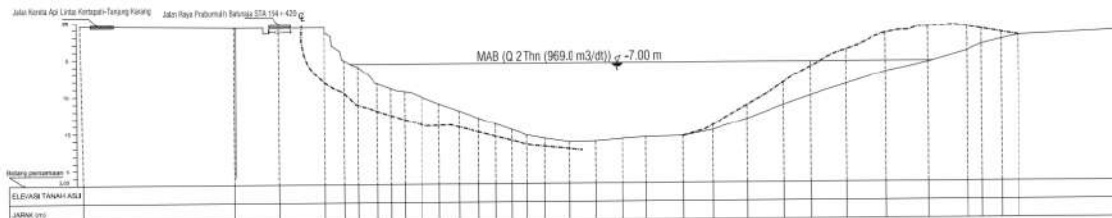
Case study 2 concerns the location of Jalan Batu Raja – Bts. Regency. Oku Km. 194+420, which is a landslide location due to the movement of materials in the form of sandy clay, clay, and claystone. The cause of this landslide is that the location is right at a bend in the geometry of the river. It is thought that the road landslide begins with continuous scouring of river water during flooding, such that the slope of the road reaches a critical point when a landslide occurs (Figure 8). The road embankment is on slippery shale claystone, which is very susceptible to landslides when there is groundwater infiltration in the material because it is very easy to bring about a decrease in shear strength in this material.

Figure 8. Cross-sectional of case study 2.

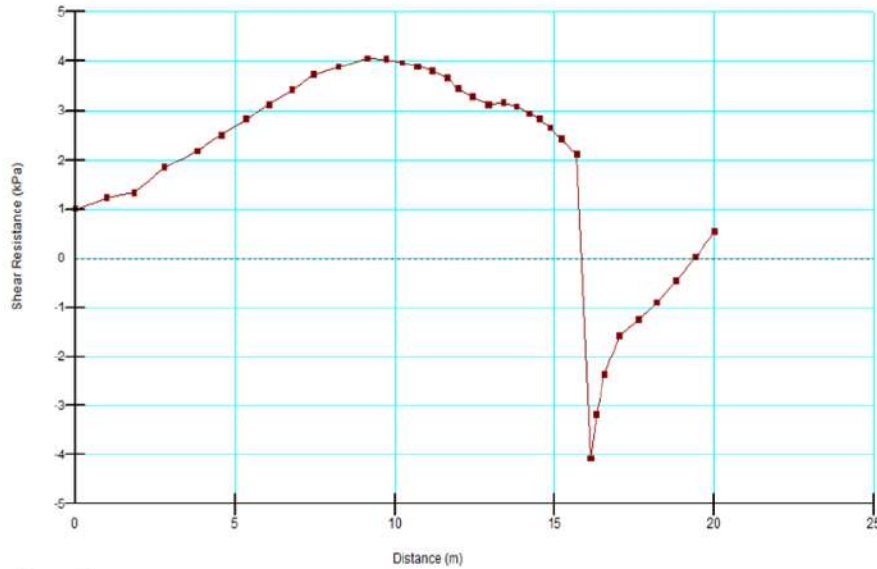
Figure 11.
The graph of FOS for case 1 (1.700).

the beginning of the slope conditions, the FOS value is still > 1.25 , but due to the influence of scouring and ground water level, the FOS value becomes < 1 . This is what causes landslides. The FOS results from the Slope/W analysis for case studies 1 and 2 are shown in Figure 9 and Figure 10. Figure 11 and Figure 12 show the FOS graph for case study 1.

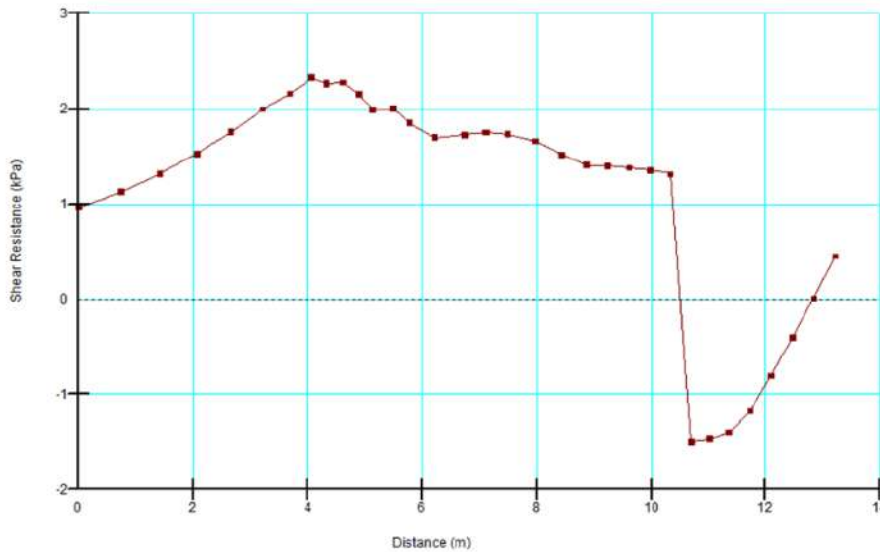
Figure 12.
The graph of FOS for case 1 (1.190).
