Identification of Slope Stability Analysis

Abstract— Landslide was natural events that most often occur in Indonesia. South Sumatra Province has a lot of areas susceptible to landslide risk. The aim of this study is to the identification of slope stability analysis. A adjustment in the constancy of a slope can be caused by several factors: geological conditions, high rainfall, and the topography. The research location in Muara Enim reGENCY (Cases: SP. Sugihwaras-Muara Enim and SP. Sugihwaras-Baturaja). The results of this research indicated Muara Enim-SP.Sugihwaras-Baturaja was the typology defined in this type of zone C because the area was included in the areas with slope 0 % to 20 %. The zone classification explained some of the caused landslides were natural factors, type of soil, and human activities. Natural factors such as heavy rainfall were 79-82 mm/month. Muara Enim reGENCY conditions were a category of landslide because it was an area that had breccia rock types that were not compact and were weathered and bentonite clay that readily absorbs water. Based on the results of Slope/W analysis, safety factor (SF) in the case of SP. Sugihwaras-Muara Enim was 1.104 and the cas

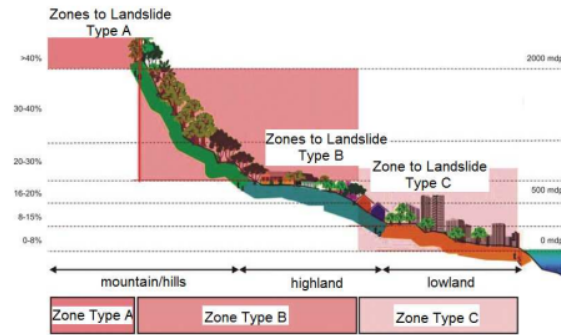
Fig. 2 Typology of the potential landslide zone

Typology of potential landslide zone (Fig. 2) is divided into three parts [a]: Zone A, Zone B, and Zone C. Zone A is zone areas potential to landslide on the slopes of the mountain, mountainside, hillside, hillsides and riverbanks with slope > 40 %, with height above 2000 m above sea

level. Zone B is zone area potential to landslide at the foot of the mountain, the foot of the mountains, foothills, foothills and riverbanks with slope ranging between 21-40 %, with a height of 500-2000 m above sea level. Zone C is zone area has the potential landslides in the highlands, low, riverbanks or river valley with slope ranges from 0-20 %, with an altitude of 0-500 m above sea level.

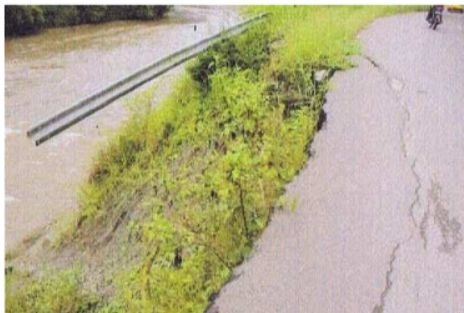
Fig. 6 The research location in SP. Sugihwaras-Muara Enim

The landslide was natural events that most often occur in Muara Enim regency, South Sumatra Province. Fig. 6 and 7 show the situation landslides that had been occurred. Table 5 and 6 describes the location of areas landslides in Muara Enim regency, South Sumatra Province. The landslide location in SP. Sugih Waras-Muara Enim such as: Tanjung Enim, Darma, Matas, Pandaenim, Simpang Meo, Sugihwaras, and Sidodadi. Table 6 described that the formation in Sugihwaras was breccia rock.

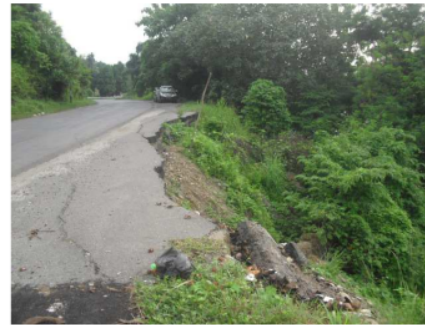
Fig. 7 The research location in SP. Sugihwaras-Baturaja

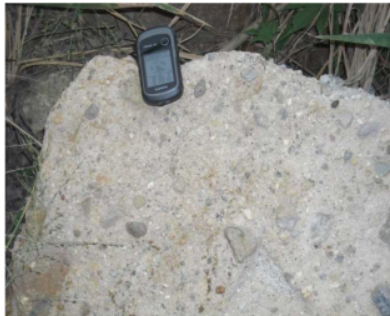
Fig. 8 Breccia rock

One of the causes of landslides was natural factors such as the influence of geological structure. According to the Department of Mines and Energy, Muara Enim regency was igneous rocks of andesite and bentonite. There were also rocky clay sedimentary rocks and breccia derived from the igneous rock fragment precipitated. Figure 8 showed an example of the breccia lithology at the landslide site.
