11th INTERNATIONAL CONFERENCE ON GEOTECHNICAL ENGINEERING
IN TROPICAL REGIONS (GEOTROPIKA) &
1st INTERNATIONAL CONFERENCE ON HIGHWAY AND TRANSPORTATION
ENGINEERING (ICHITRA)

Prompt analysis of condition priority for road improvement planning

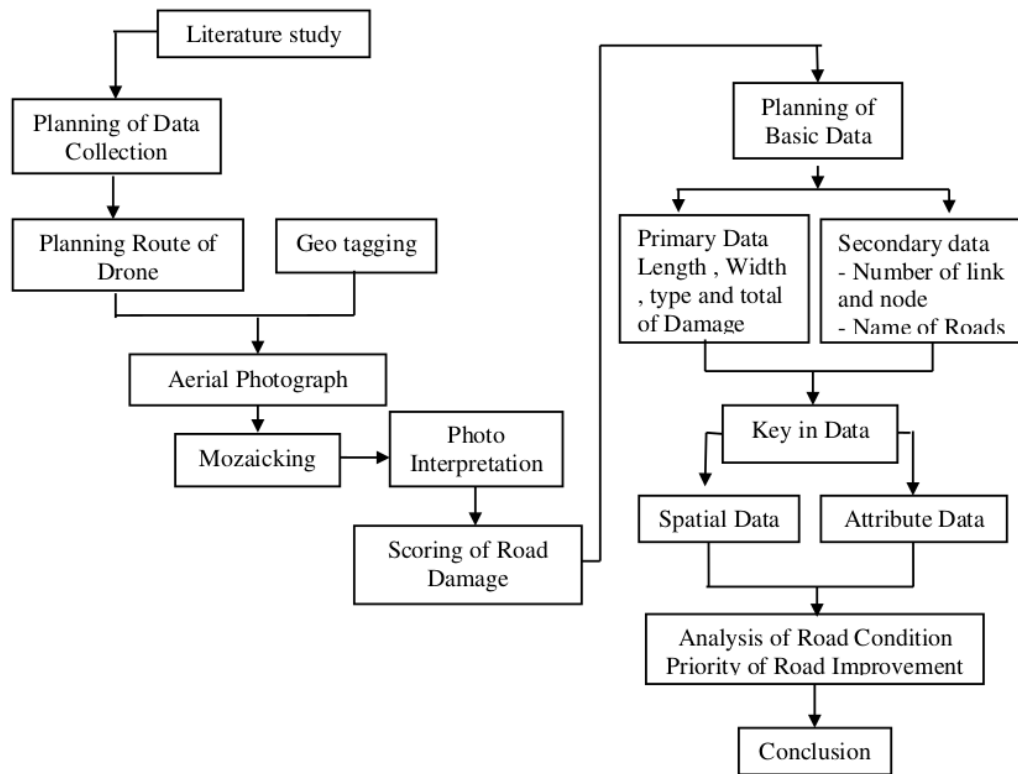
Figure 1. Flow chart of research.

Survey location was at H. M. Noerdin Pandji street, a primary collector road, at Kelurahan Kebun Sayur, kecamatan Alang-alang Lebar, Palembang. The survey is done on March 2017. First, the data was collected by using a drone. A manual data collection was done to confirm the data accuracy. The research programme was carried out according to the flow chart in Figure 1.

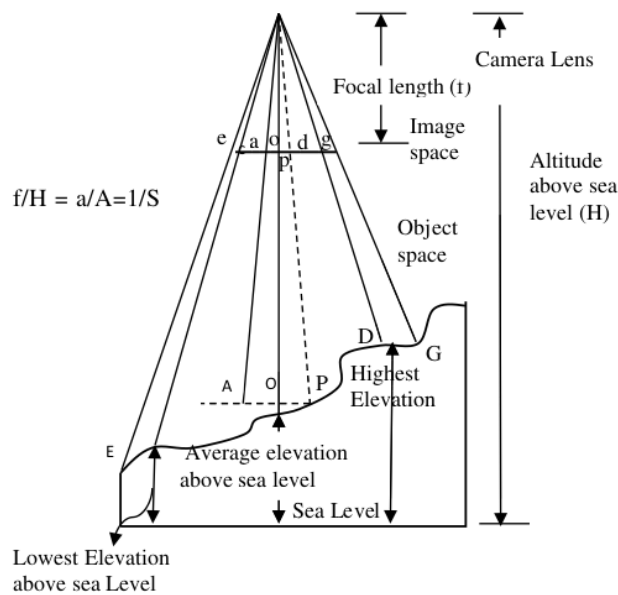
Figure 2. Correlation between Heights of flying, camera focuses and photo coverage.

Camera used for this research has photo format 24 x 36 mm, and length of camera focus (f) 18 mm. That specification is used to achieve the height and to find the minimum designed hole of 1cm [3]. Time needed to fly drone and to record the data is 15-20 minute for 600 meter length of road. The road width is 50 meter. For H.M Noerdin Pandji Street, which has 5200 length, it takes 130 minute to take aerial photo. From the survey experience, it can be concluded that the less wide the road, the faster photo recording on the field. To get sufficient coverage and resolution of spatial photo that is able to do interpretation of measurement, types of holes and road damages then the altitude of flying drone is planned initially as the following Figure 2.

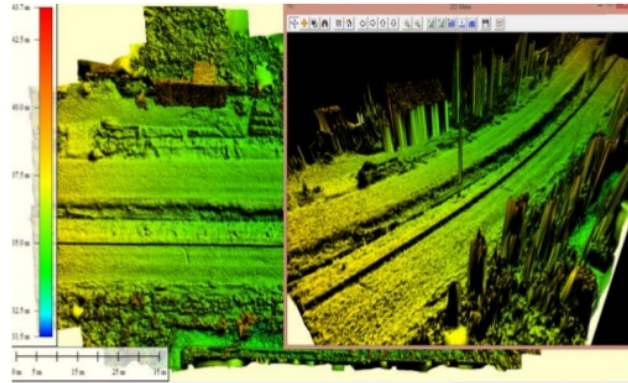
Figure 3. Three dimension of DEM results.

By using software Arc-GIS 10.3, extraction of aerial photo is carried out with the steps of mozaicking and aerial triangulation as the following Figure 3.

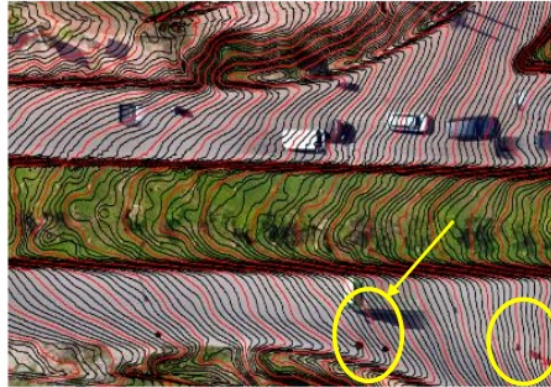
Figure 4. Identification results by Contouring.

3.2.1 *Providing contour line at the road damage.* Providing contour line is done in order to get the potholes picture on the road. In this research interpretation is done with 2 cm interval and 10 cm index. The following picture shows the contour of road and side road.

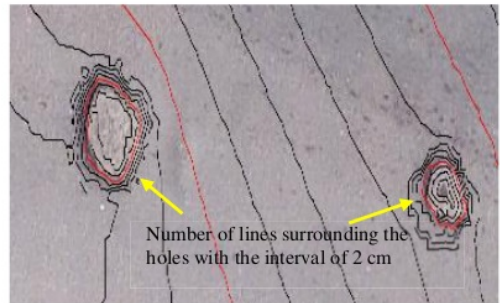
Figure 5. The depth of holes with interval of contour lines.

The depth of potholes are presented and calculated from the picture, as it is described in Figure 5.

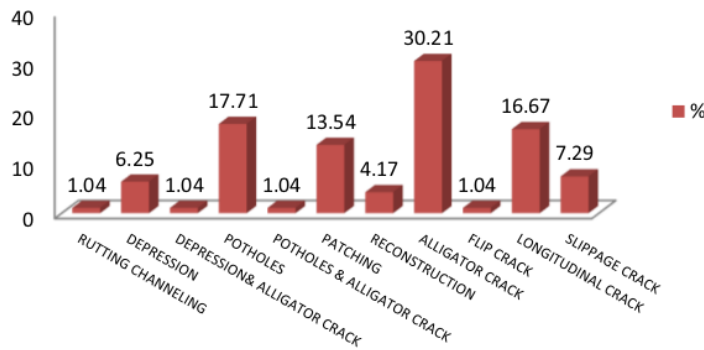
Figure 6. Percentage of number of damages according to damage types.

3.2.3 *Characteristics of damage condition.* Pavement damages in this research are classified into 7 types, namely depressions, potholes, alligator crack, longitudinal crack, slip crack, patching, and reconstruction. Number of damage according to type of damage in the study area is shown in the following Table 2.

Type of damage	Number of points	% damage
Depression	8	7.407
Potholes	14	12.963
Alligator crack	39	36.111
Slip crack	10	9.259
Longitudinal crack	5	4.630
Patching	24	22.222
Reconstruction	8	7.407
