Challenges in Conserving Bahal Temples of Sriwijaya Kingdom, in North Sumatra

Keywords: Conservation, Bahal temples, architecture, structure and material

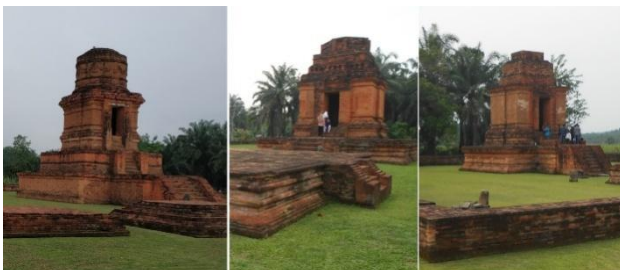
Fig. 3 The temples of Bahal I, II and III, Padang Lawas, North Sumatra Province

The Bahal I, II and III temples have been completely re-constructed for all of the main temples but the Perwara temples cannot be completed with consideration at the top of the Perwara temples made of wooden structures. At this time, the three temples complexes have been opened as cultural tourism objects that are supported by local and central governments. The Bahal I II and III temples are open in nature without a roof covering that can protect it from the effects of nature and the weather (figure 3). Likewise, no signage restrictions have been found for tourists not to act that could harm the preservation of the temples.

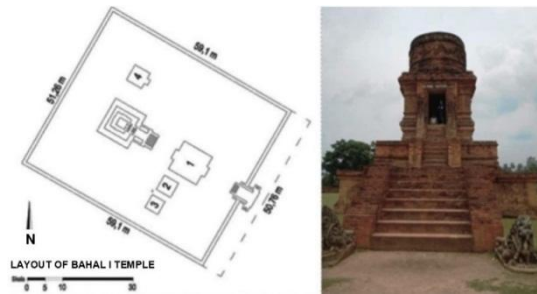
Fig. 4 Temple site of Bahal II with two Perwara temples nearby

The courtyard of the Bahal I temple is 51.26 x 59.1 meters with a border in the form of a pastoral fence. The layout of the Bahal I temple is clearly visible with a strong shaft in the form of the main temple - Perwara temple 01 - the gate. Perwara 02 is located beside the main temple with a parallel position. The temple shaft is reinforced by placing a pair of makara in front of the temple steps. have stairs (figure 4).

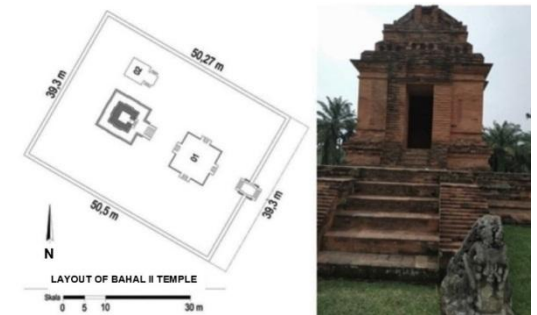
Fig. 5 Temple site of Bahal II with two Perwara temples nearby

Visitors from outside must climb the stairs at the entrance and go down again when stepping on the Bahal II temple yard. In front of the main temple there is the Perwara 01 temple which is straight with the gate forming a kind of shaft. Thus, there is a clear hierarchy between the main temple and Perwara 01 temple (figure 5).

The Bahal II temple yard has a dimension of 37.2 x 44.4 meters with a fence boundary in the form of the same brick structure as the temple.

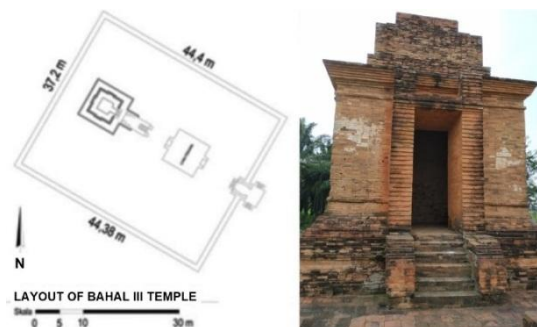
Fig. 6 The temple of Bahal III with Perwara temple in the front of it

The area of the Bahal III temple complex is smaller than the land area of the Bahal II temple complex. The layout of the temple Bahal III looks simple with a strong shaft in the form of the main temple - Perwara temple - the gate. The temple shaft is reinforced by placing a pair of makara in front of the main temple stairs. Perwara 02 is located beside the main temple with a parallel position. The Bahal II temple complex is surrounded by a stone fence as high and about 1 m thick. The fence becomes a dividing wall with the surrounding area.

The Bahal III temple complex consists of the main temple and one Perwara temple in front of it which is surrounded by brick walls and has one entrance or entrance (figure 6). Visitors from outside have to step up the stairs at the entrance and step down again when stepping on the courtyard of the Bahal III temple. In front of the main temple there is the Perwara I temple which is straight with the gate forming a kind of axis. The mass composition of the building on the site of the Bahal III temple complex is the simplest compared to Bahal I and II temples. A pair of makara in front of the Bahal III temple is no longer intact.

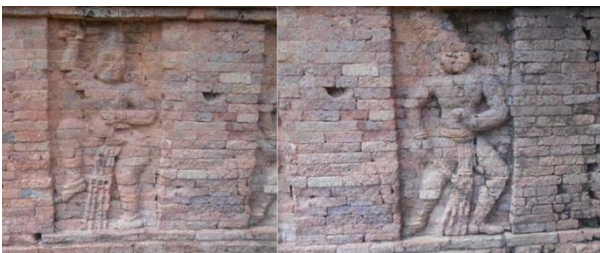
Fig. 7 Relief carved on the walls of the Bahal I temple

On the two sides of the Bahal I temple wall there are carvings or ornaments in the form of people in various positions such as dancing (figure 7). Although many carved parts have been damaged due to damage or eroded brick, there are still proportional details on the shape of the human. On the other side there are ornaments or sculptures in the form of giant creatures sitting.

Brick temples at the Padang Lawas site are the same as the temples at Muara Takus and at Muara Jambi which do not have reliefs and ornaments on the temple walls. Relief on the brick walls of the temple is very easily damaged, worn and mossy.

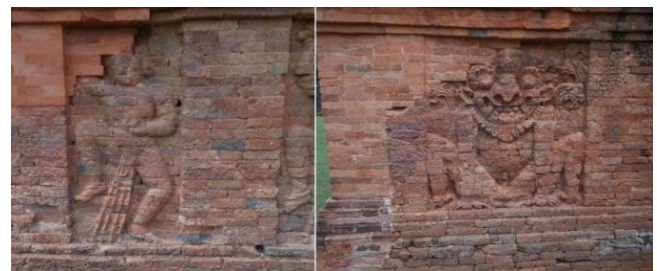
Fig. 8 The use of new bricks on the wall that have reliefs

Conversely, if a cultural heritage object has been reconstructed, rehabilitated and renovated without following the standard preservation procedure or is confused with the authenticity of the work in the present, the condition will give false data because it is different from the original (Hudson, 2008). The condition of objects of cultural heritage that are not original but blend with the original without any special signs or information will complicate the research or depiction of the past (figure 8).

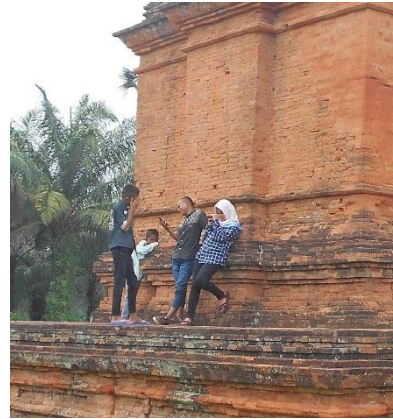
Fig. 9 Visitors or tourists leaned forward and put their feet on the brick walls of the temple.

Efforts to protect the other bricks temples that have been carried out are by limiting or prohibiting visitors to step up the temple so that the surrounding temples are given fences and metal doors in addition to prohibited signs. This is effective enough to reduce the direct interaction of visitors with the bricks temple.

This method has been implemented at the MuaraTakus temple, Riau (A. Siswanto, Farida, Ardiansyah, 2017). Although the visitor's desire to climb the temple is blocked but the protection of the temple from damage caused by footprints and the weight of visitors can be avoided.

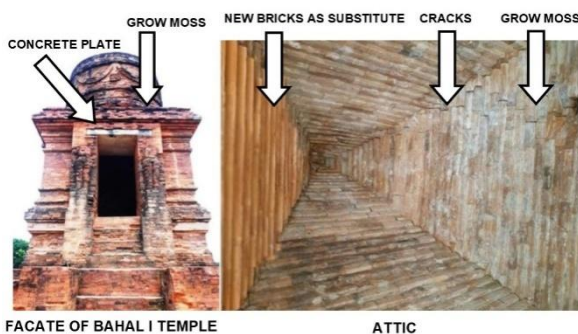
Fig. 10 The use of concrete plate (left) and the damage of temples' attic

Nevertheless, techniques and information are still being developed to maintain the durability and authenticity of a cultural heritage object with the principle and the aim of maintaining the age of the object is much longer by adding new elements to a minimum. The use of new materials should be clearly distinguishable from the original material such as the use of bricks or sandstones. The possibility of using the new material will gradually change to resemble the original material replaced (figure 10). The use of concrete material will be clearly visible at this time so that people can distinguish new materials from old materials but this may be difficult to distinguish if the cultural heritage objects increase by 1,000 years. The use of cement and chemical adhesive materials will also be able to deceive the understanding of the next 1,000 years. People may be doubtful whether cement and chemical adhesive have been discovered when the cultural heritage was built.

At this time several marker forms have been developed that distinguish between new materials and old materials, for example by providing metals in andesite stones which are used as additional material during the restoration of Borobudur temple. The use of andesite stone material in Borobudur temple is only done to strengthen the temple structure of andesite stones to be more stable, stronger and not easily loose. This consequence continued by not adding a new head to the Buddha statue who had lost his head. Reconstruction measures to support preventative conservation are good because they can prevent further damage. For example, the use of anti-watertight material at the bottom and top of the building to be reconstructed. However, this can reduce the authenticity of cultural heritage. As a middle ground, the use of new materials in the reconstruction action
