Identification of Slope Stability Analysis

Abstract— Landslide was natural events that most often occur in Indonesia. South Sumatra Province has a lot of areas susceptible to landslide risk. The aim of this study is to the identification of slope stability analysis. A adjustment in the constancy of a slope can be caused by several factors: geological conditions, high rainfall, and the topography. The research location in Muara Enim regency (Cases: SP. Sugiharas-Muara Enim and SP. Sugiharas-Baturaja). The results of this research indicated Muara Enim-SP.Sugiharas-Baturaja was the typology defined in this type of zone C because the area was included in the areas with slope 0 % to 20 %. The zone classification explained some of the caused landslides were natural factors, type of soil, and human activities. Natural factors such as heavy rainfall were 79-82 mm/month. Muara Enim regency conditions were a category of landslide because it was an area that had breccia rock types that were not compact and were weathered and bentonite clay that readily absorbs water. Based on the results of Slope/W analysis, safety factor (SF) in the case of SP. Sugiharas-Muara Enim was 1.104 and the case of

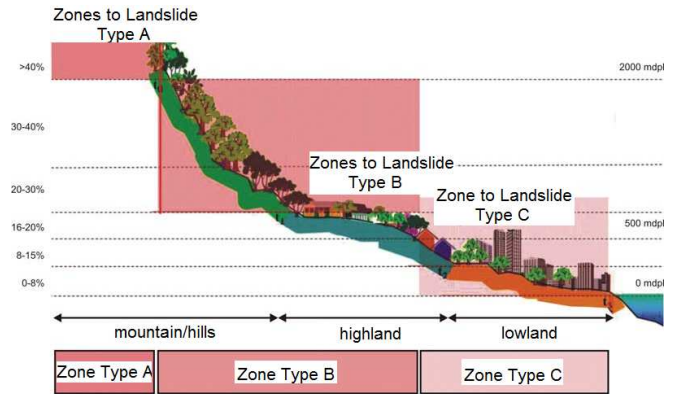
Typology of potential landslide zone (Fig. 2) is divided into three parts [a]: Zone A, Zone B, and Zone C. Zone A is zone areas potential to landslide on the slopes of the mountain, mountainside, hillside, hillsides and riverbanks with slope > 40 %, with height above 2000 m above sea

level. Zone B is zone area potential to landslide at the foot of the mountain, the foot of the mountains, foothills, foothills and riverbanks with slope ranging between 21-40 %, with a height of 500-2000 m above sea level. Zone C is zone area has the potential landslides in the highlands, low, riverbanks or river valley with slope ranges from 0-20 %, with an altitude of 0-500 m above sea level.

Fig. 2 Typology of the potential landslide zone

The slope (ϕ) was 16,4° in SP. Sugihwaras-Muara Enim. Based on [4], the typology of the case study (SP. Sugihwaras-Muara Enim and SP. Sugihwaras-Baturaja) defined of zone C because the area was included in the areas with a slope of 0 % to 20 %. Heavy rainfall in November (2012) also causes of the landslide of the case study (SP. Sugihwaras-Muara Enim and SP. Sugihwaras-Baturaja). Rainfall reached 79-82 mm/month based on Meteorology Climatology and Geophysics Council (BMKG).

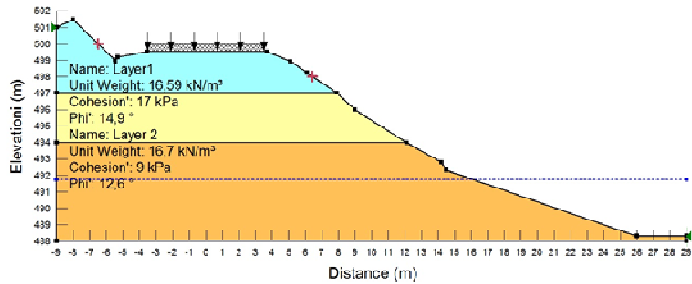
Fig. 4 Cross section in case study SP. Sugihwaras-Baturaja

Beside of that, the case study landslide in SP. Sugihwaras-Baturaja: Condition 1 is the initial condition with the data layer 1 $c = 17$ kPa, $\phi = 14.9^\circ$ and layer 2 $c = 9$ kPa, $\phi = 12.6^\circ$. On two conditions: a data layer 1 $c = 19$ kPa, $\phi = 14.9^\circ$ and layer 2 $c = 14$ kPa, $\phi = 12.6^\circ$.

While the conditions three: a data layer 1 $c = 17$ kPa, $\phi = 17^\circ$ and layer 2 $c = 9$ kPa, $\phi = 14.6^\circ$. Landslide condition 4 assumes the value of the friction angle $\phi = 0^\circ$ and in layers assumes layer 1 $c = 17$ kPa, $\phi = 0^\circ$ and layer 2 $c = 9$ kPa, $\phi = 0^\circ$. Fig. 4 and 5 show the case study using Slope/W.

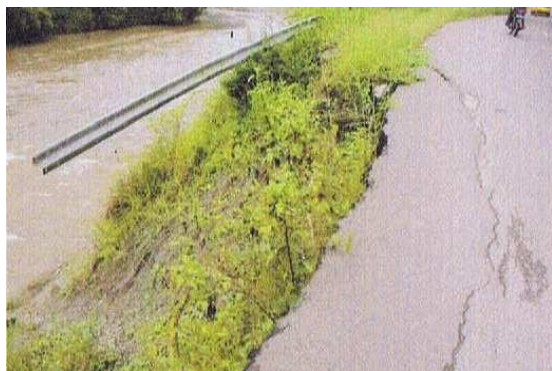
Fig. 6 The research location in SP. Sugihwaras-Muara Enim

The landslide was natural events that most often occur in Muara Enim regency, South Sumatra Province. Fig. 6 and 7 show the situation landslides that had been occurred. Table 5 and 6 describes the location of areas landslides in Muara Enim regency, South Sumatra Province. The landslide location in SP. Sugih Waras-Muara Enim such as: Tanjung Enim, Darma, Matas, Pandaenim, Simpang Meo, Sugihwaras, and Sidodadi. Table 6 described that the formation in Sugihwaras was breccia rock.

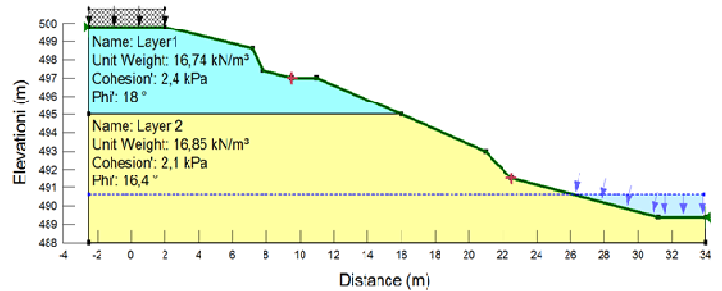
Fig. 5 Cross section in case study SP. Sugihwaras-Muara Enim

In the case study landslide initial condition with the data layer 1 $c = 2.4$ kPa, $\phi = 18^\circ$ and layer 2 $c = 2.1$ kPa, $\phi = 16.4^\circ$. On condition two: a data layer 1 $c = 4.8$ kPa, $\phi = 18^\circ$ and layer 2 $c = 2.1$ kPa, $\phi = 16.4^\circ$. While the condition three: a data layer 1 $c = 2.4$ kPa, $\phi = 18^\circ$ and layer 2 $c = 2.1$ kPa, $\phi = 21^\circ$. Landslide condition 4 assumes the value of the friction angle $\phi = 0^\circ$ and in the layers assumes layer 1 $c = 2.4$ kPa, $\phi = 0^\circ$ and layer 2 $c = 2.1$ kPa, $\phi = 0^\circ$.

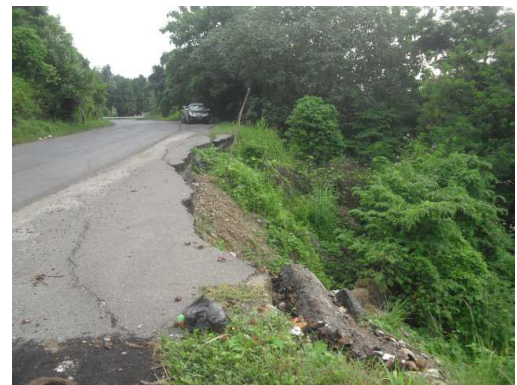
Fig. 7 The research location in SP. Sugihwaras-Baturaja

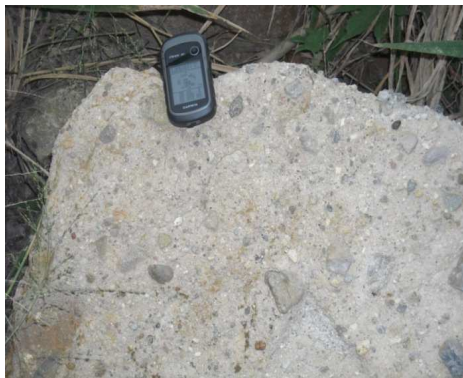
One of the causes of landslides was natural factors such as the influence of geological structure. According to the Department of Mines and Energy, Muara Enim regency was igneous rocks of andesite and bentonite. There were also rocky clay sedimentary rocks and breccia derived from the igneous rock fragment precipitated. Figure 8 showed an example of the breccia lithology at the landslide site.

Fig. 8 Breccia rock

Conditions Muara Enim regency was a category of landslide because it was in an area that has breccia rock types that were not compact and weathered, and bentonite clay that readily absorbs water.
