Corrosion Analysis on Internal Plastic Coating Drill Pipe 5 Inch 19.50 PPF Grade G-105

Ario Oktora¹, Eka Sri Yusmartini^{1,2*}, Muhammad Faizal³

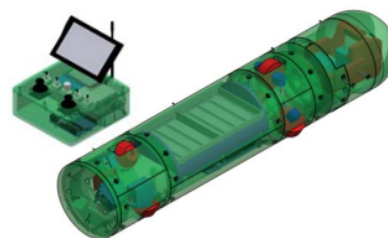
Figure 1. Prototype Automatic Drift With Internal Cam

Each drill pipe that will be used in the drilling program is subjected to an initial inspection to ensure the condition of the drill pipe is still suitable for use. After the drill pipe is used, every multiple of 1500 hours of running hours will be inspected in non-real time conditions or not when used in drilling. This research uses the Automatic Drift With Internal Cam prototype tool (Figure 1), which consists of two main parts, namely the transmitter and receiver. The transmitter functions to move the components in the receiver, including the servo which functions as a camera driver and direction. Where this tool can see the visual condition of the inside of the drill pipe.

1. A reduction in thickness of 2.2mm and 2.5mm from the initial thickness is obtained after the use of drill pipe with a span of 1500 hours to 3000 hours
2. From the samples conducted research, the highest corrosion rate is 0.25mm / month
3. From the results of the inspection with a span of 10 months, the internal condition of the plastic coating has decreased in quality. With the worst condition (IPC4) as many as 10 samples
4. The resulting Automatic Drift With Internal Cam prototype tool works well and can make it easier to monitor the internal plastic coating conditions

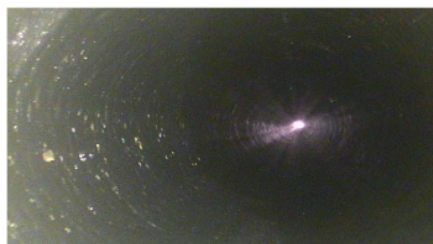
Internal Plastic Coating Condition 1

To inhibit corrosion of the internal parts of the drill pipe, the drill pipe has been coated with plastic coating, however, from the analysis and inspection reports, it was found that corrosion was quite significant in some drill pipes. The storage of the drill pipe in an open space and exposed to the sun allows the internal plastic coating to peel off so that it cannot completely protect the inside of the drill pipe. The pressure of the drilling mud when the user can erode the internal plastic coating itself, causing corrosion to the parts in the drill pipe. To find out the actual condition of the plastic coating, the Automatic Drift With Internal Cam prototype was used. In Figure 3 below is a comparison result of the internal plastic coating conditions using the DS-1 Volume 3 reference. Figure 1 is the condition of the internal plastic coating without any damage. Figure 2 is the condition of the internal plastic coating which is damaged by 30% of the total length of the pipe or from the surface area of the drill pipe. Figure 3 is the condition of the internal plastic coating which is damaged by 30% to 50% of the total length of the pipe or from the surface area of the drill pipe. Meanwhile, Figure 4 is the condition of the internal plastic coating which is damaged more than 50% of the total length of the pipe or from the surface area of the drill pipe.

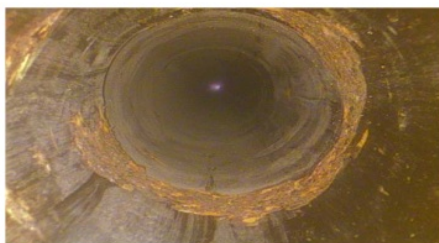
Internal Plastic Coating Condition 2

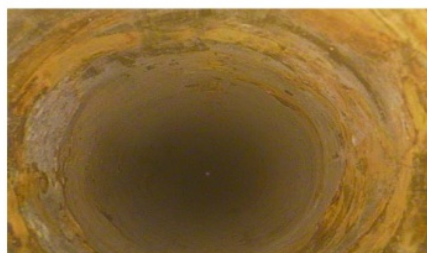
Internal Plastic Coating Condition 3

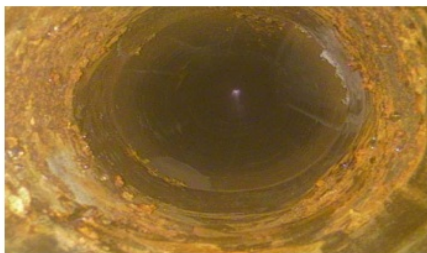
Internal Plastic Coating Condition 4
