The 5th International Conference of Euro Asia Civil Engineering Forum (EACEF-5)

## Effect of Area Development on the Stability of Cut Slopes

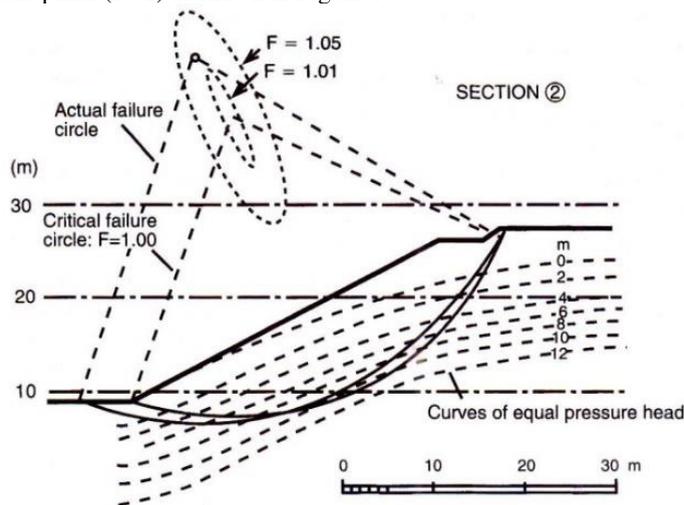
Fig.1. Slip plane generated from back-analysis of slope failure using Bishop routine method [2]

construction of the railway, the slope was trimmed back to a slope of 1V:1<sup>1/2</sup> H for further area development. The slope failed five years after the latter modification. The soil consisted of a firm, homogeneous, intact lightly over consolidated clay with some thin layers of silts and sand. The properties of the soil, obtained from a series of consolidated undrained triaxial test with pore water pressure measurement, are  $c' = (10 \pm 2.2) \text{ kN/m}^2$  and  $\phi' = 27^\circ \pm 2$  ( $\tan \phi' = 0.512 \pm 0.038$ ). The lowest value of internal friction angle was  $22^\circ$ . Back-analysis, performed after failure using Bishop routine method and average shear strength parameters, yield in an average FS of 1.05 considering actual failure circle or 1.01 considering critical failure circle (Figure 1).

The highest shear strength parameters ( $c' = 12.2 \text{ kN/m}^2$ ,  $\phi' = 29^\circ$ ) were used for calculation of slope stability in the original condition, after the first cutting and after the second cutting. Lowest shear strength properties ( $c' = 7.8 \text{ kN/m}^2$ ,  $\phi' = 22^\circ$ ) were used for condition at failure i.e. five years after the second excavation. In the simplified Bishop method, the program defines the most critical circular failure surface for each case except for the case where tension crack has developed at the crest. For M-P method, all cases were analyzed for pre-defined failure surface as indicated in [2] (Fig. 1). Analyses show that both Simplified Bishop and M-P methods show a clear decrease FOS as the results of the in change in slope inclination. Both methods show a reduction of factor of safety from 1.95 (original condition) to 1.67 (after the first cutting), and 1.39 (after the second cutting). In fact, the slope can be considered as stable after the second cutting ( $FS > 1.3$ ) however, tension cracks has developed at the crest and the soil properties may have changed due to continued movement of the slope face. By considering the residual strength and the presence of tension crack, Simplified Bishop Method gives FS of 0.99 while M-P method gives 1.02. These values are almost similar to back-calculation by [2] considering actual failure plane (1.05) and considering critical failure plane (1.01) as shown in Figure 1.

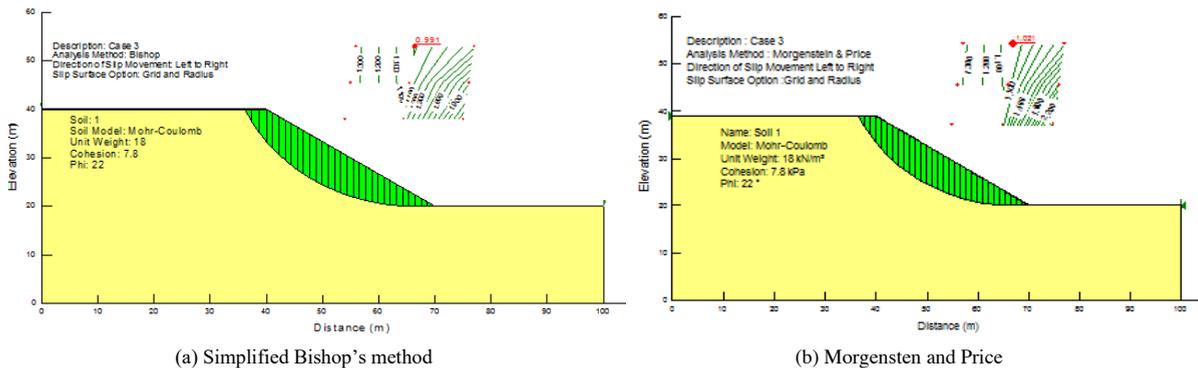
Fig. 2. LEM analysis for slip circle at failure condition using SLOPE/W

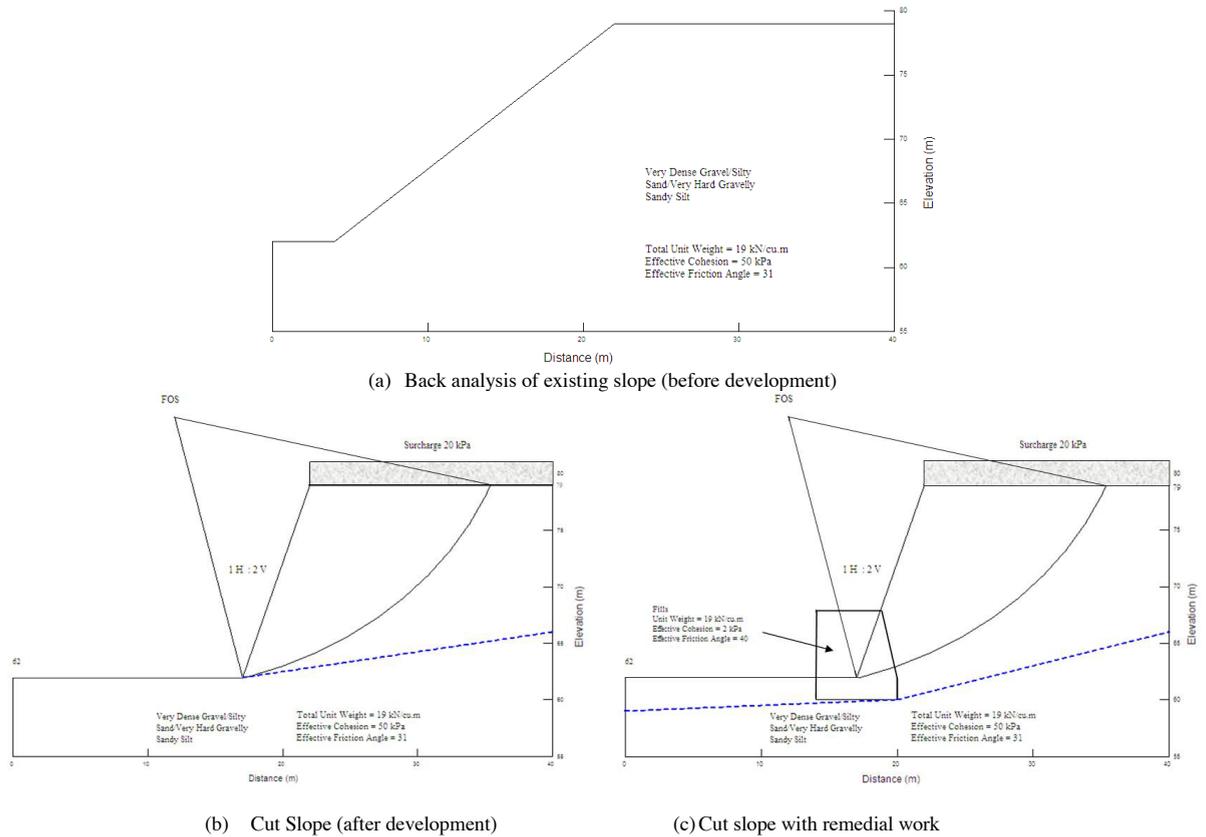
Fig.3. Geometry of the slope before and after excavation as well as after stabilization

The second case was presented in [3] where a slope was subjected to cutting to make room for construction of factories in an industrial area in Johor Bahru. A critical section was selected and a cross-section of the slope before and after development was defined as shown in Figure 2. The original slope was about 18 m to 20 m high formed an angle of about  $43^\circ$  to the horizontal. The slope was formed by very dense silty sand and or very hard sandy silt materials. Laboratory tests indicated that the soil has a unit weight of  $19 \text{ kN/m}^3$  and effective shear strength parameters of  $c' = 50 \text{ kN/m}^2$  and  $\phi' = 31^\circ$ . These hard materials do not encourage vegetation to grow, thus slope remained barren with little vegetation. Ground water table was very deep.

the face of the slope from movement. Another concern, some utility lines were presence some 2 m away from the crest of the slope, thus cutting at the toe is expected not to results in disturbance to the crest. On the other hand, the crest should be treated so that the development of tension crack could be avoided. Figure 3 shows the rectification work implemented on the slope which consists of retaining structure (Betoflor) at the toe of the slope and shotcrete application (guniting) at the slope face. Betoflor is a patented dry build interlocking system of concrete block walling which can be constructed up to 2m high while guniting is a dry mixture of cement, sand or crushed slag, and water, sprayed over the slope face as a lightweight concrete. Treatment was also made at the crest to mitigate the development of tension crack.

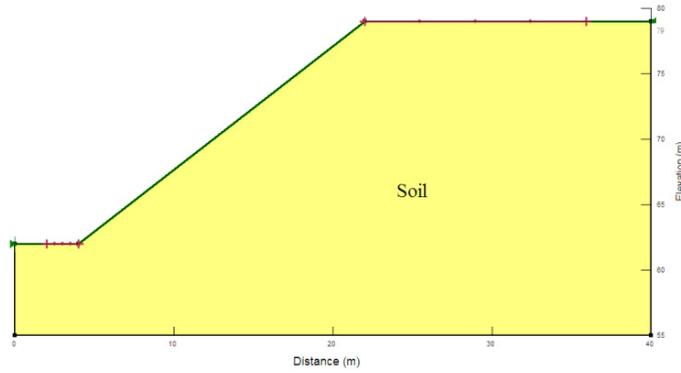
(a) Before analysis

Fig. 4. Limit equilibrium analysis by SLOPE/W

LEM analysis by Simplified Bishop method was performed in SLOPE/W to analyze the stability of the original slope. The result indicated that the original slope is stable with FS of 2.08. Preliminary analysis also indicated that the slope can stand with factor of safety of 1.51 if cut to an angle of  $55^\circ$ . However, the development plan requires that excavation to be made that to a slope angle of  $70^\circ$  at some parts of the slope. Stability analysis of the cut slope (to  $70^\circ$  angle) resulted in the factor of safety of 1.28. Note that the stability analysis of the new slope configurations considered a surcharge load of 20 kPa to represent some utility lines and construction at the crest

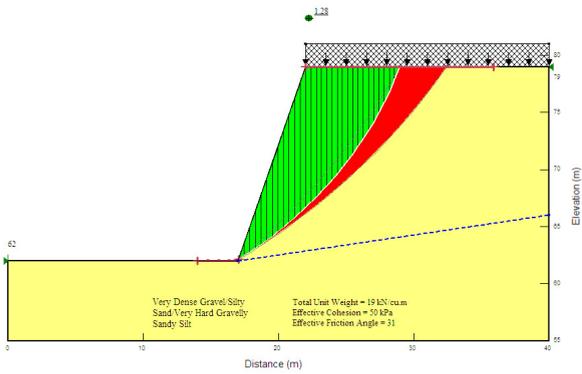
(b) Existing cut slope with 70° to the horizontal

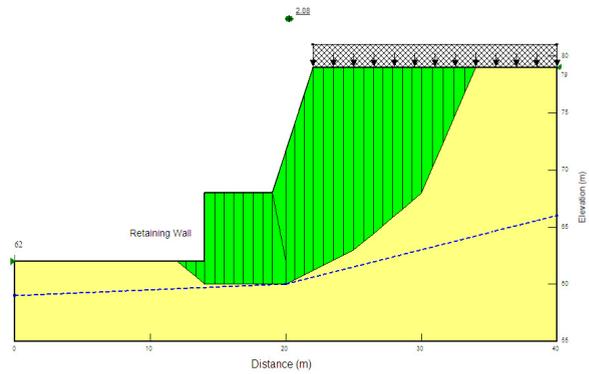
(c) Existing cut slope with 70° to the horizontal and six meters of retaining structure

Stability analysis of stabilized slope was performed by M-P method using pre-defined failure surface considering the dimensions of retaining wall and surcharge weight at the crest. The results showed that the implementation of the selected rectification work increases the factor of safety to 2.08 for the slope angle 70° and 2.3 for the slope angle 55°.

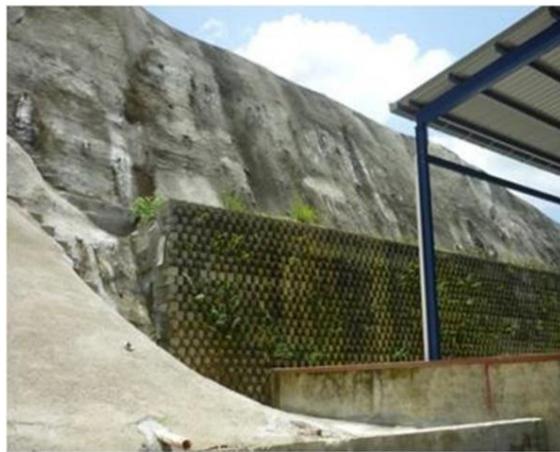
Fig. 5. Slope face after stabilization [3]
