**THE STUDY OF LANDSLIDE USING SLOPE STABILITY RADAR
WITHIN FAILURE SS_P4_028 IN PT NEWMONT,
NUSA TENGGARA BARAT, INDONESIA**

Marwan Asof, Sriwijaya University, South Sumatera, Indonesia
E W Dyah Hastuti, Sriwijaya University, South Sumatera, Indonesia
H I Manuhutu, PT. Sinarmas Energy and Mining, Indonesia
Yuda Nasution, PT. Newmont, Nusa Tenggara Barat, Indonesia

Abstract

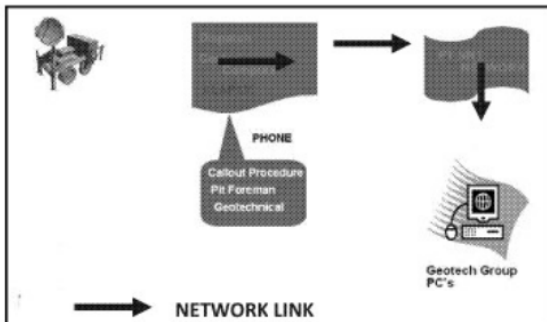
Figure 5. Information Flowchart of Slope Stability Radar

If the movement of the mine wall indicates an landslide will occur then the Slope Stability Radar will provide a warning alarm that will appear on the screen in the room geotech (Slope stability radar display), a warning alarm, so help the work of geotech team in addressing the movement of the walls of the mine which was observed as well as initial actions to take the next step.

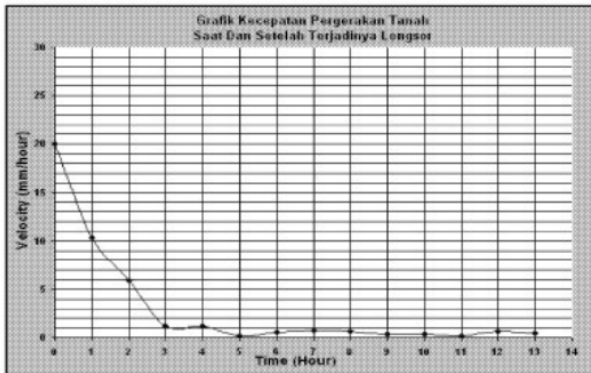
Figure 13.: Grphic which show the velocity of land movement after and event landslide occurred

Critical limits movement (threshold) is required to perform the action or anticipation of an instability that meant to hazards caused by the movement of the mine walls can be minimized. Critical limit values from the results of monitoring using Slope Stability Radar is based on the pattern of movement changes (deformation) which can be determined from the pattern of the graph changes, so that from this movement will get a speed value and level of conducive speed that allows landslide can occur (Figure 13)

After the landslide, the movement of the wall mine shows the residual resistant conditions, which in this case the mine wall to find a new stability, illustrated by a decrease in the value until the speed of movement velocity movements in a stable condition. From the Table 1 can be made a graph by comparing the speed value during and after the occurrence of landslides with time difference in each hour (Figure 5.8). This condition is a condition that is safe in mining activity.
