# Assessment material selection for chain-submerged scarppe conveyor

## ASSESSMENT MATERIAL SELECTION FOR CHAIN - SUBMERGED SCRAPER CONVEYOR

**ABSTRACT:** Chain-submerged scrapper conveyor bottom ash handling in the petrochemical industry has failed several times and was repaired with AISI 420, which can only operate for three months. AISI 420 is recommended in applications requiring moderate corrosion resistance, high hardness, excellent wear resistance, and good edge retention in cutting surfaces. The initial cracks and fractures occur in the pin-link joint hole, which causes chain failure. Some evaluation has been performed for both as-received and failed links. It can be concluded that chain link failure occurs due to fatigue failure with low-stress levels. Microstructure observation, XRD, and hardness properties showed no significant difference in both as-received and failed links. Since the operating conditions of the chain are in a corrosive environment, experiencing dynamic loading and working temperatures between 23 °C and 60 °C, the selection of HSL materials such as AISI 4140 should be considered.

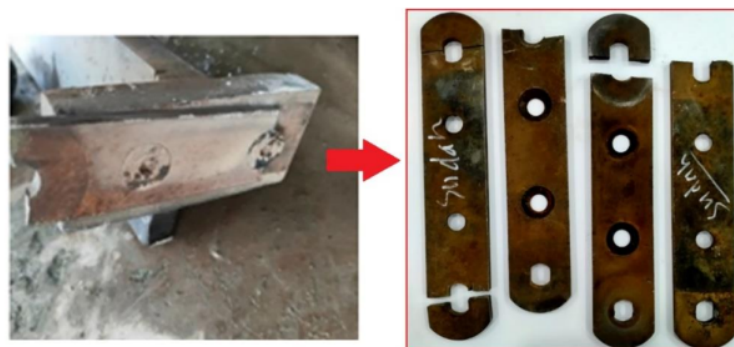
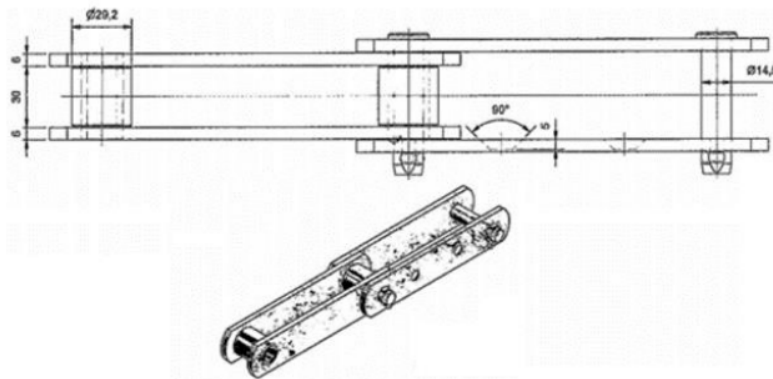
Fig. 1. Failure part of chain scrapper.

The fracture occurs in the pin-link joint hole in one or both end holes. The initial cracks were identified from the corrosion color, which was more concentrated than in other areas. There are two main areas where crack initiation occurs; first, in the area that experiences higher residual stresses due to changes in dimensions that are not streamlined (notch root); the second initial cracks occur in the middle of the pinhole. In both cases, in terms of loading condition, it is believed that the cracks occurred due to the influence of the interference fit pin-links joint assembly and cyclic loading. The failure of the chain-submerged scrapper conveyor can be seen in Fig. 1.

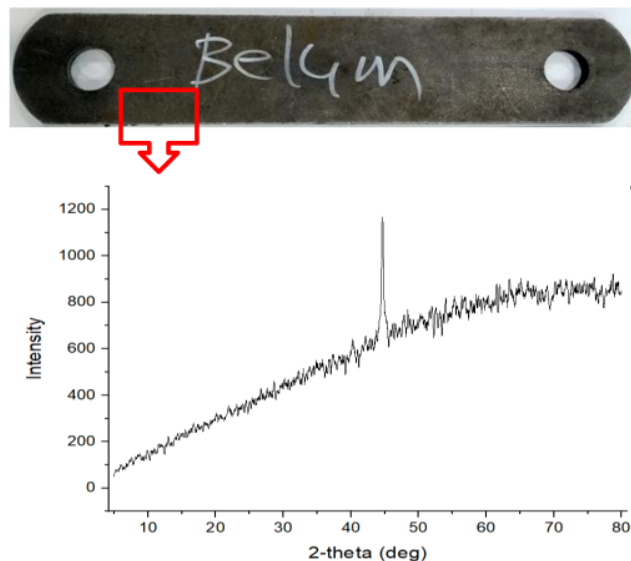
Fig. 2. XRD result of chain scrapper

X-Ray diffraction analysis is a typical means to determine the structure and relative configuration of solid compounds in an unequivocal way. X-Ray Diffraction (XRD) testing on Rigaku MiniFlex 600 with a Cu K $\alpha$  X-ray tube ( $\lambda = 0.17889$  nm) in the Bragg–Brentano configuration. XRD result of chain material is shown in Fig. 2. XRD analysis shows there was not found another peak in the material sample.

The highest presents one peak (at  $2\theta$  angle of  $44.9^\circ$ ) attributed to the martensite phase. The remaining peaks occurring at  $37.2^\circ$ ,  $39.3^\circ$ ,  $40.3^\circ$ ,  $42.5^\circ$ ,  $43.3^\circ$ ,  $45.6^\circ$ ,  $48.8^\circ$ ,  $51.5^\circ$ ,  $55.7^\circ$  and  $57.7^\circ$  correspond to the  $Fe_3C$  phase. The occurrence of the  $Cr_7C_3$  and  $Cr_{23}C_6$  phases could be suggested in the present case. Diffraction peaks occurred for  $2\theta$  angles of  $37.2^\circ$ ,  $39.3^\circ$ ,  $43.3^\circ$ ,  $48.8^\circ$ , and  $51.5^\circ$ , but it should be noted that such peaks could also be indexed for the  $Fe_3C$  phase.

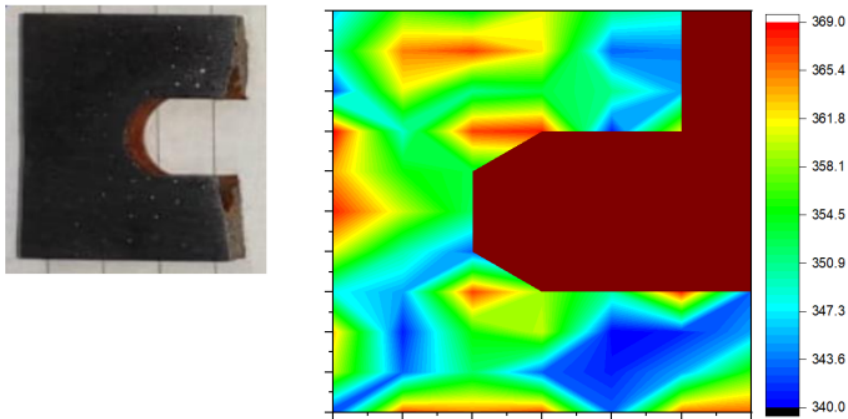
Fig. 3. Contour Vickers hardness test of surface fail link

Typically hardness distribution at various positions using Vickers (VHN) and Rockwell C (HRC) can be seen in Fig. 3. Vickers hardness contour on the link surface is in the range of 340 – 369 VHN. Referring to contours analysis, there is no specific pattern of VHN hardness on the sample surface. High VHN values can be found not only on the edge surface but also on the surface far from the edge.

The material hardness, either as-received or failed link, did not show a significant difference in the hardness value and the pattern of hardness distribution. This is due to an inhomogeneous distribution of carbides in the microstructure. Then, the presence of retained austenite within lath martensite, which usually has a detrimental effect on hardness, is shown in Figs 10 and 11. As previously explained, inhomogeneous distribution was also detected on the as-received link of large and small carbides inside the lath martensite associated with  $M_7C_3$  and  $M_{23}C_6$ .  $M_{23}C_6$  carbide was found in colonies with the irregular shape of individual carbides. These carbides have very large sizes ranging from 15 to 20 microns.

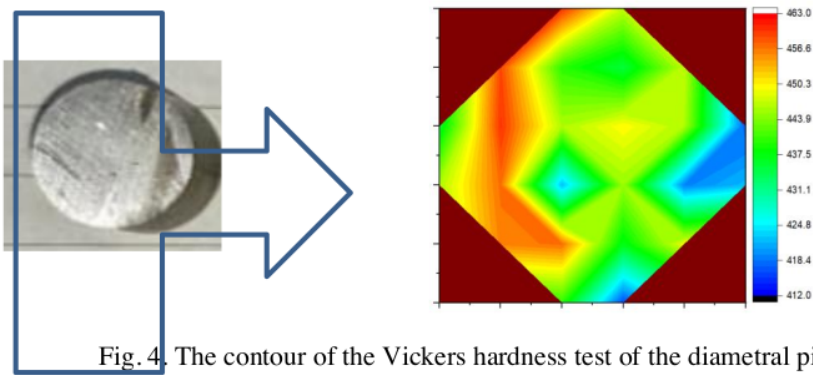
Fig. 4. The contour of the Vickers hardness test of the diametral pin

Random VHN patterns are also found on the pin surface in Fig. 4 in the 412 – 463 VHN. The VHN pin hardness value is relatively higher than that in the link surface. Even in the as-received sample detected using the HRC test (Fig. 5.), the random patterns found on the HRC hardness value indicate the surface hardness of the failed sample, and the as-received sample does not experience a significant change in pattern.

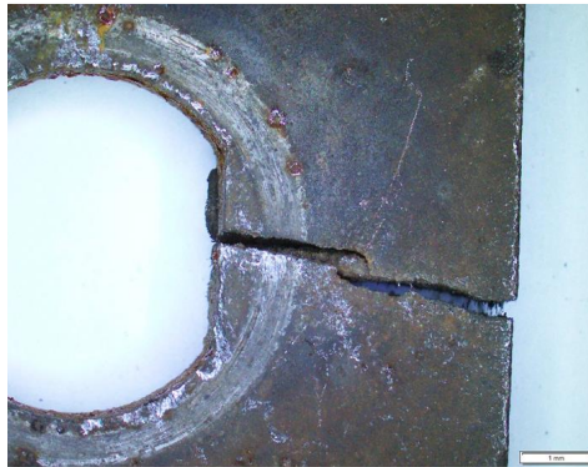
Fig. 6. Typically fractured chain link

Fig. 6 shows the type of failed link. The fracture occurs in the pin-link joint hole in one or both end holes. The initial cracks were identified from the corrosion color, which was more concentrated than in other areas (Fig. 7). There are two main areas where crack initiation occurs; first, in the area that experiences higher residual stresses due to changes in dimensions that are not streamlined (notch root) as depicted in Fig. 7; second initial cracks occur in the middle of the pinhole. In both cases, in term of loading condition, it is believed that the cracks occurred due to the influence of the interference fit pin-links joint assembly and cyclic loading.

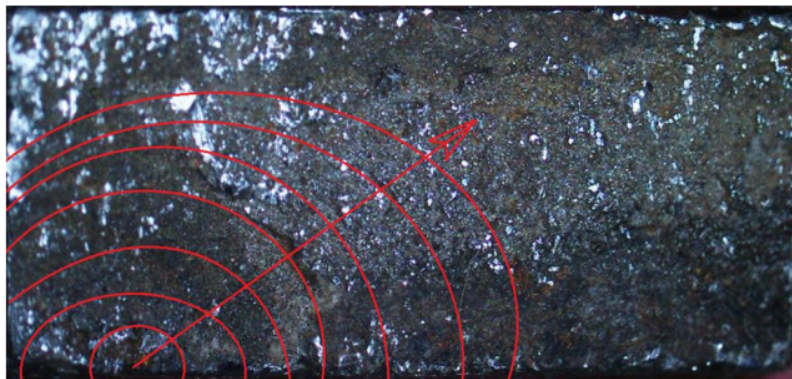
Fig. 7. Initial crack location and crack growth direction on the cross-section of the chain failed

Macrostructure fractographic results are illustrated in Fig. 8; as shown, all specimens have negligible plastic deformation. However, there are some plastic deformation places and microvoids in specimens. A mixture of ductile and brittle mechanisms is visible in these specimens. The fracture appearance appears mainly as the cleavage and river pattern or brittle features mixing with a little ductile region. In addition, some voids are present in the fracture surface, probably formed at the matrix/carbide interfaces. Metallography observation also showed. Generally, the fracture was observed on vertex holes. The fracture surface consists of the initiation zone, the fibrous zone, the unstable zone, and the shear lips zone. Fig. 7. shows the profile of crack propagation across the initiation zone and fibrous zone.

Fig. 7 illustrates crack growth based on fractographic patterns and surface contours. Although the beach mark pattern as a general indication of fatigue failure is not visible, the relatively smooth surface contour with a circular pattern, as shown in Fig. 7, indicates the cracks propagate due to cyclical loading. A smooth fatigue fracture surface contour also indicates a very low load level compared to the material's tensile strength. Another evidence of a fatigue fracture mode can be seen in Fig. 8, where the link fails on both sides, but still, parts are connected. The fracture pattern clearly shows the link does not break apart suddenly due to excessive loads that exceed the tensile stress limit. However, fracture occurs slowly and gradually at low-stress levels.

1. Chain link failure occurs due to fatigue failure with very low-stress levels
2. Brittle fracture is found on the surface of the fractured specimen
3. Microstructures, XRD, and hardness properties showed no significant difference between as-received and failed links.
4. AISI 420 Chain link operates at ductile to brittle transition temperature (DBTT), where naturally, DBTT for AISI 420 steel is in the range 0 - 50°C.

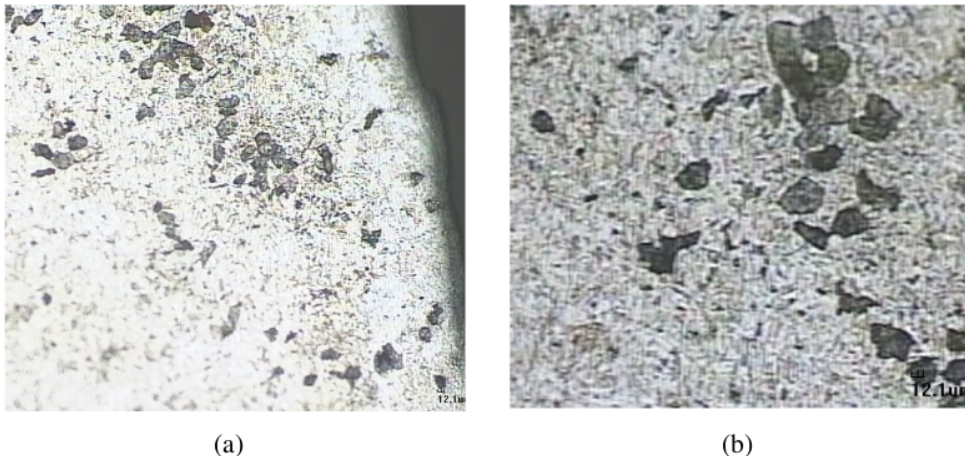
Fig. 11. Microstructure of as-received surface link chain: (a) near the edge, and (b). middle area

The tempered martensite microstructure of normalized-and-tempered ferritic/martensitic steels is more complicated than a solid solution, as shown (Fig. 11). During the normalization treatment, the steel is heated above the  $AC_3$  temperature to transform the ferrite to a solid solution of austenite that transforms into body-centered tetragonal (BCT) martensite when it is air cooled.
