Improvement Incoloy Alloy 800 Weldability After 10 Years of Service through Solution Annealing and Normalizing Method

DOI : 10.36909/jer.16773

Amir Arifin, Gunawan*, Jaya Rizki Saputra

Department of Mechanical Engineering, Sriwijaya University, 30662 Indralaya, Sumatera Selatan, Indonesia.

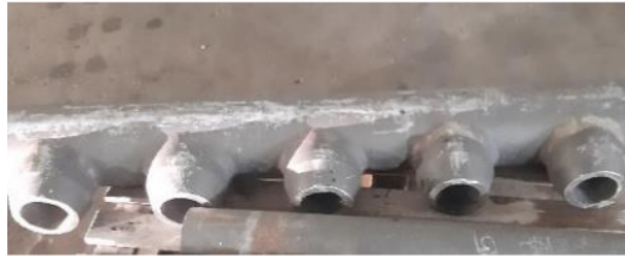
Figure 1. Outlet Manifold Bottom Header

The material used during this research process came from the Outlet Manifold Bottom Header (OMBH) component (Figure 1). It operates at high pressure and temperature categorized as a superalloy type, namely alloy 800, which has resistance to high pressure and temperature and resistance to corrosion. The Incoloy alloy 800 used by a fertilizer plant for the OMBH component produced by Manoir Industries is M900. Furthermore, its composition was investigated through X-Ray Fluorescence Analyzer Niton XL 2. The welding was performed using Gas tungsten arc welding (GTAW) with Filler Rod Er NiCrMo-3. Liquid penetrant testing is conducted before and after welding to reveal open surface welding defects. In this work, the Weldability sample is measured to refer to the effect of welding on indications of defects or crack appearance after the dye penetrant test. A weldability test was performed before and after the welding process. Heat treatment for OMBH was carried out through solution annealing and the normalizing process refer to the Association of Mechanical Engineering (ASME) standards for Incoloy alloy 800 material. A schematic diagram for heat treatment can be shown in Figure 2. The measurement of the hardness value in the weld area was carried out using the Vickers method with a diamond indenter to get better accuracy. Vickers method was performed with load 20 Kgf based on JIS Z 2244 standard with three repetitions. X-Ray Diffraction was conducted on the welding position to investigate phase formation. Furthermore, analysis metallography was conducted using etching fluid (20 ml HNO₃ and 80 ml HCl) and optical microscope, which refers to ASTM E-407 standard.

The primary reformer is a reactor in a fertilizer plant operated at a 600-800 °C temperature and a pressure of 30-40 Kg/cm². It has a function as a breakdown of hydrocarbon gas into hydrogen. This process occurs at high temperatures and pressures (Alvino, Lega et al. 2010). One of the essential parts of the primary reformer in fertilizer plants is the Outlet Manifold Bottom Header (OMBH).

OMBH is manufactured using Incoloy alloy 800 and has been operating for ten years. The OMBH is subjected to high-temperature heat during operation, changing the microstructure

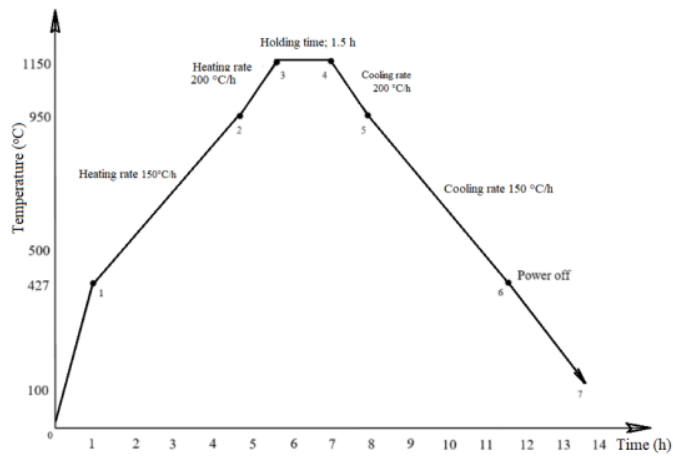
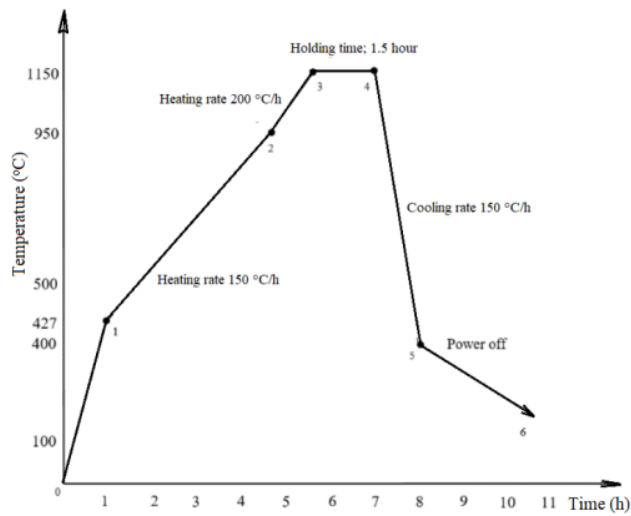
Figure 2. Schematic diagram of the heat treatment process, a) Normalizing and (b) Solution

(a)

(b)

Annealing

Heat treatment of samples was carried out by solution annealing and normalizing methods that have the main objective of reducing residual stresses to improve the ductility of the alloy 800.

Parameters in heat treatment refer to ASME Section VIII Div 1 part UCS-56 and UNF-56.

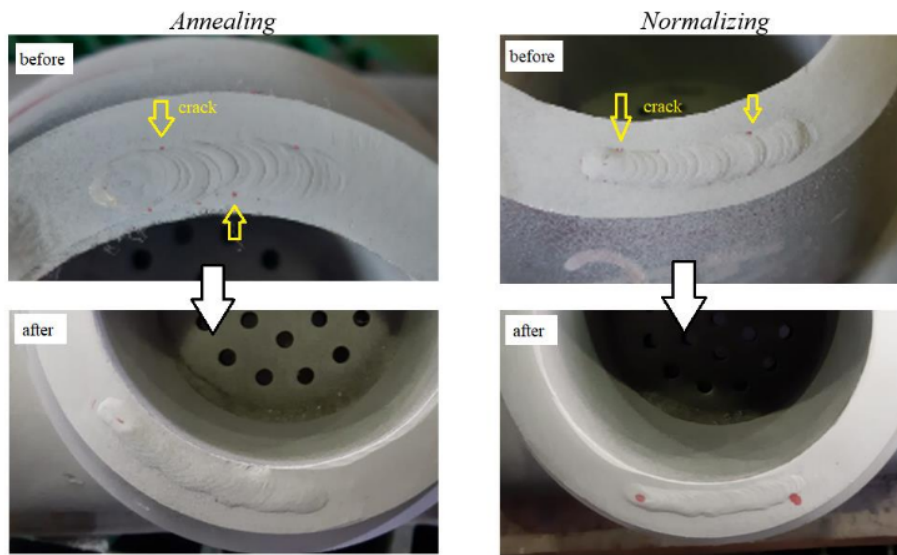
Figure 3. Weldability test before and after heat treatment

treatment process stated that the normalizing sample indicated that there were still indications of defects or cracks on the surface of the normalizing sample that the welding process had carried out. The indication of defects or cracks in normalizing samples has been significantly reduced, as shown in Figure 3. Defects or cracks can be seen from the results of the penetrant test, which resulted in a red penetrant liquid after the developer fluid spraying process. Weldability test revealed that sample annealing solution showed no indication of defects or cracks after the welding process was carried out on the sample surface.

The results of the annealing solution sample and the normalizing sample after the heat

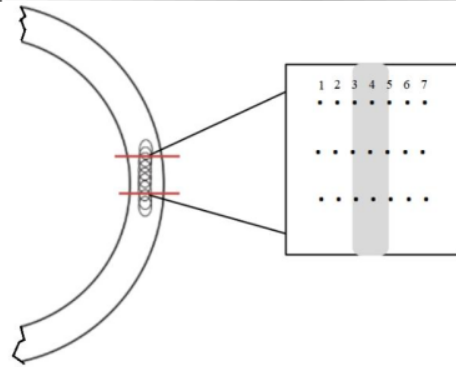
Figure 4 Hardness test position

Hardness testing is used to measure the resistance of the material to deformation caused by penetration of the surface of a material. The position hardness test of the sample refers to the red line, which can be seen in Figure 4. Incoloy Alloy 800 samples that have been subjected to a weldability test process are then prepared to perform a hardness test by cutting the sample into 2x2 cm sizes and carrying out a framing process derived from a mixture of resin and catalyst.

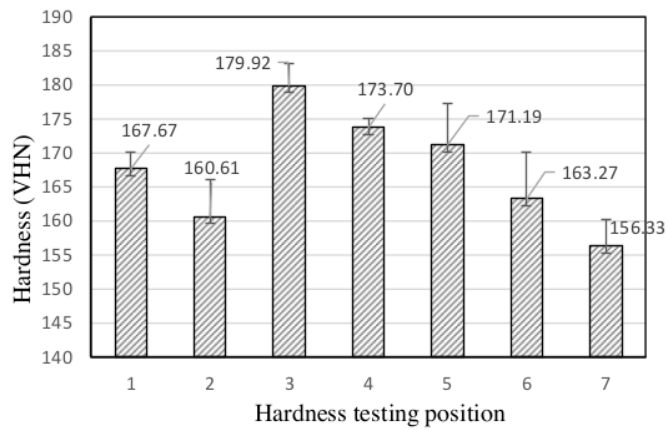
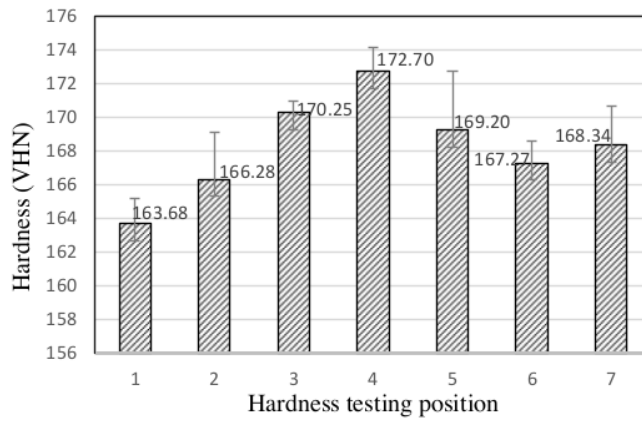
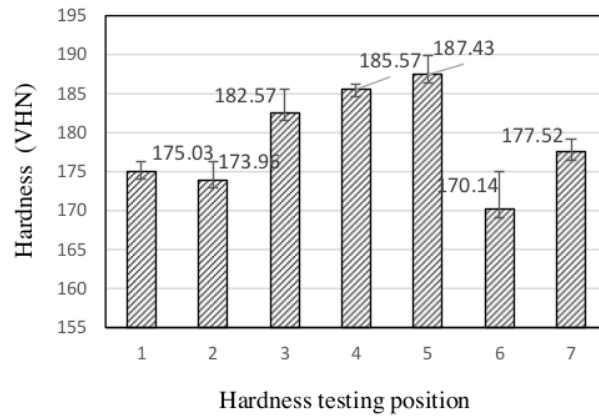
(c)
Figure 5. Hardness profile on weld zone (a) Nontreatment, (b) Solution annealing, and (c) Normalizing

The hardness test results shown in Figure 5 states that the base metal represented by zone 1,2,6 and 7 has decreased hardness from the technical data standard of the alloy 800. The material standard technical data shows the hardness value of the superalloy material with the main element made from nickel and chromium are 170 VHN, while the highest hardness in the base metal is 167 VHN. The low hardness value on the non-treated samples is due to the prolonged exposure to heat during the operation process, as shown in Figure 5 (a). a decrease in the hardness value results in a failure phenomenon such as creep. The hardness value increases in the fusion zone (3,4, and 5) due to new alloys from the filler rod, as shown in Figure 5 (b). The normalizing sample was machined and polished for preparing the hardness sample test. Furthermore, Hardness testing was carried out seven times at different zone with three repetitions, as shown in Figure 4. Figure 5 (c) shows the hardness testing results on normalizing samples. The test results show that the hardness value of the base metal is close to the Incoloy alloy 800 standard hardness value. The base metal hardness value increased after normalizing treatment if compared to solution annealing and non-treated samples. Due to the slower cooling rate impact, the greatest hardness value on the base metal was reached at 177 VHN during the normalizing process. The preservation of carbide throughout the heat treatment procedure with a slow cooling rate is significant in the resultant growth (Aloraier,

A., K. et al 2014, Sharma, N., W. et al 2020). An increase in the amount of carbide plays a role in increasing the hardness value.

The maximum hardness value is 187 VHN in zone 5 on the welding zone. Several variables, such as carbide precipitation and additional alloying elements, influence the hardness value to be high in the welding area. Figure 6 (a) shows the XRD test results from nontreatment samples. The phase characteristics of the alloy material 800, which has been operating for a relatively long time, consist of phases of austenite, Cr_{23}C_6 , and NbC. The main peaks show the austenite phase with an angle value of 2θ of 43.582 and a peak intensity of 768. An angle value of 2θ of 50.1 indicates the second-highest peak phase with a peak intensity of 368 diffusions (Arifin, Gunawan, et al., 2020). The lowest peak is the diffusion of niobium and carbon, forming NbC carbides with an angle of 2θ of 74.2 and a peak intensity of 90.

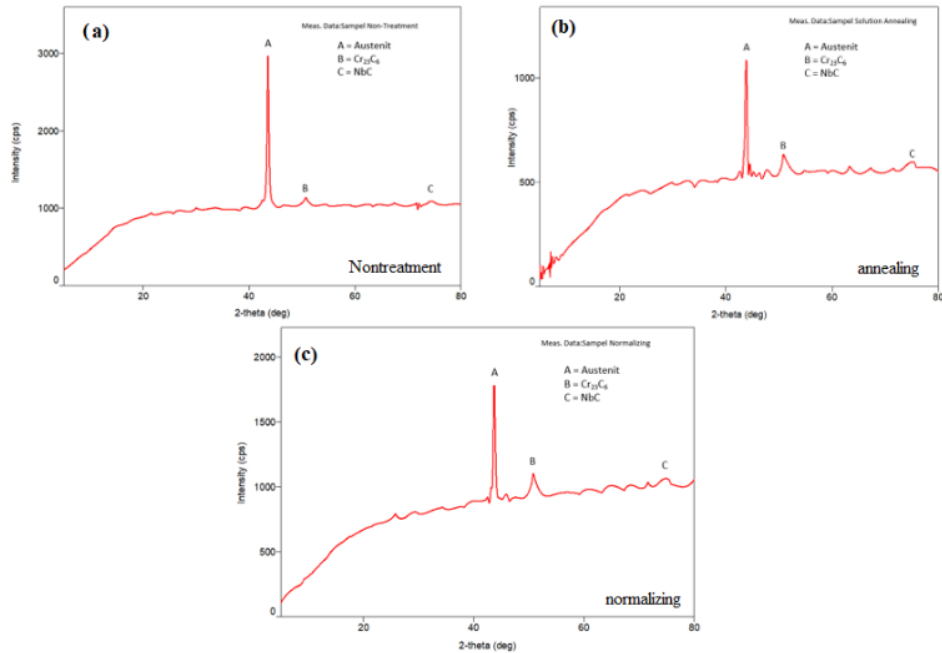
Figure 6 (b) shows the XRD test results of the Incoloy alloy 800 heat treatment process with the solution annealing method. The results showed that the phase characteristics consisted of austenite, Cr_{23}C_6 , and NbC phases. The peak list shown by the graph states that the austenite phase is the peak phase formed with an angle of 2θ of 43.82 and a peak intensity of 279. The second highest peak of the phase is the diffusion between carbon and chromium, which forms Cr_{23}C_6 carbide. The diffusion of niobium and carbon owns the lowest peak to form NbC carbides.

Figure 6. XRD testing results ;(a) nontreatment, (b) annealing, and (c) normalizing sample XRD test results for Incoloy alloy 800 through the normalizing method can be seen in Figure 6. The results showed that the phase characteristics consisted of austenite, Cr₂₃C₆, and NbC phases. The peak list shown by the graph states that the austenite phase is the peak phase formed with an angle of 2θ of 43.82 and a peak intensity of 279. The second highest peak of the phase is the diffusion between carbon and chromium, which forms Cr₂₃C₆ carbide. The diffusion of niobium and carbon owns the lowest peak to form NbC carbides.

The XRD test results show almost the same pattern in each trial sample, but the results of the diffraction peak pattern show a widening curve. In the heat-treated sample, the peak shift to 2θ is more significant. Solution annealing samples experienced a significant peak shift than normalizing samples. If material is affected by an inhomogeneous strain field, the peak position shifts and the diffraction peaks are expelled. The peak shift in the XRD result indicates a change in residual stress in each sample due to The effect of strain correlates with the residual stress.

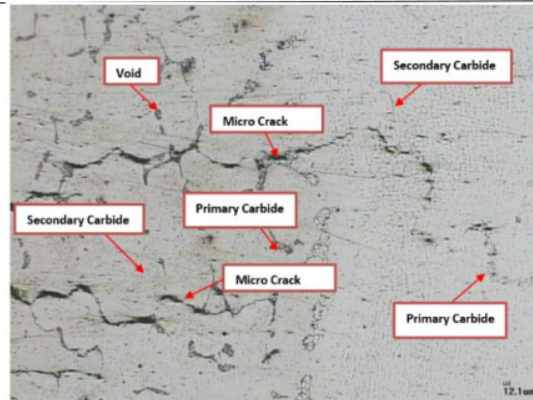
Figure 7. Metallographic testing results of nontreatment sample

The observation result of the nontreatment sample is shown in Figure 7. the microcrack attacks the grain boundaries because there are voids that have fused and are connected. The voids have been spread out in grain boundaries to around grains. Voids can coalesce and be connected due to the influence of residual stress from thermal activity. The microcrack will cause creep cracking on the surface, which causes cracking in the aging Incoloy alloy 800. According to the standard of Manoir Industries, the appearance of microcracks following the weldability test method indicates that the performance of the material has deteriorated. (Anderoglu 2004).

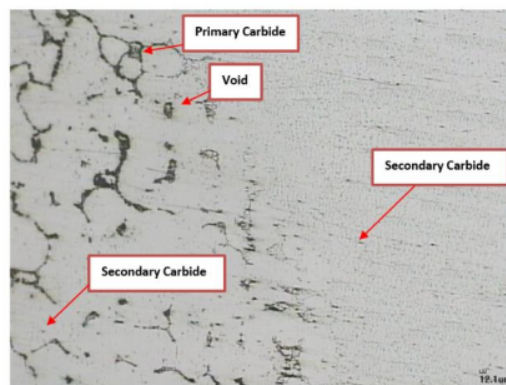
Figure 8. Metallographic testing results of solution annealing sample

The annealing solution sample shown in Figure 8 revealed no microcracks like the non-treated sample. The sample annealing solution indicates the presence of primary carbide, secondary carbide, and voids, but microcrack does not occur in the annealing solution sample. The absence of microcrack is caused by a reduction in residual stress, which minimizes the

formation of connected and unified voids.

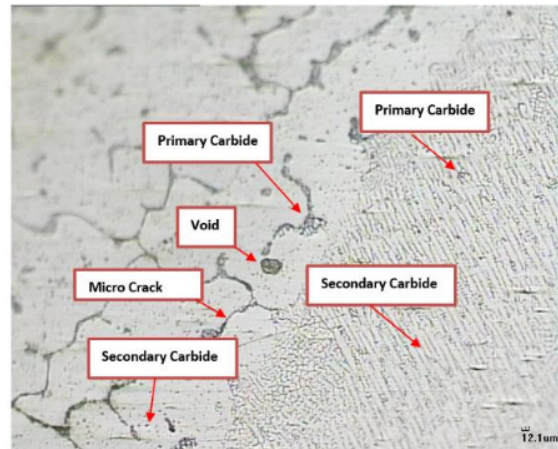
Figure 9. Metallographic testing results of normalizing sample

The normalizing sample is shown in Figure 9 states that there are microcracks that have spread to the boundaries of the weld area. Micro crack propagation occurs due to the influence of heat on the weldability test process. The reduction in residual stress also occurred in the normalizing samples, which was shown in the microcrack formation results that were not as large as the nontreatment samples. The heat treatment minimizes residual stress that can affect voids so that voids do not coalesce and coalesce to form a microcrack.
