**ANALYSIS OF LANDSLIDE AT OUTSIDE DUMPING AREA
AIR LAYA COAL MINING SITE, INDONESIA**

ABSTRACT

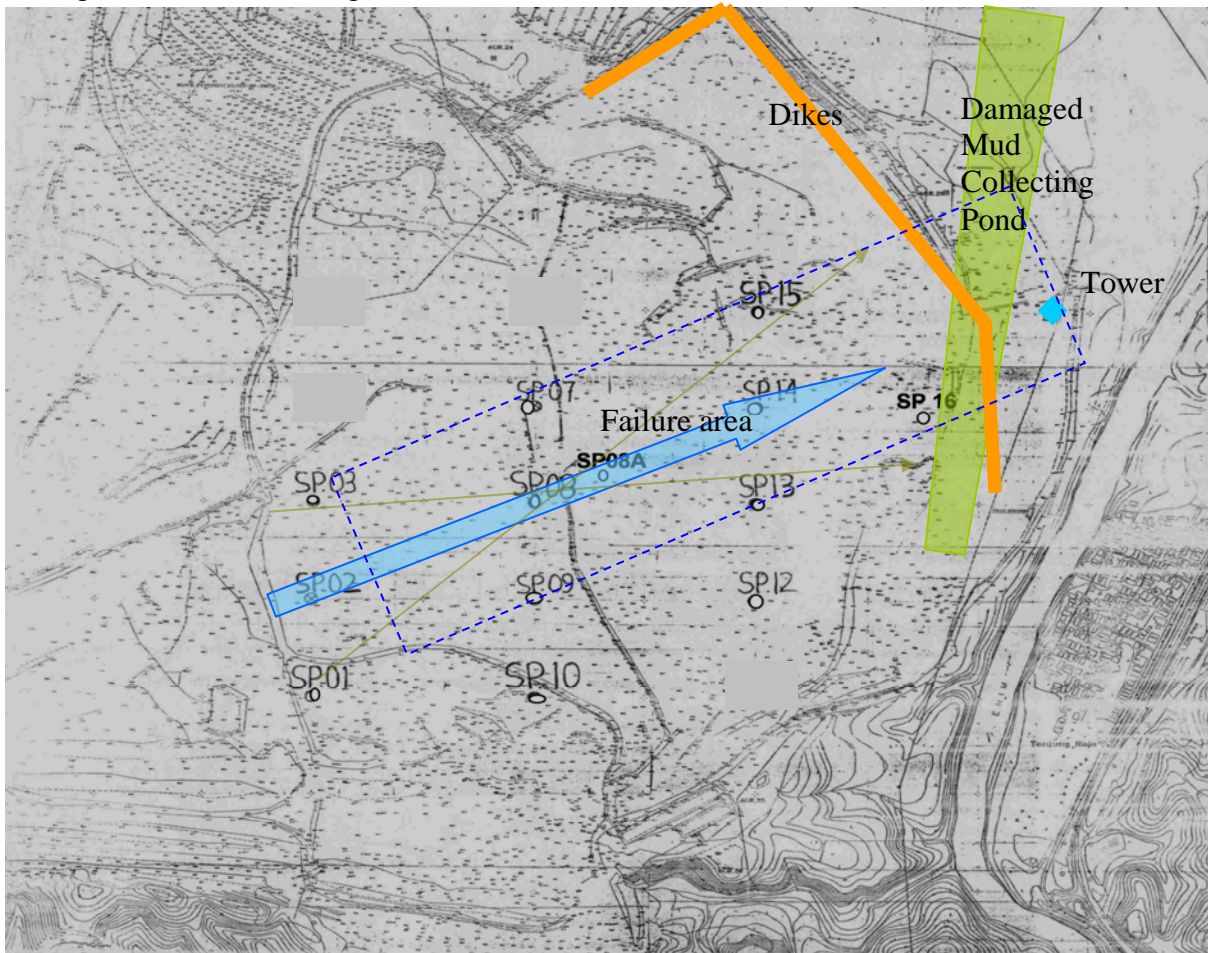
Figure 6 Layout of the boreholes

The ground investigation was planned based on the analysis of topography and the geometry of the landslide. It comprises of 11 bore holes and 2 check-bore-holes through the sliding area as shown in Figure 6.

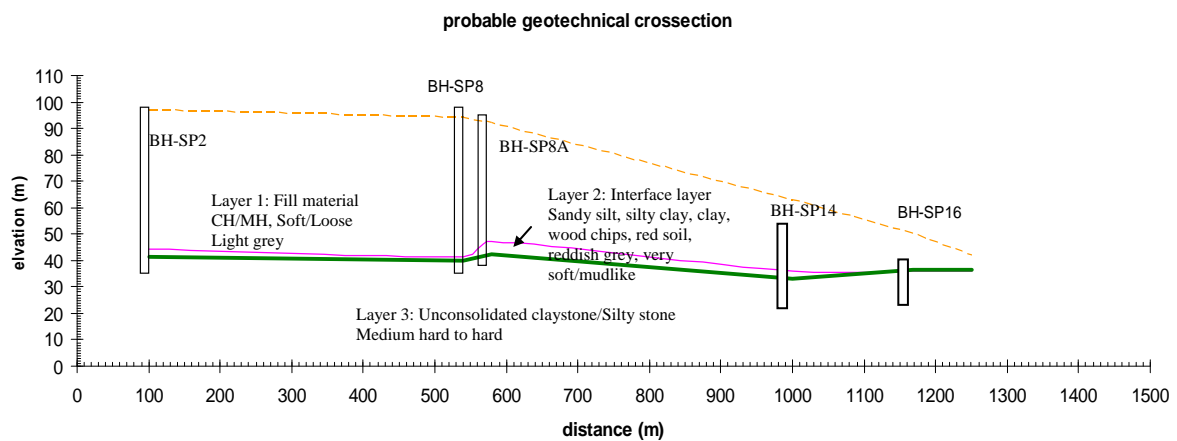
Figure 7 Soil Profile

The bore-log was drawn carefully to establish the soil profile. As expected, the general stratification of the fill area consisted of three layers. Layer 1 is the dumped material, mostly comprises of silty clay with some sand fraction. Layer 2 is the interface layer between the natural ground and the fill that comprises of loose silty clay mixed with wood chips, soft rock and red clay, and some organic matter. Layer 3 is the unconsolidated natural ground consists of unconsolidated weathered clay stone and siltstone. The soil profile along the most critical cross-section and the properties of soil at each layer is given in Figure 7. This profile passes a location where the failure starts at a tension crack (BH- SP8) to the toe where most of the damage occurred (Figures 8). Five boreholes were completed along the cross-section i.e. BH-SP2, BH-SP08, BH-SP08A, BH-SP14, and BH SP16.
