Damage Analysis of Moldboard Plow

Diah Kusuma Pratiwi¹, Hendri Chandra^{1*}, Nurhabibah Paramitha Eka Utami¹, Okta Irawan¹, and Arman Natal Purba¹

¹Department of Mechanical Engineering, Universitas Sriwijaya, 30662, Indralaya, South Sumatera, Indonesia

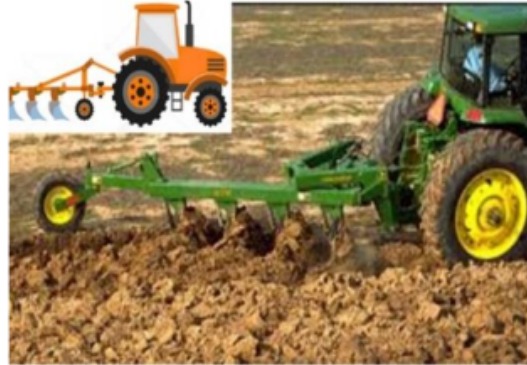
Fig. 1. Multiple moldboard plow

Currently, multiple moldboard plows are used as shown in Figure 1 (a) and (b) show the bottom of the moldboard plow. The edge of the moldboard is the most easily cracked, broken, or deformed plastic part.

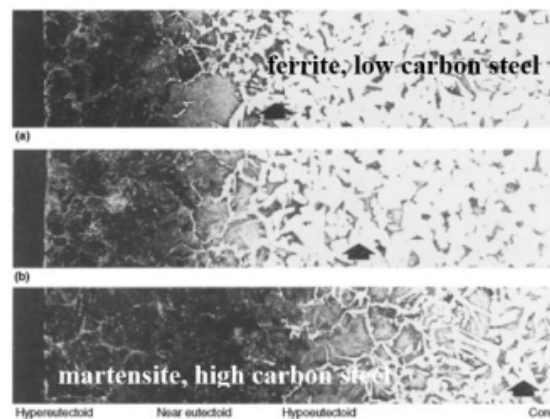
Fig. 3. Double layer microstructure consisting of martensite and ferrite [3]

Moldboard usually is made of two layers of steel. The outer layer is high carbon steel with the chemical composition are 0.9 to 1.05 %C. However, the middle layer has carbon composition of 0.08 to 1.3% [2]. Near to the surface of the double layer, the material contains martensite phase in the outer and ferrite in the inner, whereas martensite is consist of high carbon steel and ferrite is low carbon steel[3]. Figure 2 shown double layer steel.

The cause of the damage is because the composition of carbon is too low and on the outside surface is not done heat treatment on the surface of the moldboard so that no martensite phase. should the material used to make the moldboard plow has been done the addition of carbon composition on the surface through carburization process that will form martensite phase plated outside the bottom plow.
