4
ANALYSIS OF LANDSLIDE AT OUTSIDE DUMPING AREA
AIR LAYA COAL MINING SITE, INDONESIA

Marwan Asof,
Sriwijaya University, Indonesia

ABSTRACT

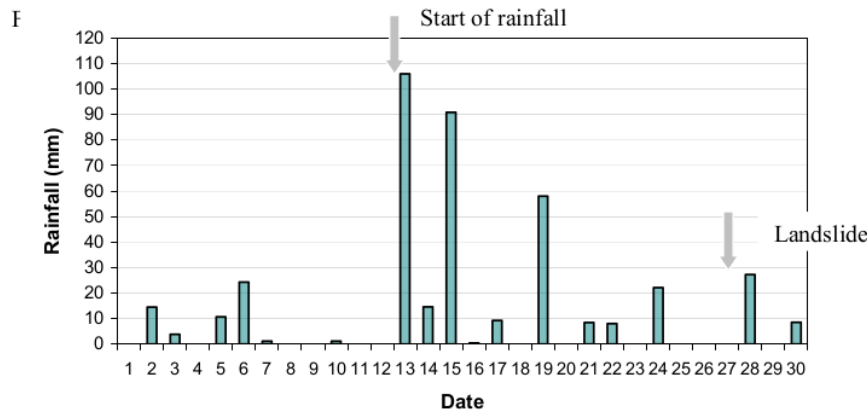
Figure 4 Daily rain-fall in November 2004

The ground failure occurred after periods of heavy rainfall that started on 13 November 2002 after a period of a very dry season that last for about six months. This condition suggested that rainfall might play a contributory part into the landslide. A rainfall of more than 100 mm took place within 2 hours in November 13 followed by periods of rain continued until November 24 with cumulative rainfall of 318 mm (Figure 4, and 5). Analysis of rainfall data based on 20-year return period showed that the rainfall after November 13 was on the highest rating for 3, 5, and 7 day-rainfall data.

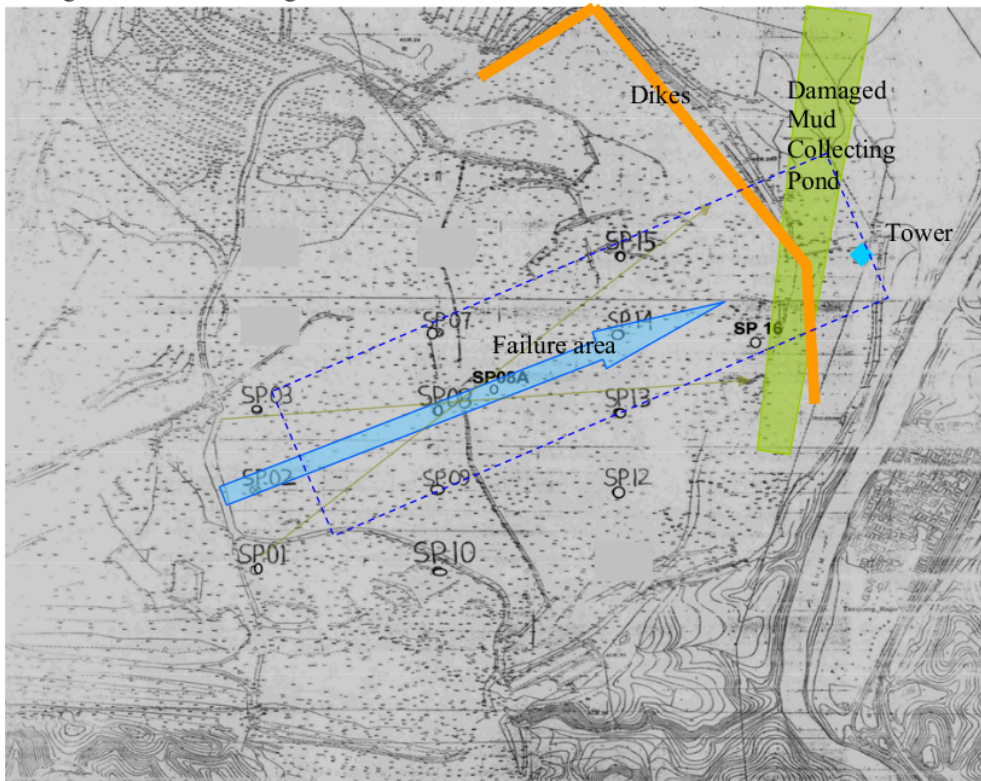
Figure 6 Layout of the boreholes

The ground investigation was planned based on the analysis of topography and the geometry of the landslide. It comprises of 11 bore holes and 2 check-bore-holes through the sliding area as shown in Figure 6.

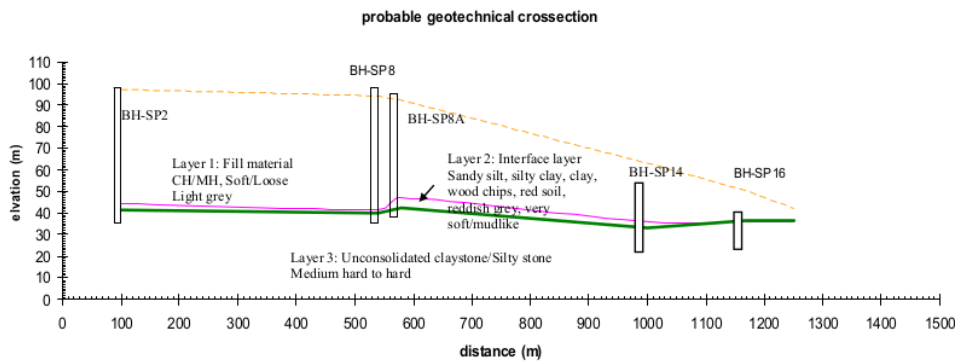
Figure 7 Soil Profile

The bore-log was drawn carefully to establish the soil profile. As expected, the general stratification of the fill area consisted of three layers. Layer 1 is the dumped material, mostly comprises of silty clay with some sand fraction. Layer 2 is the interface layer between the natural ground and the fill that comprises of loose silty clay mixed with wood chips, soft rock and red clay, and some organic matter. Layer 3 is the unconsolidated natural ground consists of unconsolidated weathered clay stone and siltstone. The soil profile along the most critical cross-section and the properties of soil at each layer is given in Figure 7. This profile passes a location where the failure starts at a tension crack (BH- SP8) to the toe where most of the damage occurred (Figures 8). Five boreholes were completed along the cross-section i.e. BH-SP2, BH-SP08, BH-SP08A, BH-SP14, and BH SP16.
