Analysis of Utilization of Pandan Fiber Biocomposite Materials as a Motorcycle Body Kit Using Impact Testing With Charpy Method

Key words: Body Kit, Pandan Mat, Epoxy Resin, Impact Test.

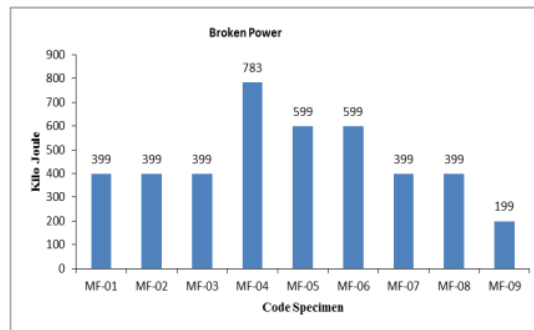
Figure 5 Explaining Fracture

From the graph above, it can be explained that the specimen with the code MF-04 with a composition of 85% resin + hardener with a mixture ratio (Mix A: B) 2:1 and 15% pandan mat fiber, the highest value of fracture strength was obtained from the impact test of 783 KJ (kilojoules). With specimen code MF-05 with a composition of 85% resin + hardener with a mixture ratio (Mix A: B) of 2:1 and 15% pandan mat fiber and MF-06 with a composition of 85% resin + hardener with a mixed ratio (Mix A: B) 2:1 and 15% pandan mat fiber obtained a moderate value of fracture strength from the impact test results of 599 KJ. With specimen code MF-01, MF-02, MF-03 with a composition of 95% resin + hardener with a mixture ratio (Mix A: B) of 2:1 and 5% pandan mat fiber and MF-07, MF-08 with a composition of 75 % resin + hardener with a mixture ratio (Mix A: B) 2:1 and 25% pandan mat fiber obtained a value below moderate fracture strength from the impact test results of 399 KJ. With the code specimen MF-09 with a composition of 85% resin + hardener with a mixture ratio (Mix A: B) 2:1 and 15% pandan mat fiber, the lowest fracture strength value was obtained from the impact test results of 199 KJ.

From the table, the results of the calculation of the data above can be explained in the form of a graph below:
